FIELD OBSERVATION REPORT

Project: Landfill Solar Project
Client: Town of Cumberland
GP Field Rep: Benjamin Grondin (BG)
Weather: No major storms

GPCEI Project No: 1636.98
Visit Date: Multiple visits
Report Date: May 24, 2019
Temp. Range: 45 – 60°F

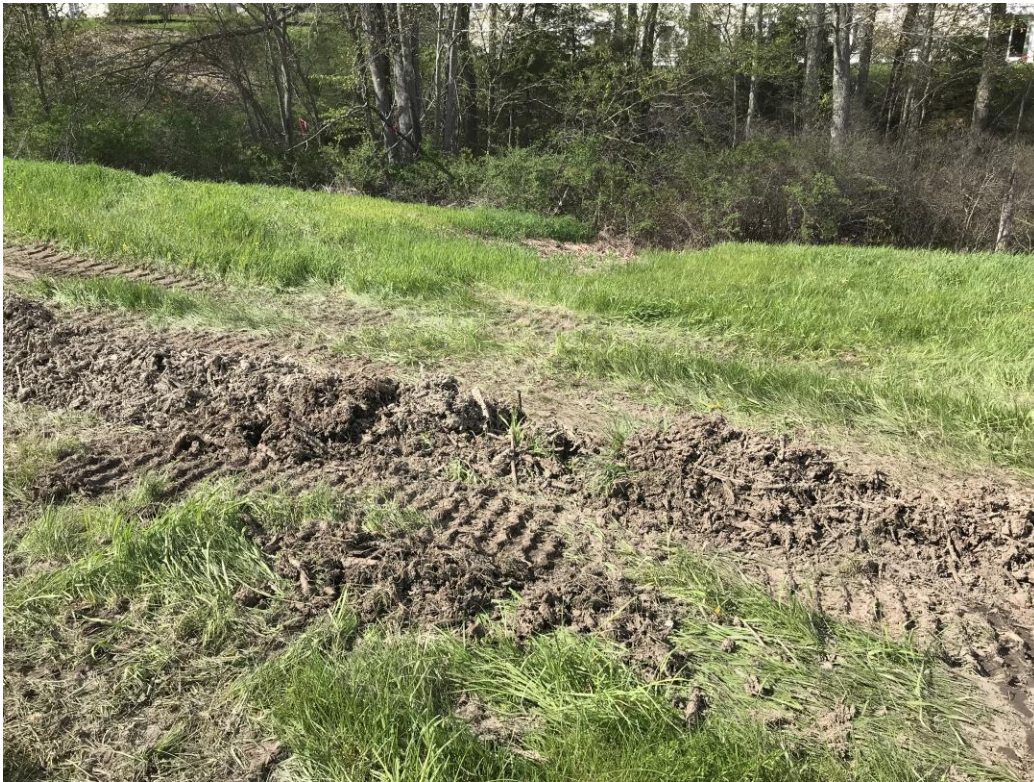
- Bark mulch berm has been placed in general accordance with the plans.
- BG observed multiple areas of the mulch berm that do not appear to be sufficient. There appears to be adequate surrounding vegetation and currently no work in the deficient areas. Additional material should be added to the mulch berm prior to working near the deficient areas.

Photo 1 – Deficient area on mulch berm.

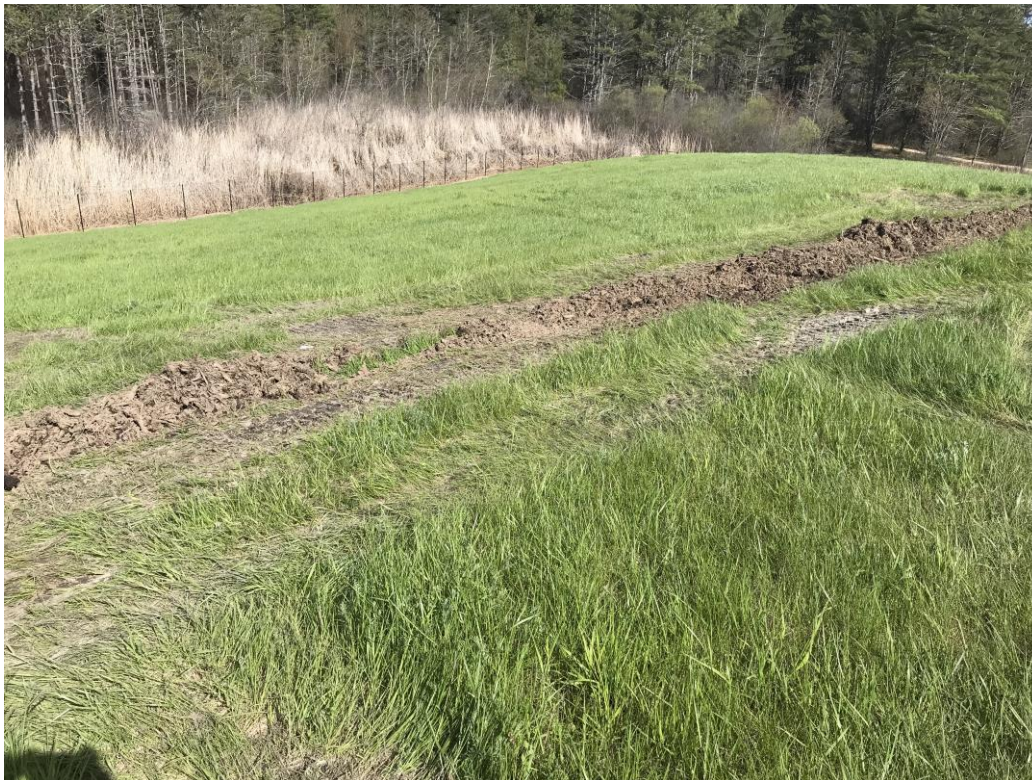
Photo 2 – Deficient area on mulch berm.

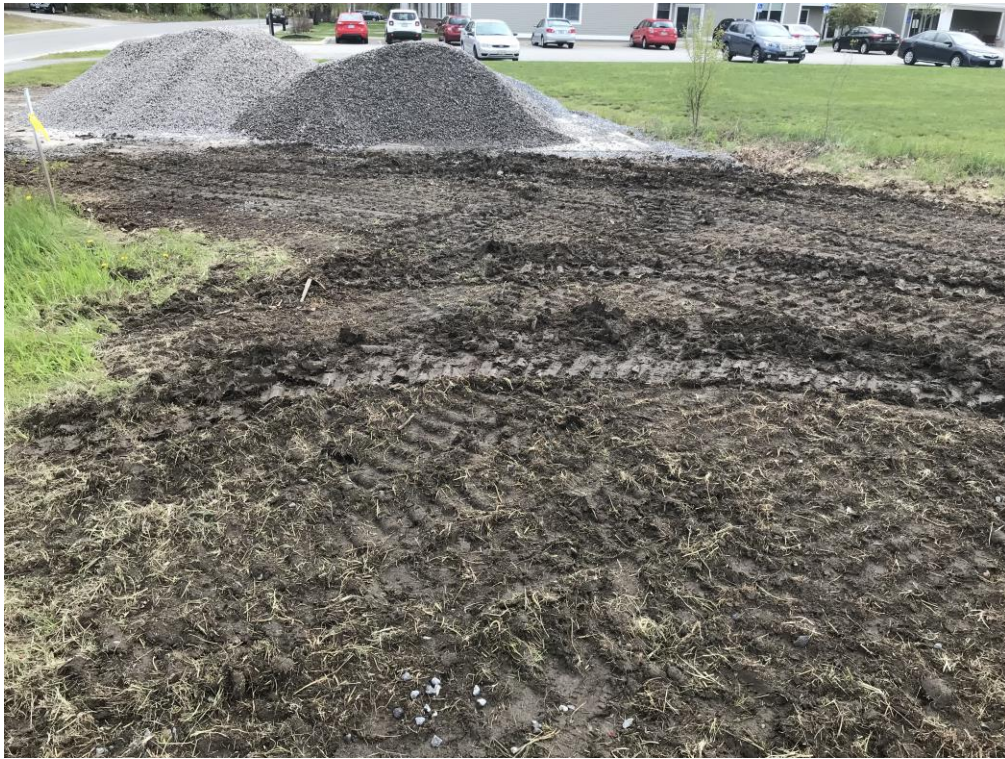
- BG met with Tate Porter and Bill Shane (Town of Cumberland) onsite on Friday, May 24, 2019. BG indicated it appeared crew was accessing the site near the concrete pad area and equipment has denuded the area. BG suggested to Bill that a stabilized construction entrance be installed at the area. Bill indicated a construction entrance should be installed if trucks will be entering and leaving the site from this area. But if equipment is just accessing the staging area and not going onto the roadway then a construction entrance is not necessary. Bill did indicate a bark mulch berm should be installed along the denude area to reduce sedimentation onto the sidewalk however. Bill also indicated the mulch berm on the southern portion of the site should be extended.

Photo 3 – Denude area near concrete pad staging area.

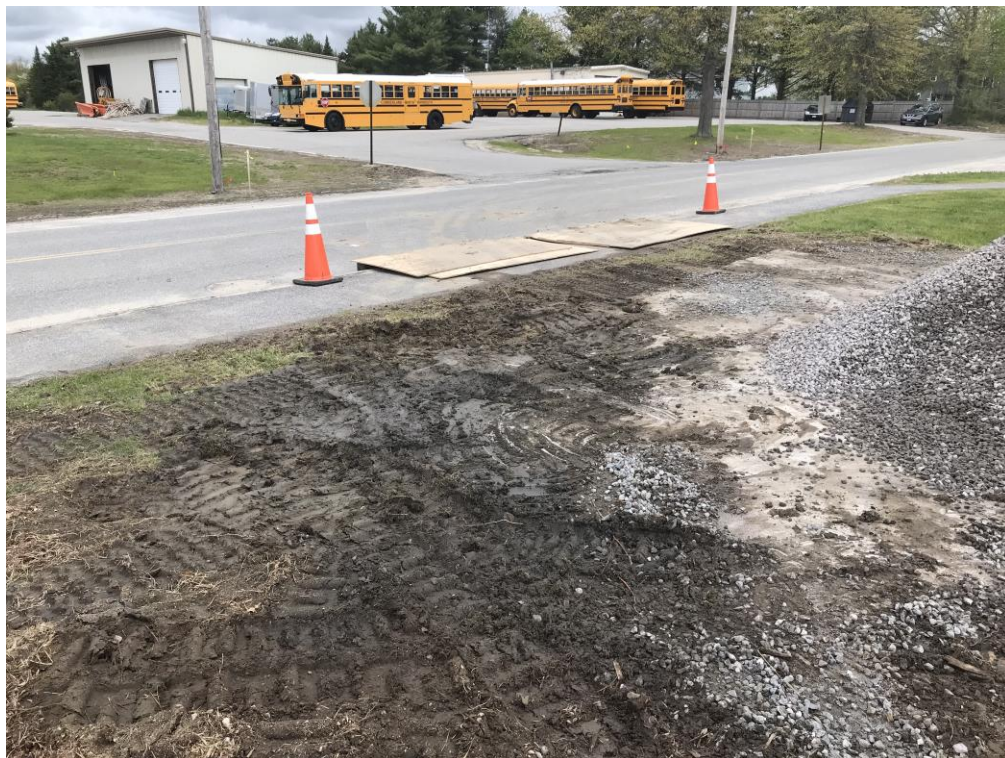
Photo 4 – Denude area near concrete pad staging area.
