**DAILY CONSTRUCTION REPORT**

Date: Wednesday, 6-10-2020

**PROJECT:** 2020 Tuttle Road Sidewalk Extension  
**CLIENT:** Town of Cumberland  
**CONTRACTOR:** Storey Brothers  
**PROJECT MANAGER:** Dan Diffin, P.E.

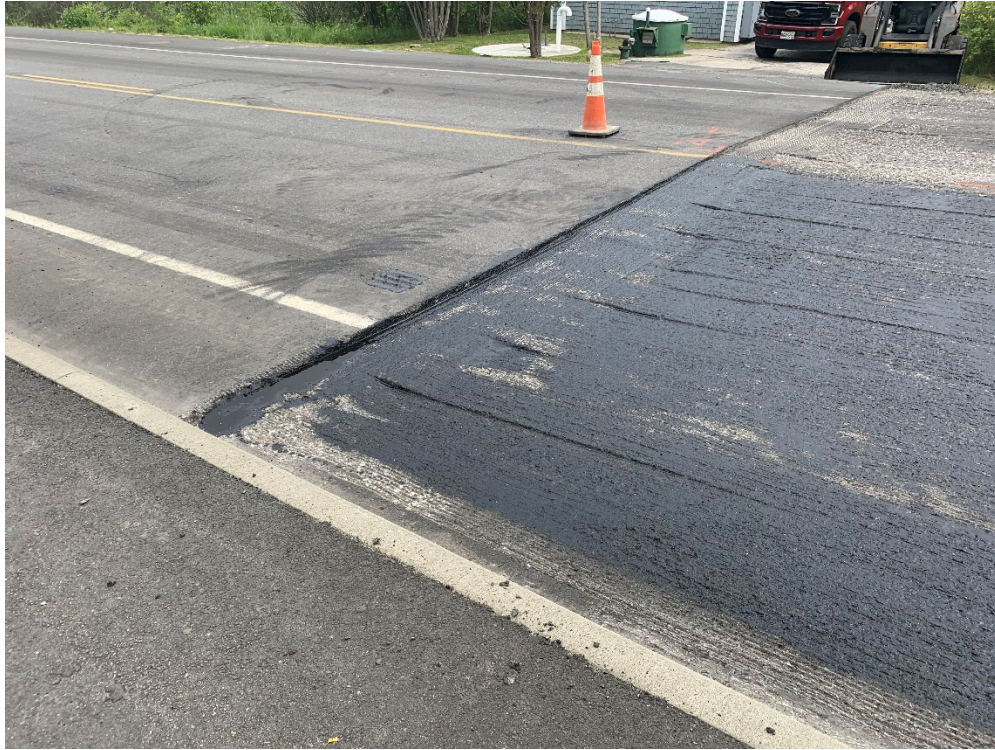
Photo 1 – Tacked pavement joint and surface on southeast travel lane near PWD Sewer Pump Station, looking north.

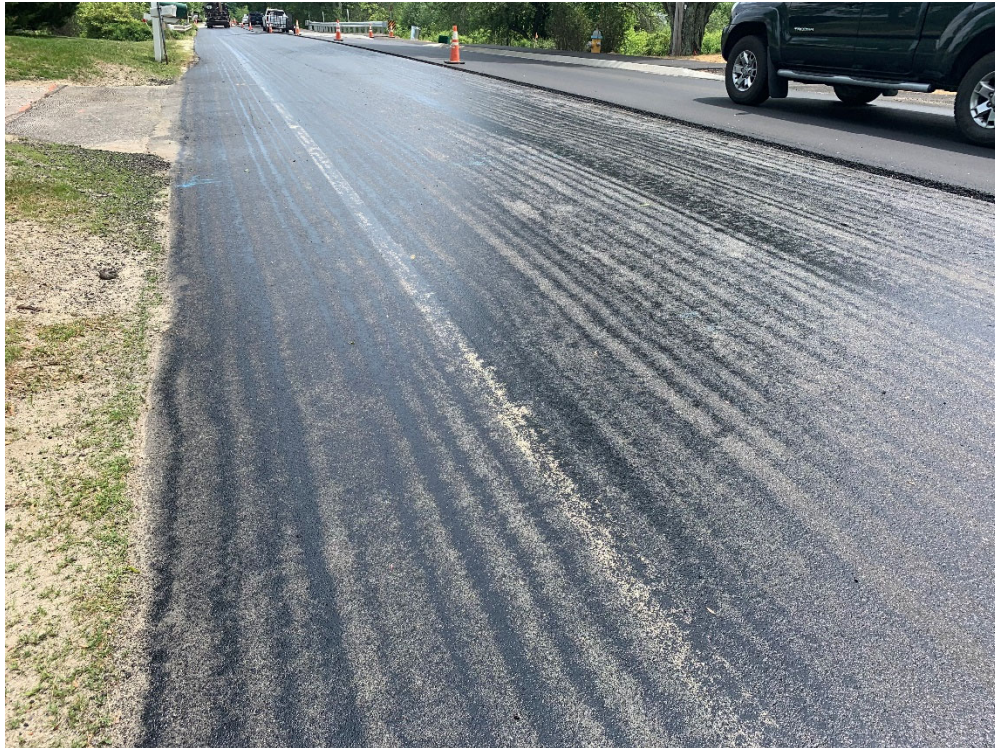
Photo 2 – Tacked existing southeast lane road surface near 197 Tuttle Road, looking southeast.

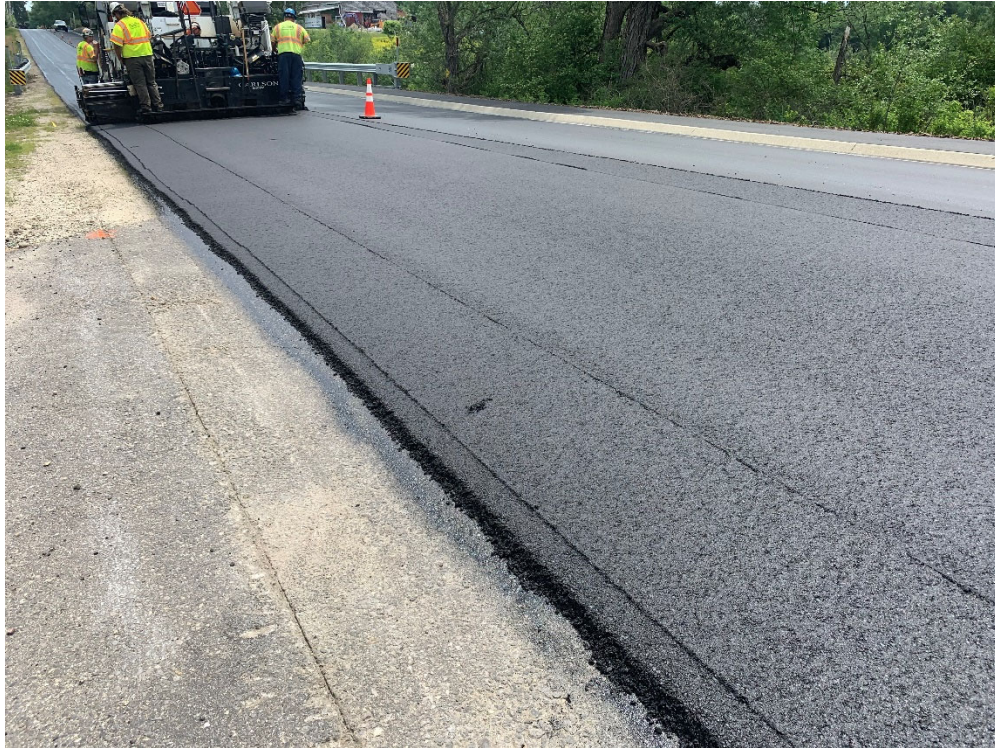
Photo 3 – Surface pavement placement on southeast lane near 215 Tuttle Road, looking southeast.

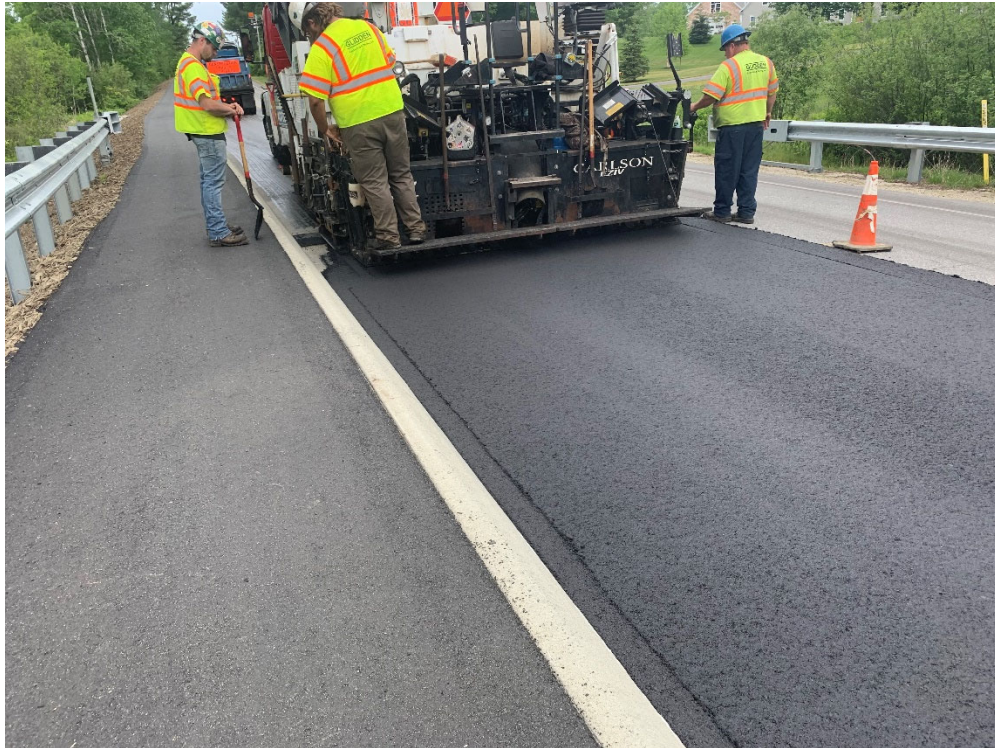
Photo 4 – Surface pavement placement on northwest lane near 12-foot diameter culvert crossing, looking northwest.

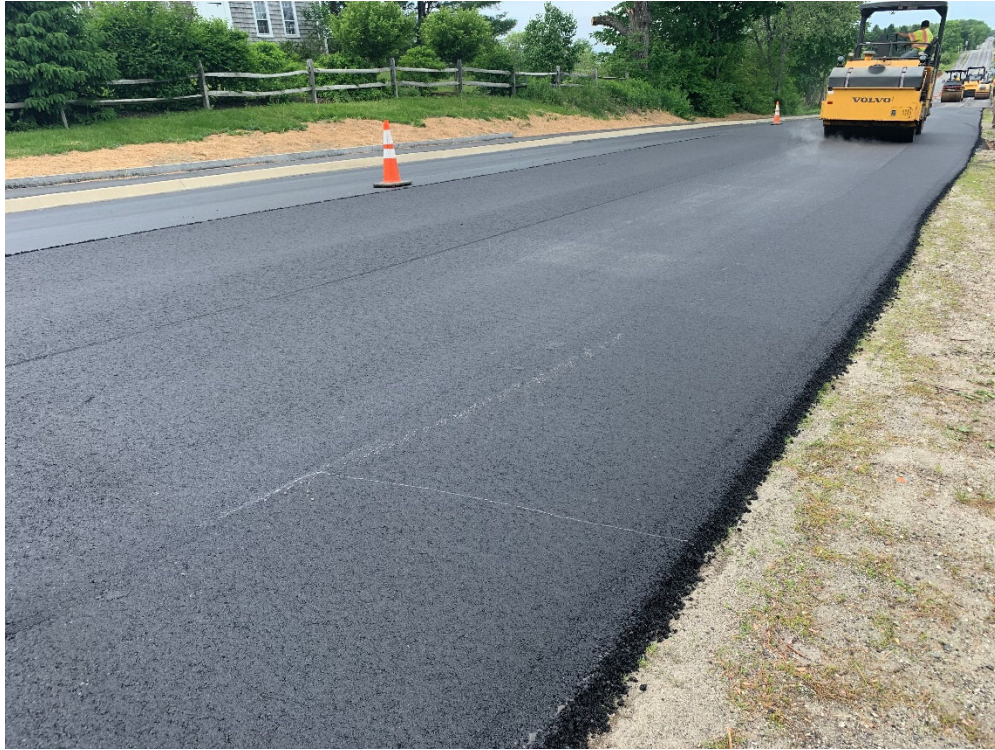
Photo 5 – Roll compaction of surface pavement in northwest lane near 224 Tuttle Road, looking northwest.

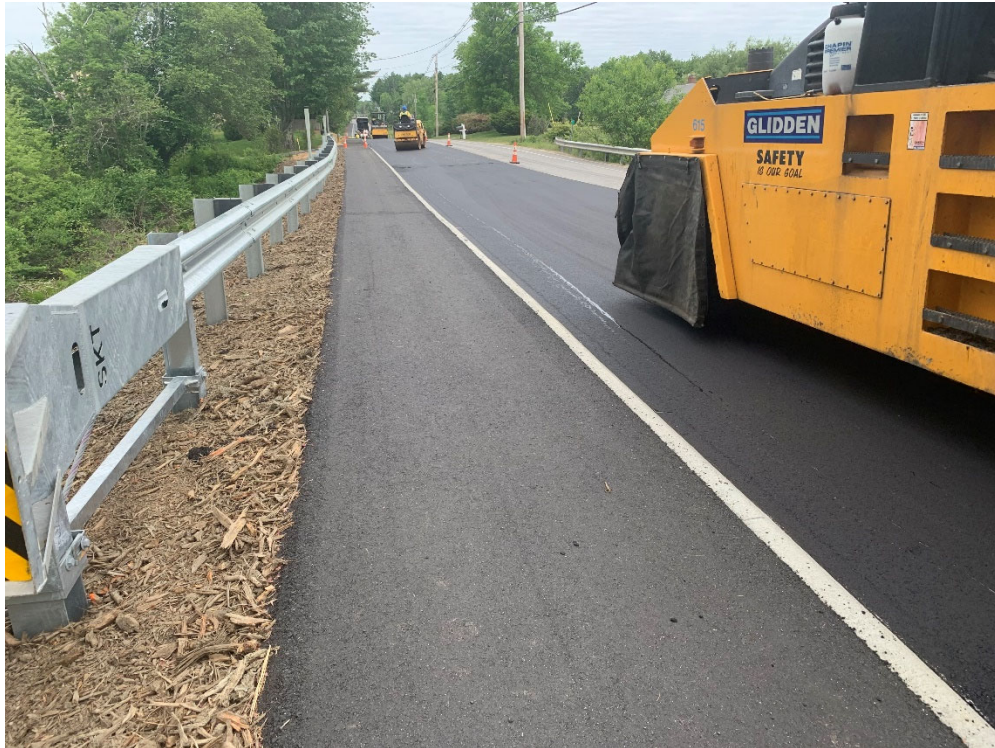
Photo 6 – Roll compaction of surface pavement in southeast lane near 186 Tuttle Road, Looking northwest.

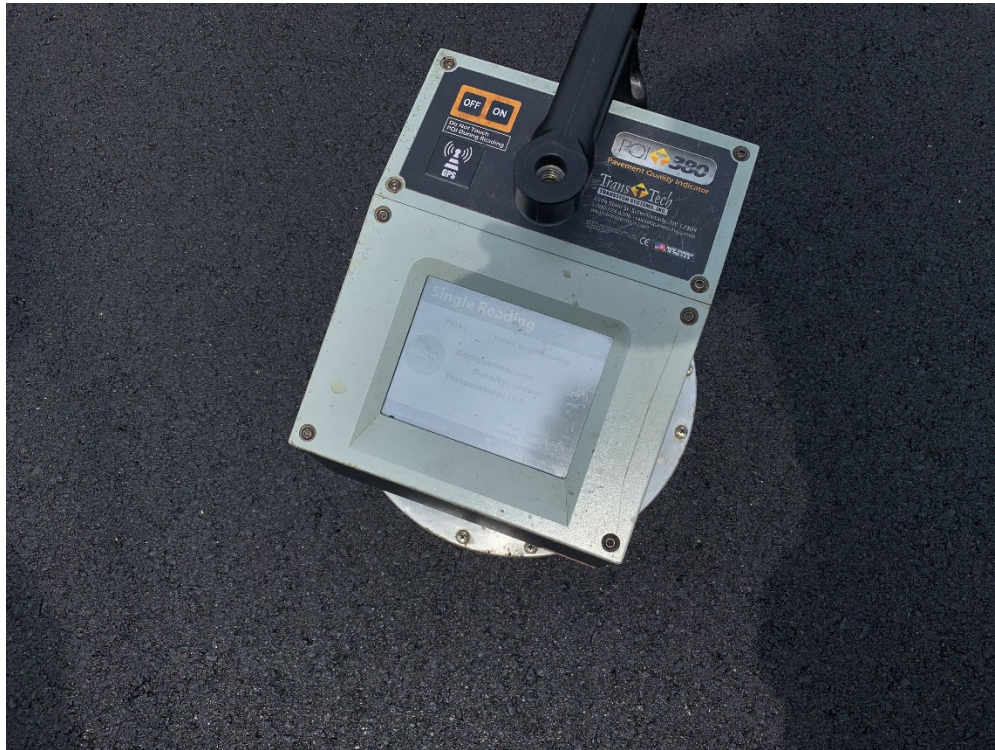
Photo 7 – Compaction of 94.9% and density of 148.9 pcf on surface pavement in northwest lane near 198 Tuttle Road.

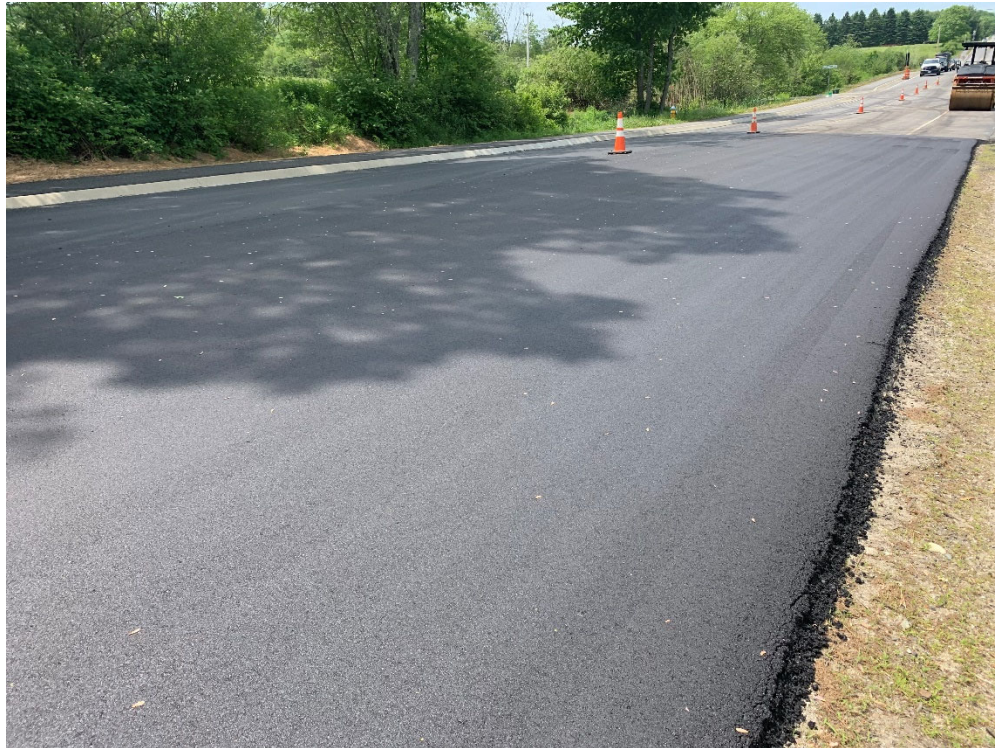
Photo 8 – Compacted surface pavement in northwest travel lane near 225 Tuttle Road, looking northwest.

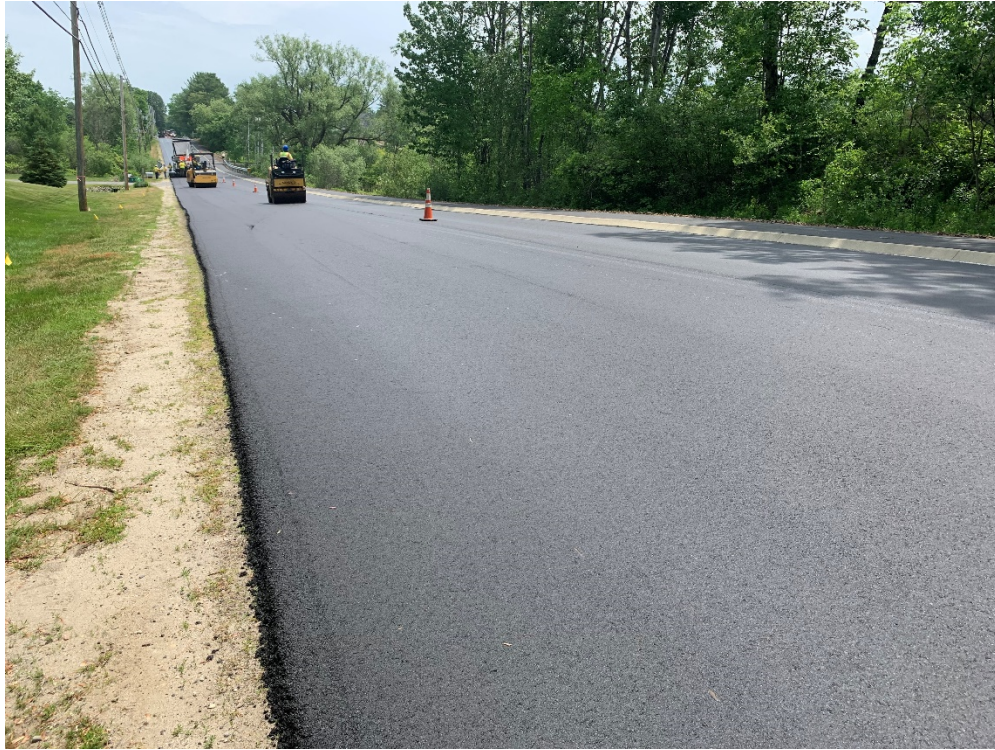
Photo 9 – Compacted surface pavement in northwest lane near 215 Tuttle Road, looking southeast.

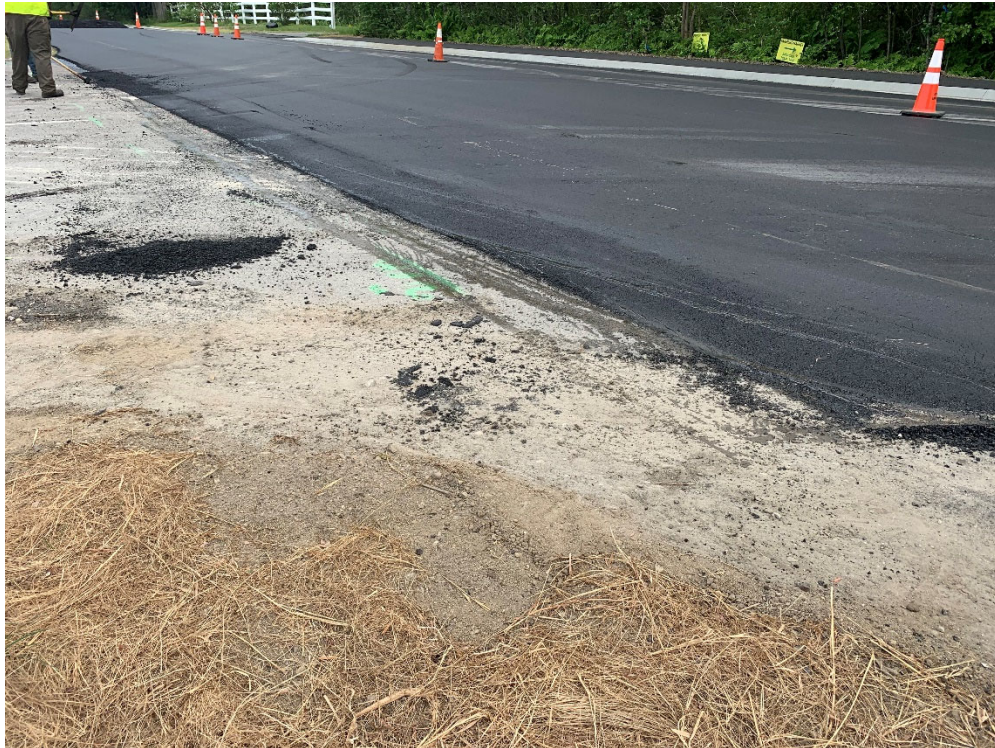
Photo 10 – Surface pavement placement and compaction in Twin Brook entrance joint, looking southeast.

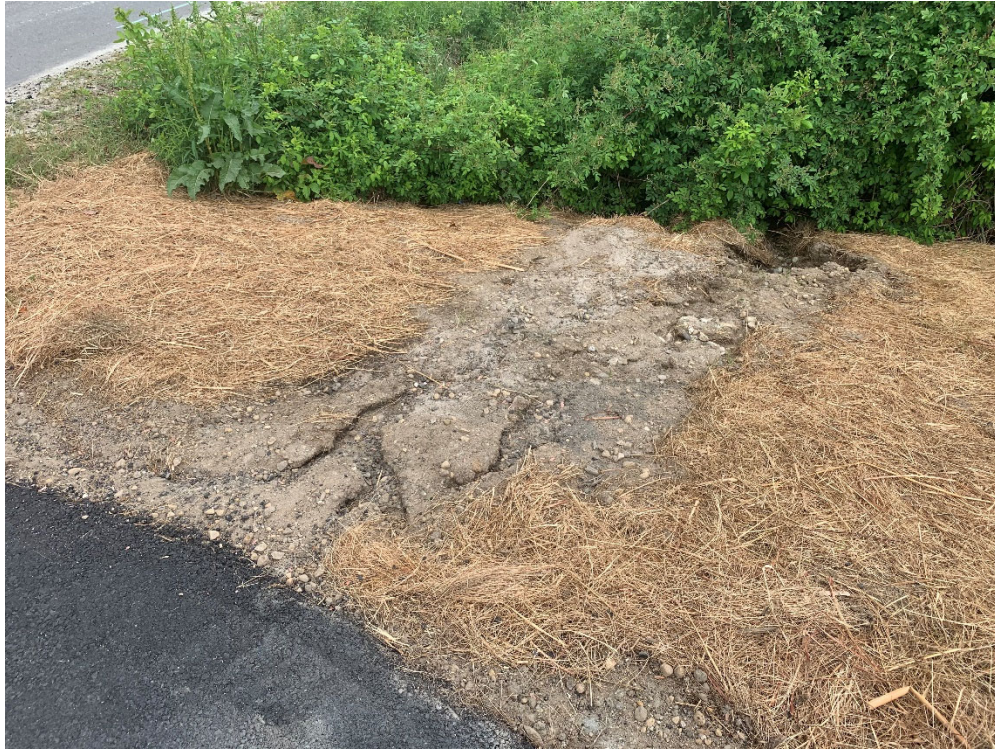
- SME on site to oversee progress, facilitate communications, and inspect erosion control measures.
- Erosion rills were observed adjacent to Twin Brook sidewalk entrance. The location should be repaired and stabilized.
  - Disturbed areas around the riprap drainage pipe apron near 225 Tuttle Road were not stabilized. The area should receive loam, seed, and mulch.

Photo 11 – Erosion rills adjacent to Twin Brook sidewalk entrance, looking northwest.

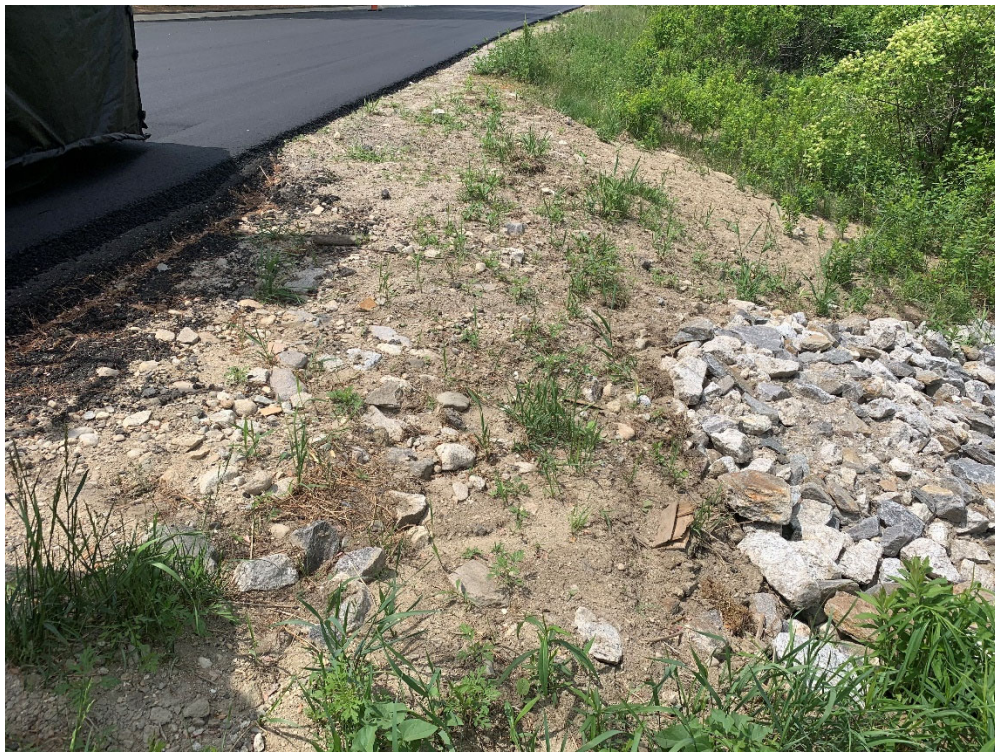
Photo 12 – Disturbed material around the drainage pipe riprap apron adjacent to 225 Tuttle Road, looking northwest.
