FIELD OBSERVATION REPORT

Project: Longmeadow Rd & Ole Musket Rd – Drainage Improvements
Client: Town of Cumberland
GP Field Rep: Kassey Northrop (KN)
Weather: Sunny
Time onsite: 12:15 – 1:00 PM/ 4:30 – 5:00 PM
Contractor: A.H. Grover, Inc.
Distribution: File; Town of Cumberland

GP Project No: 3656
Visit Date: April 12, 2023
Report Date: April 13, 2023
Temp. Range: 54-56°F

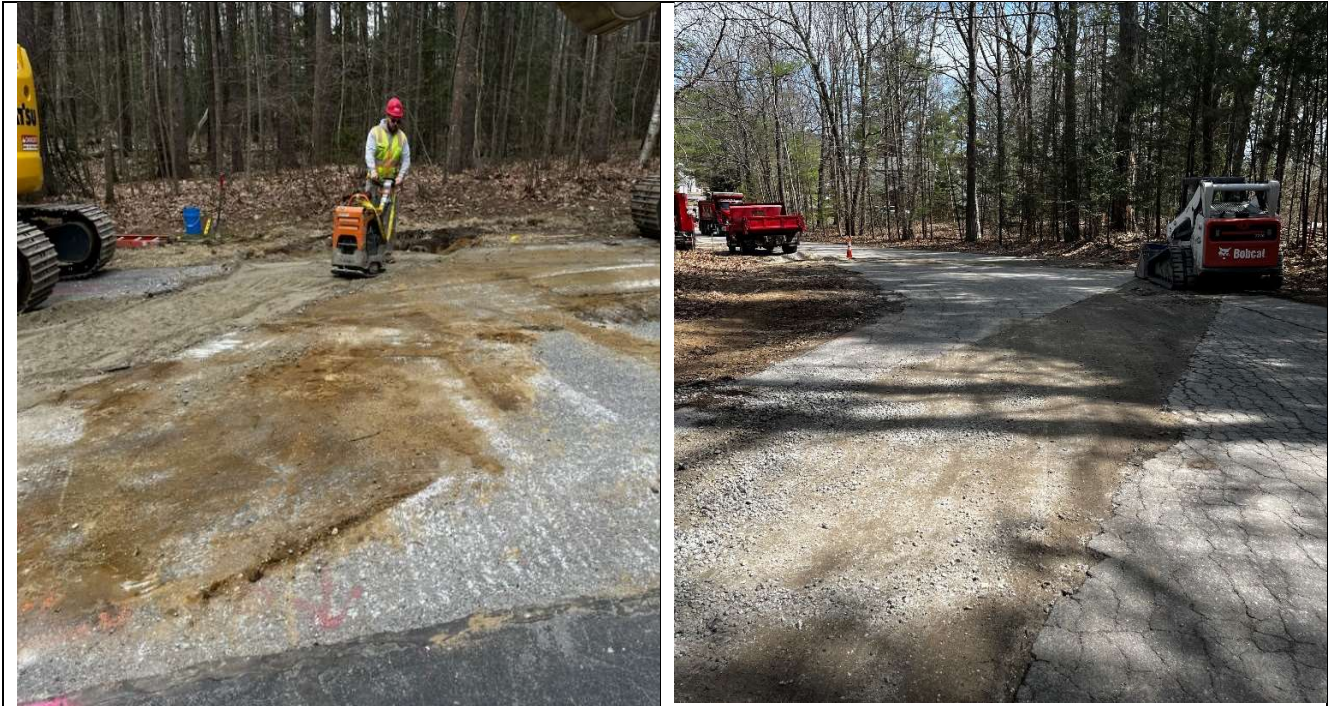
- Ole Musket Road appeared to have been swept prior to arrival in the morning. A water truck was utilized to spray down the road, reducing the amount of dust and soil that collected during construction. (Photo 1 & 2)

Photos 1 & 2 – Comparison pictures of before and after road sweeping around the same area. The left picture shows sediment onto the roadway from trench construction. The right side is post sweeping and water truck, sediment from the trenches do not appear to be on the roadway.

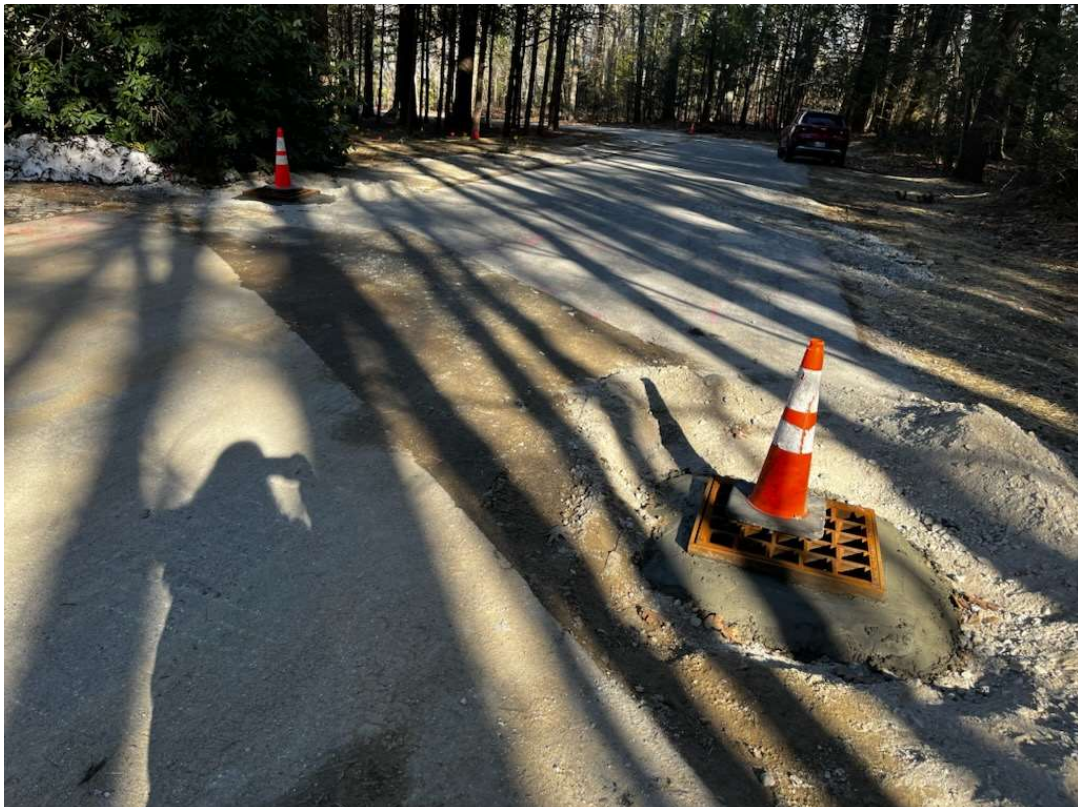
- While on site, A.H. Grover, Inc. actively worked on installing the collars, frame, and covers of the catch basins installed on Ole Musket.
 - Catch basin's #20, #21, #22, #23, #27, and #28 had collars, frames, and covers installed today. (Photos 3 & 4)

Photo 3 – Frame and covers installed on CBs # 20 and #21.

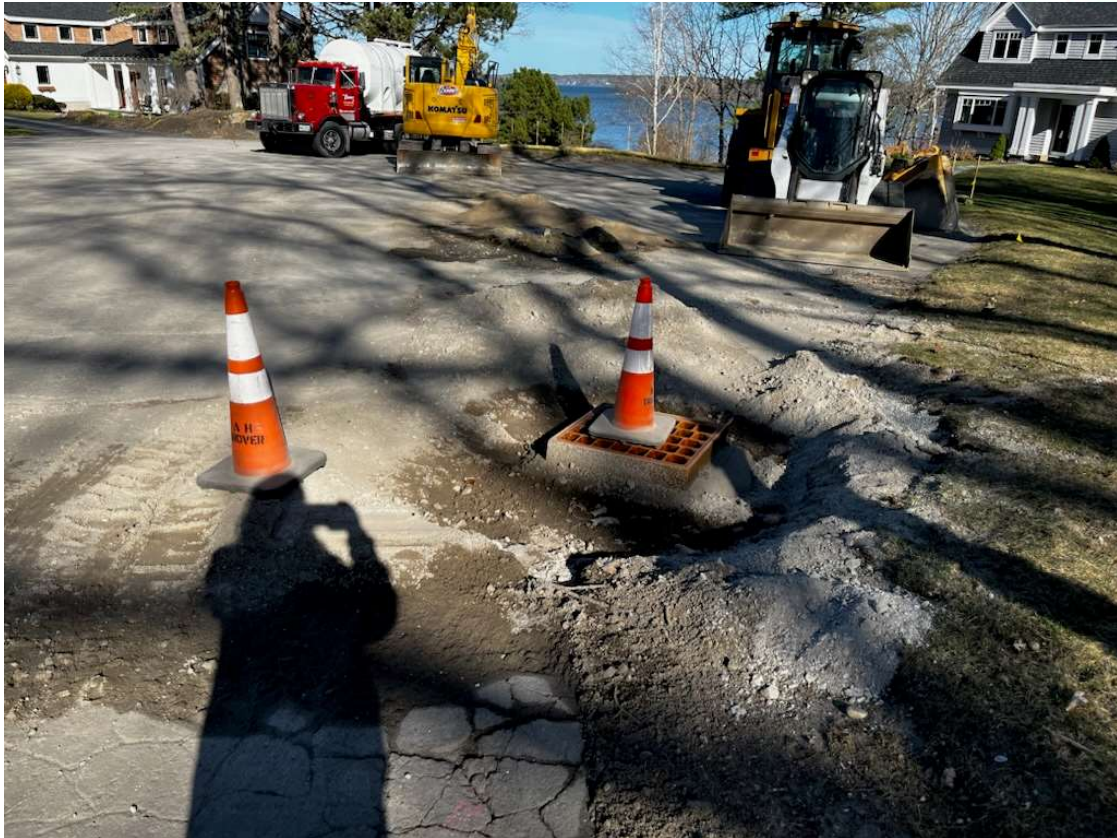
Photo 4 – Frame and cover installed on CB #26. Water truck used is also pictured in the background.

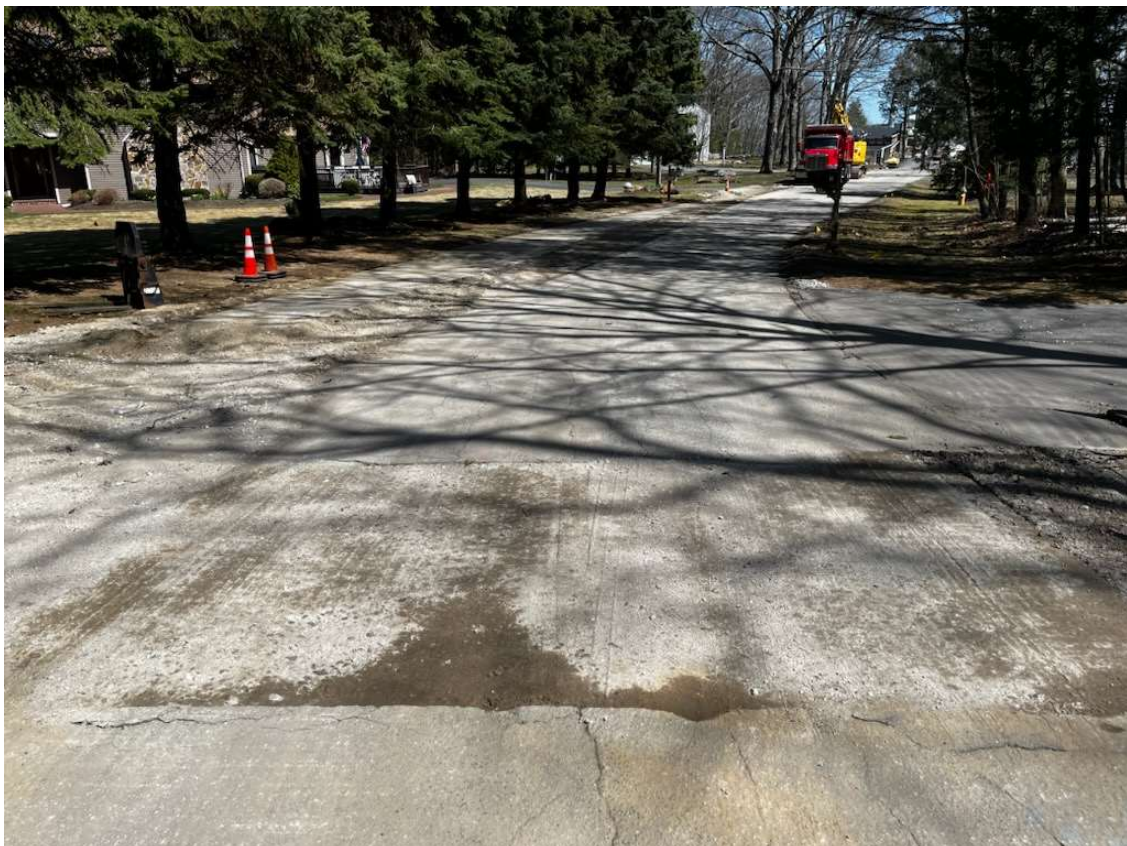
- Upon arrival in the afternoon, the cross-trench areas appeared to be prepped for paving by fine grading with a few 'touch up' areas needed in the morning due to vehicle travel. A.H. Grover, Inc. to compact trenches with 5-ton roller tomorrow. (Photo 5)

Photo 5 – Cross trench area (between CB #24 & CB #25) fine graded for paving.

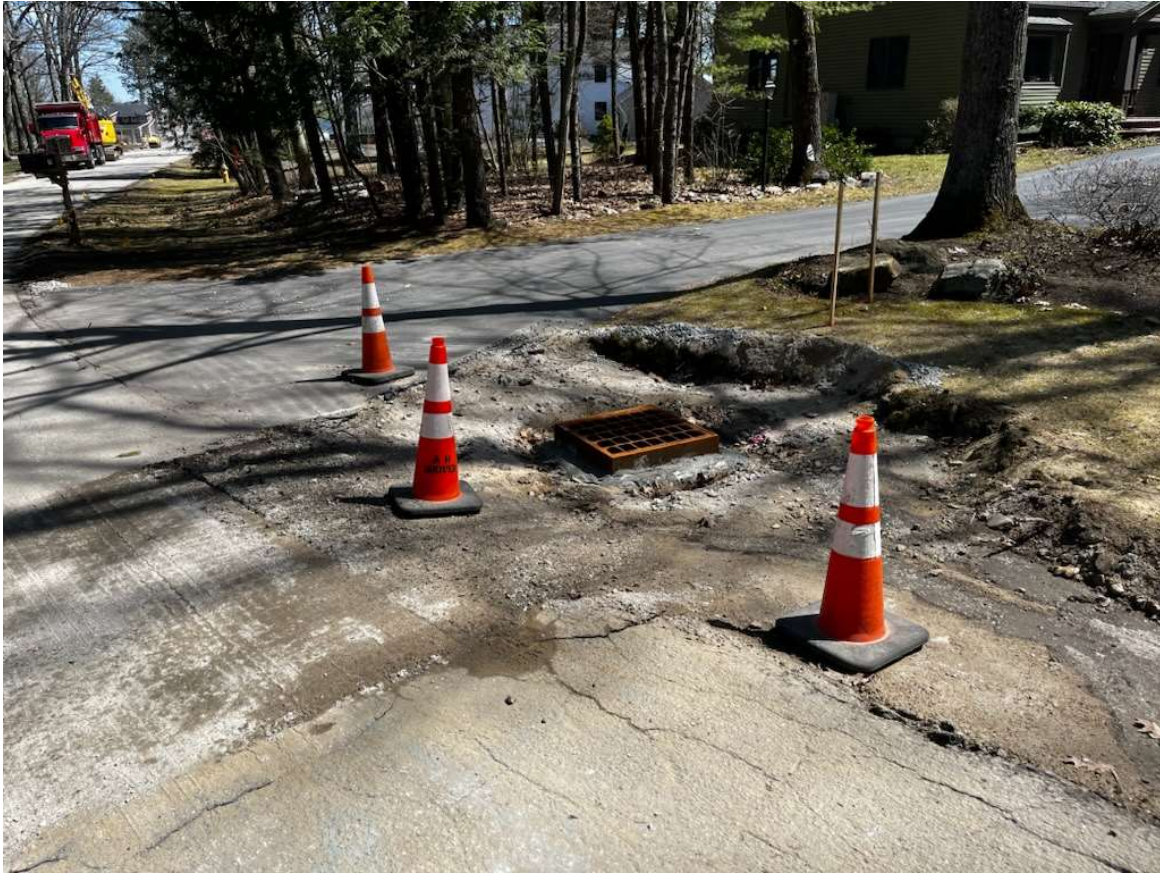
- KN to observe cross-trench area conditions in the morning, prior to paving.
- A.H. Grover, Inc. makes efforts to communicate with homeowners.
 - The homeowner of 11 Ole Musket Road made a complaint to A.H. Grover, Inc. while KN was not present. The complaint was regarding the placement of CB #25 (see photo 6). The homeowner was concerned of the 'hole' next to their driveway. A.H. Grover, Inc. ensured that upon backfilling the frame and cover area of the catch basin, and paving that the 'hole' would not be present and will eventually look better. CB #25 had to be installed where it was due to the gas and water mains. Upon discussion with Ben Grover, it appeared that no additional follow up with 11 Ole Musket was necessary and they seemed okay upon discussion with A.H. Grover, Inc.

Photo 5 – CB #25 at 11 Ole Musket Road.
