FIELD OBSERVATION REPORT

Project: Longmeadow Rd & Ole Musket Rd – Drainage Improvements
Client: Town of Cumberland
GP Field Rep: Sam Foglio (SF) – AM
Kasey Northrop (KN) – PM
Weather: Rain, Cloudy
Time onsite: 9:30 AM – 10:30 AM/ 1:00 PM – 1:45 PM
Contractor: A.H. Grover, Inc.
Distribution: File; Town of Cumberland

GP Project No: 3656
Visit Date: April 18, 2023
Report Date: April 18, 2023
Temp. Range: 50-52°F

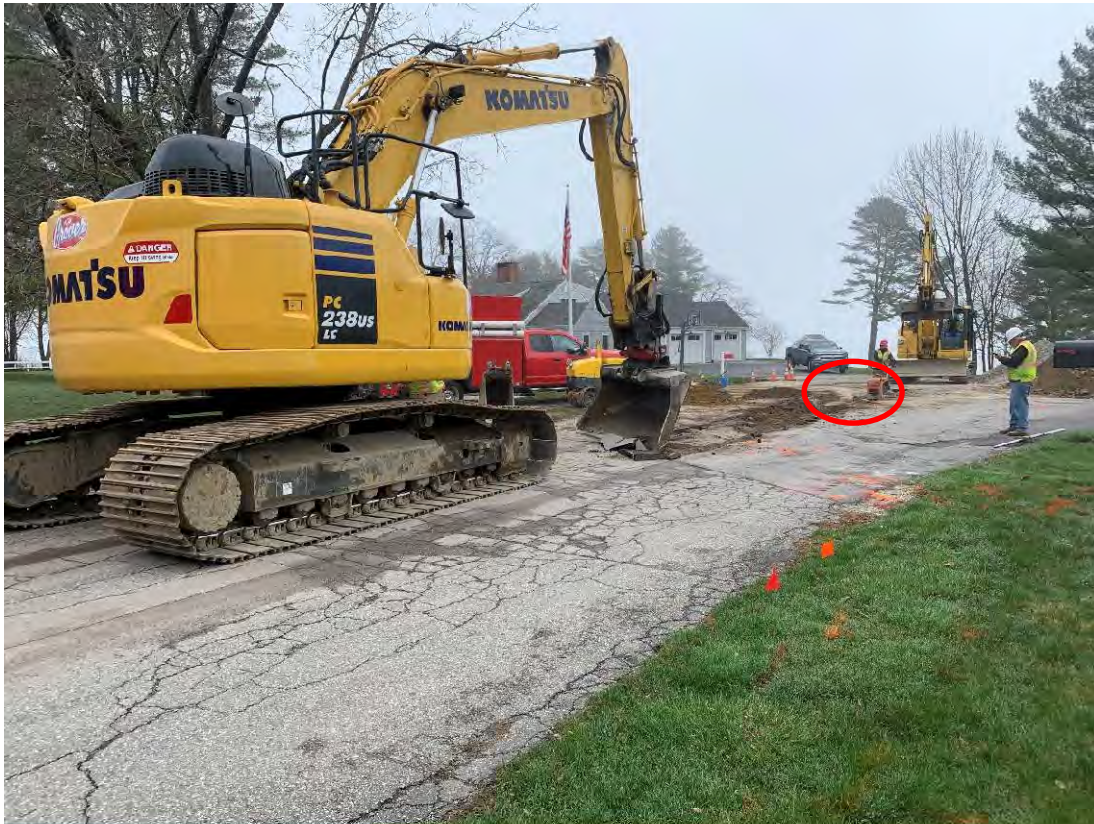
- Prior to arrival in the morning, DMH 1 had been installed and backfilled with material consistent with MDOT 703.22 Type B Underdrain. (Photo 1)
 - The 15" SD installed from CB 11 yesterday was continued approximately 37 feet to DMH 1 prior to arrival.

Photo 1 – DMH 1 (circled in red) installed. Matt Grover excavating towards DMH 2 for SD installation.

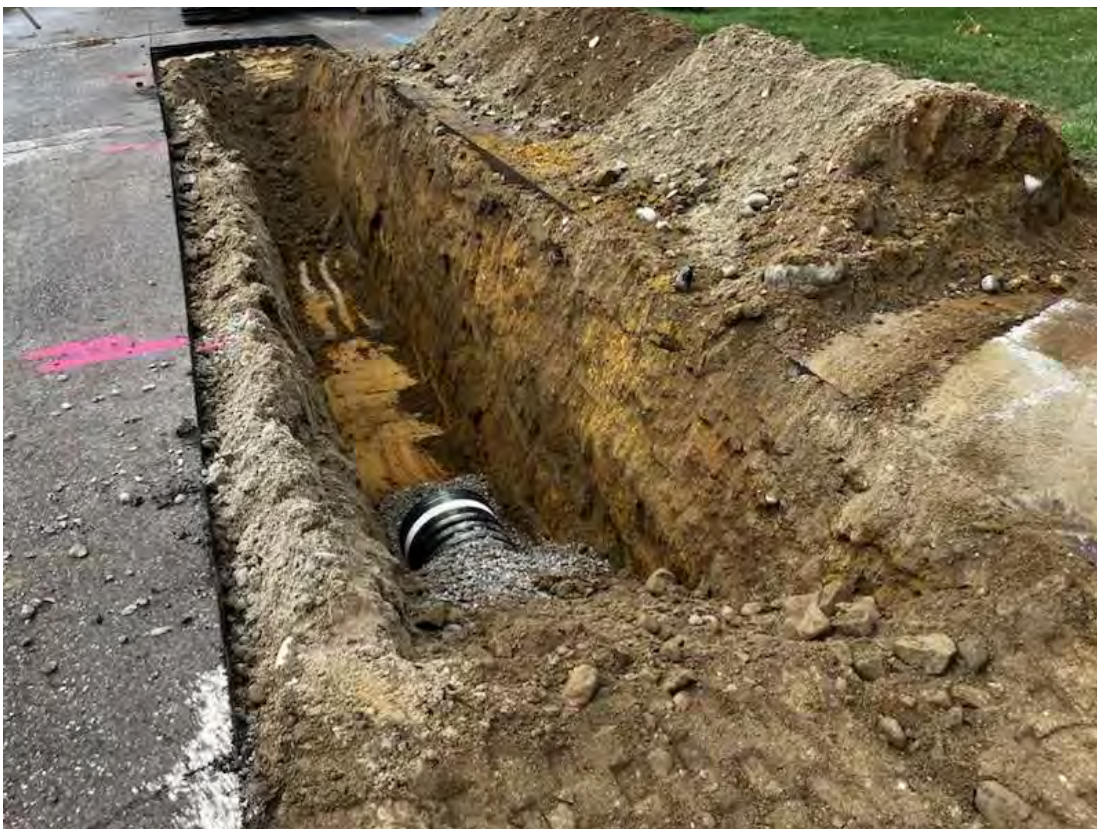
- While on site in the AM and PM, A.H. Grover, Inc. actively worked on installing 15" SD between DMH 1 and DMH 2.
 - No rock ledge appears to be present (Photo 2)

Photo 2 – Trench excavated full depth and no ledge rock present.

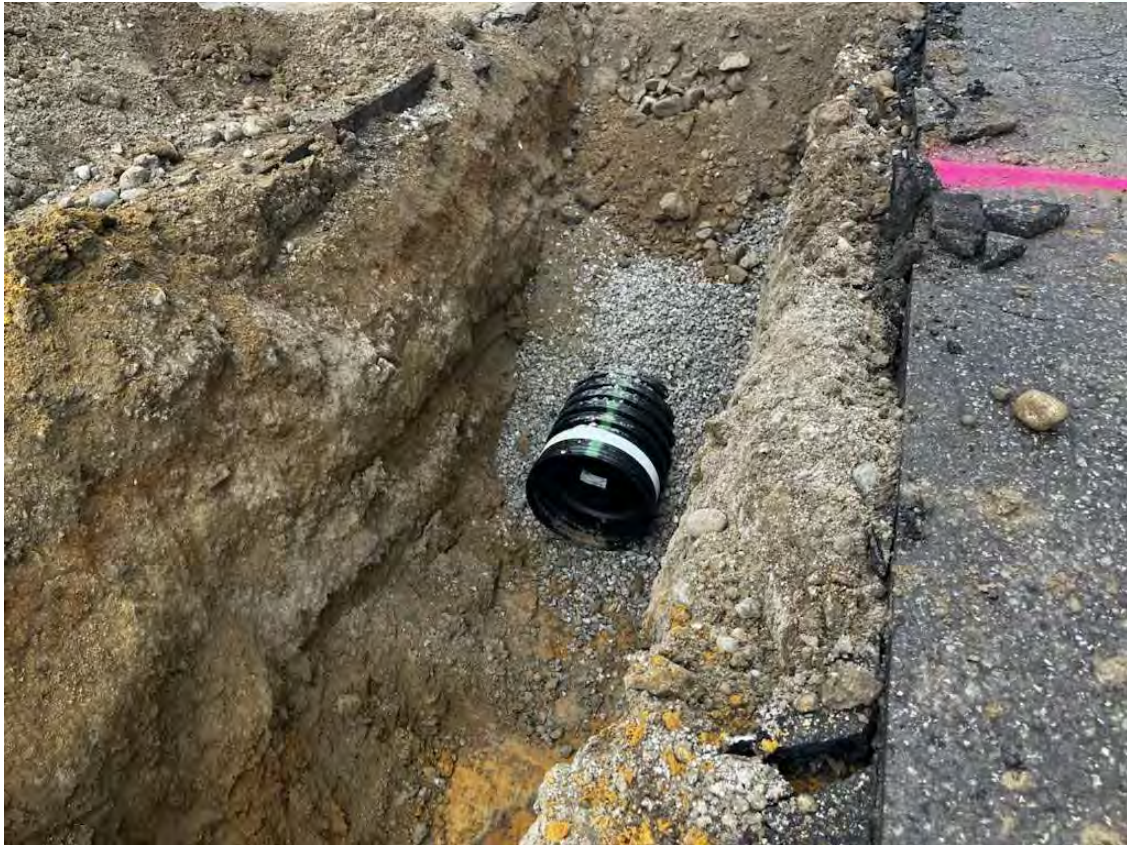
- Approximately 153 feet of 15" SD was installed between DMH 1 and DMH 2 prior to ending the workday. The 15" SD was embedded with material consistent with MEDOT 703.22 Type C $\frac{3}{4}$ " Crushed Stone to the spring line of the pipe. (Photo 3) As pictured in photo 3, material that appeared to be MEDOT 703.22 Type B Underdrain was used to backfill the 15" SD approximately 1.75 feet from the spring line. Suitable excavated material stored to the side of the trench was used to backfill the trench to the subbase layer. 18" of subbase material consistent with MEDOT 703.06 was installed, then compacted with efforts of a Remote-Control RTSC3 Wacker Neuson. (Photo 4)

Photo 3 – Stormdrain embedded with $\frac{3}{4}$ " stone and backfilled with suitable excavated material.

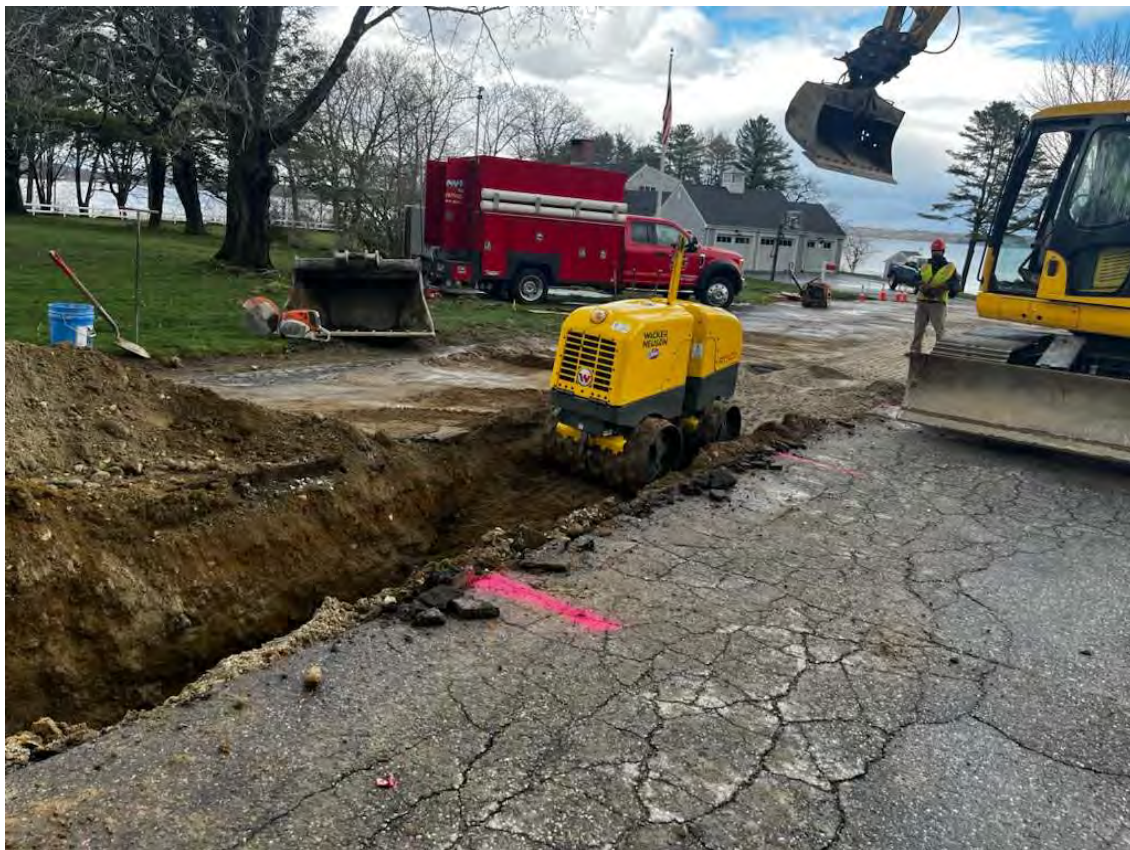
Photo 4 – Remote-Control Wacker Neuson compacting backfill material in the trench.

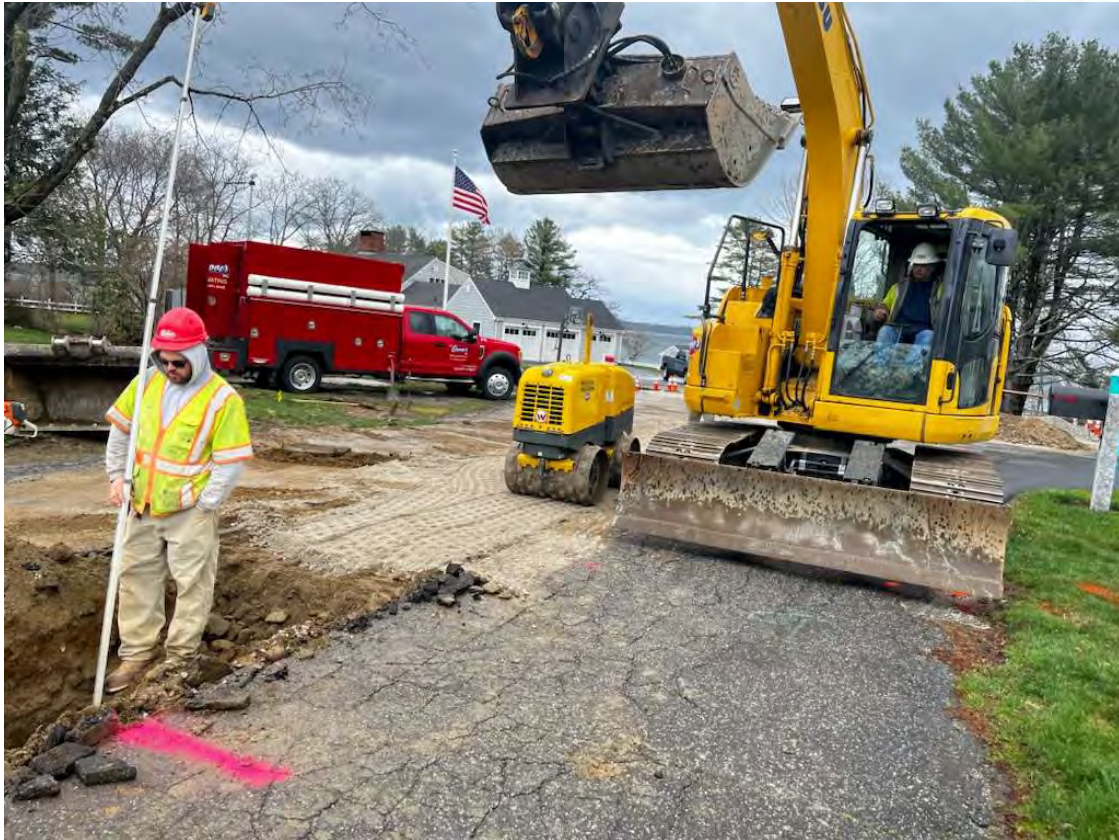
- Crew members use a laser level and survey rod while installing the storm drain to ensure grade. (Photo 5)
- Crew members with A.H. Grover, Inc. makes efforts to avoid underground utilities.

Photo 5 – Crew member using survey rod to check grade of pipe installed in trench.

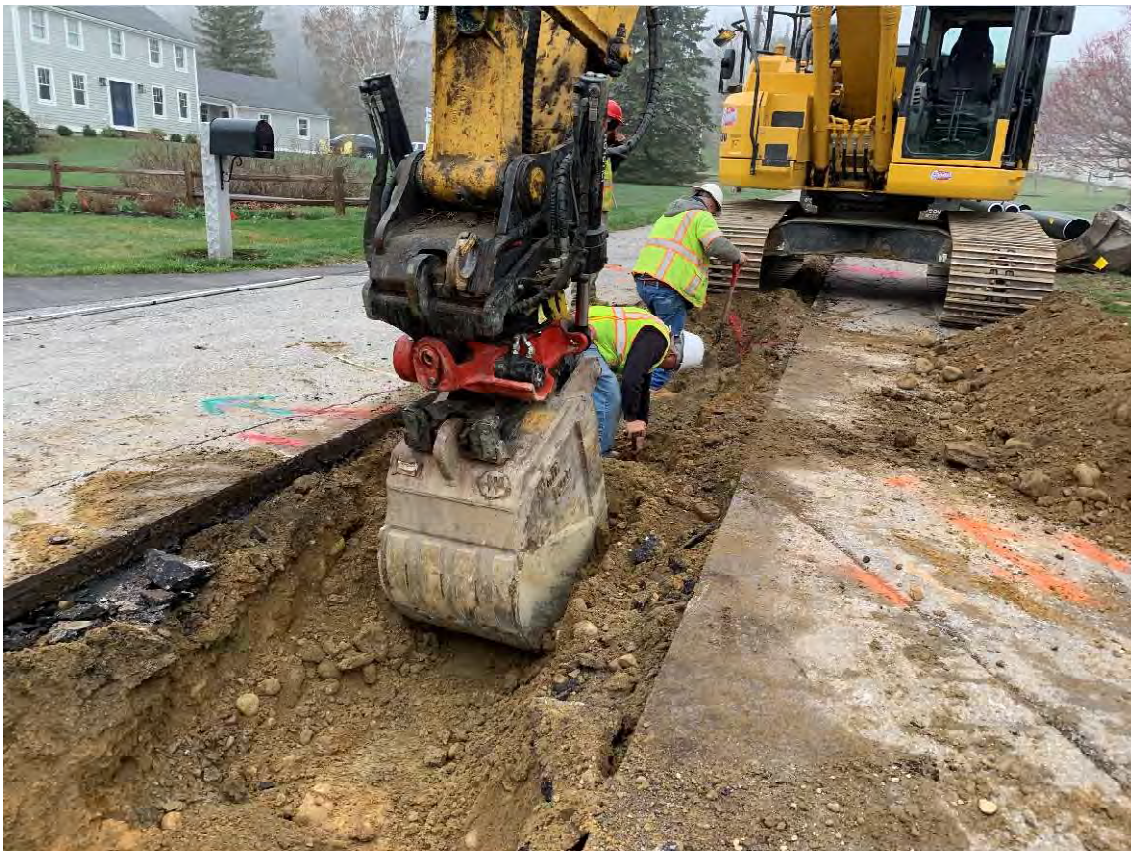
- Ben Grover and Stewart are pictured hand shoveling to avoid underground utilities. (Photo 6) Photo 7 shows the underground utility avoided.
- A.H. Grover, Inc. makes efforts to communicate with homeowners.

Photo 6 – Ben Grover and Stewart hand shoveling to locate underground utilities.

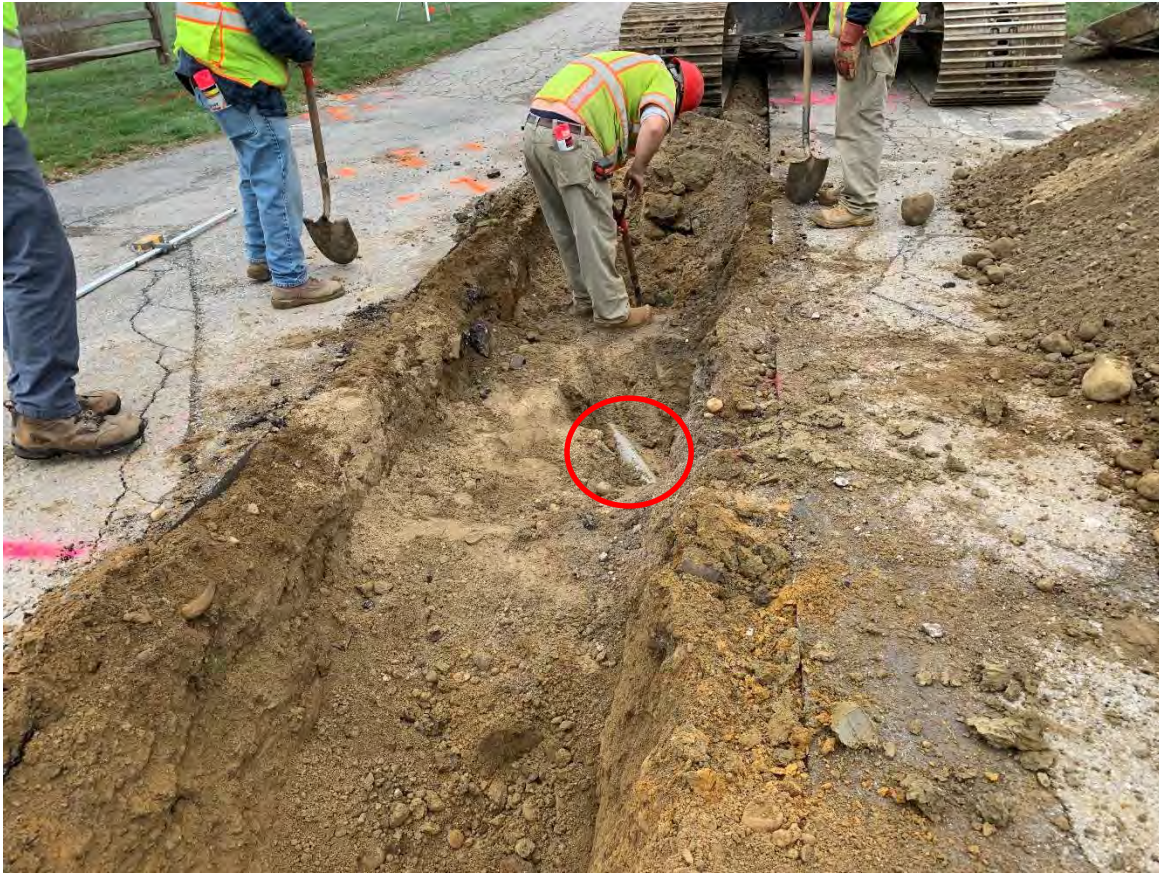
Photo 7 – Underground utility (circled in red) found and avoided.
