FIELD OBSERVATION REPORT

Project: Longmeadow Rd & Ole Musket Rd – Drainage Improvements
Client: Town of Cumberland
GP Field Rep: Sam Foglio (SF) – AM
Kassey Northrop (KN) – PM
Weather: Clear, Sunny
Time onsite: 9:30 AM – 10:30 AM/ 5:00 PM – 5:15 PM
Contractor: A.H. Grover, Inc.
Distribution: File; Town of Cumberland

GP Project No: 3656
Visit Date: April 20, 2023
Report Date: April 21, 2023
Temp. Range: 43-52°F

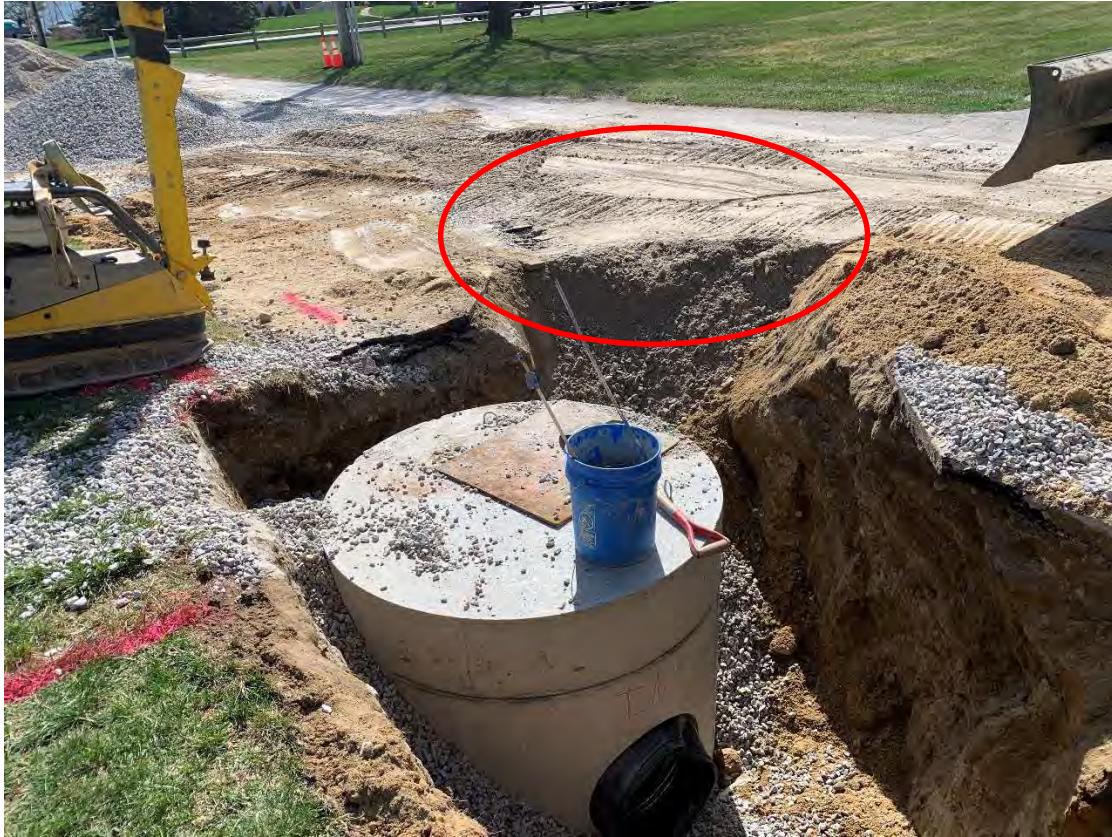
- DMH 3 was set prior to arrival with the 6 feet of 15" SD described above inletting to it. The manhole speared to be set on a ¾" crushed stone base, per detail. A.H. Grover backfilled the manhole with material consistent with MaineDOT 703.22 Type B Underdrain. Prior to backfilling the barrel section completely, A.H. Grover, Inc. installed approximately 8.5 feet of 15" SD towards CB 3 with the same efforts as described above. DMH 3 was then backfilled to the top of the barrel section, then A.H. Grover, Inc. backfilled the top of the manhole (with a 2' x 2' plate over the opening) with material consistent with MaineDOT 703.06 to existing grade, until they install the collar, frame and covers for ease of vehicle traffic. (Photo 1)

- While on site, CB 3 was set on what appeared to be a ¾" crushed stone base, as can be seen in photo 1.
 - The 8.5 feet of 15" SD described above was installed to inlet from CB 3 towards DMH 3 per plan.

Photo 1 – Circled area is where DMH 3 has been backfilled until frame and cover can be installed.

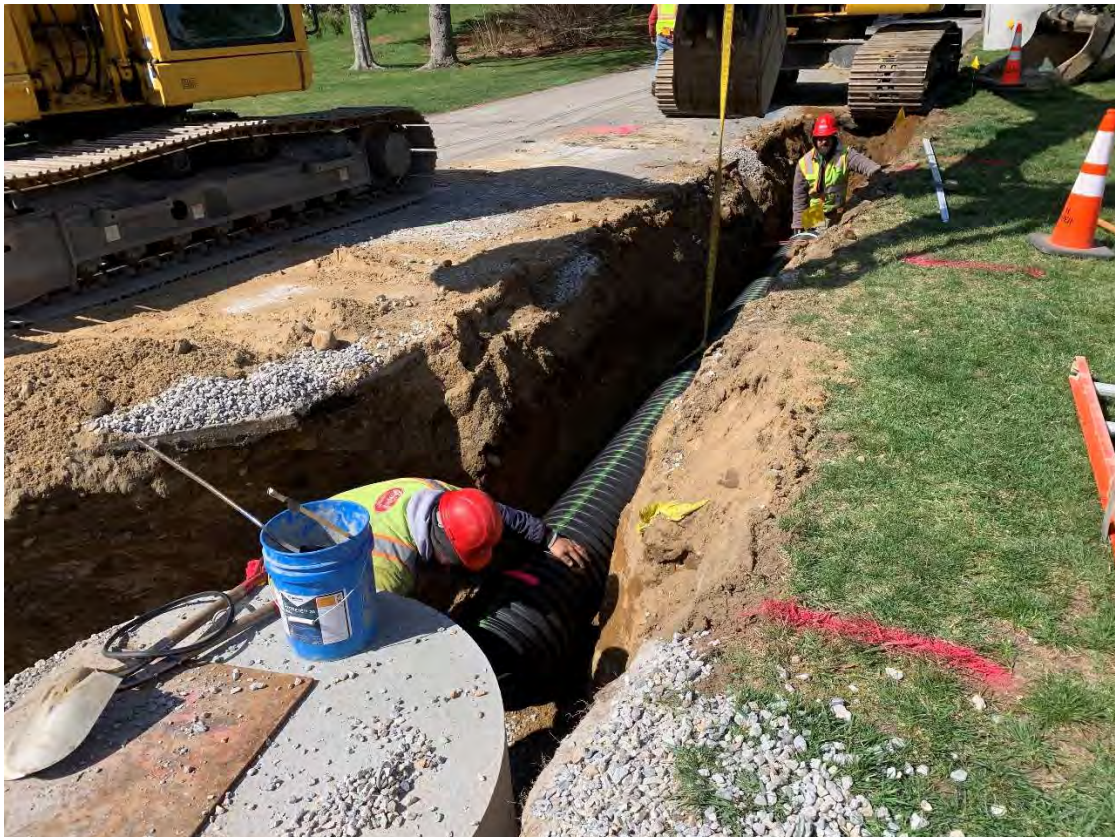
- Crew with A.H. Grover, Inc. prior to backfilling CB 3, placed a 20-foot segment of 15" Perf. SD towards CB 5. (Photo 2) Crew was observed using a laser level and survey rod to check grade prior to placement of the SD. (Photo 3)

Photo 2 – 20-foot segment of 15" Perf. SD installed to CB 3.

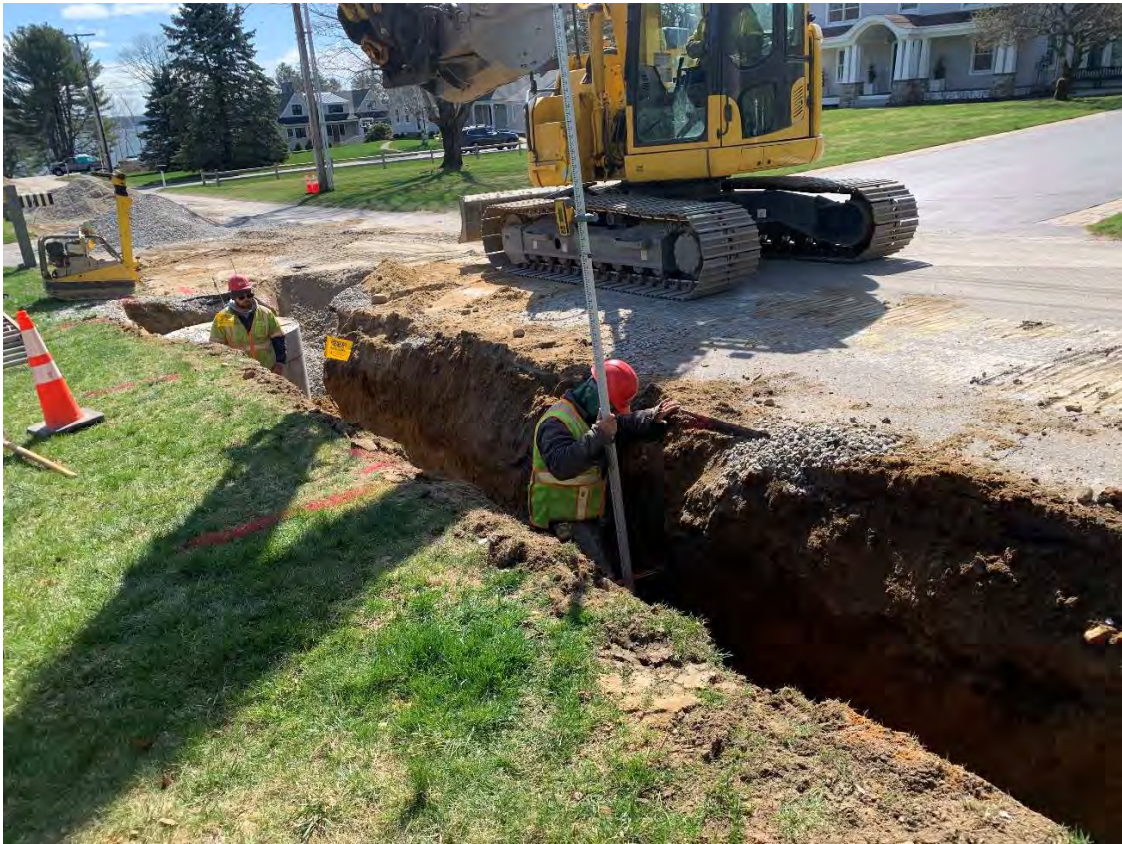
Photo 3 – Crew member using survey rod and laser level to check grade prior to SD installation.

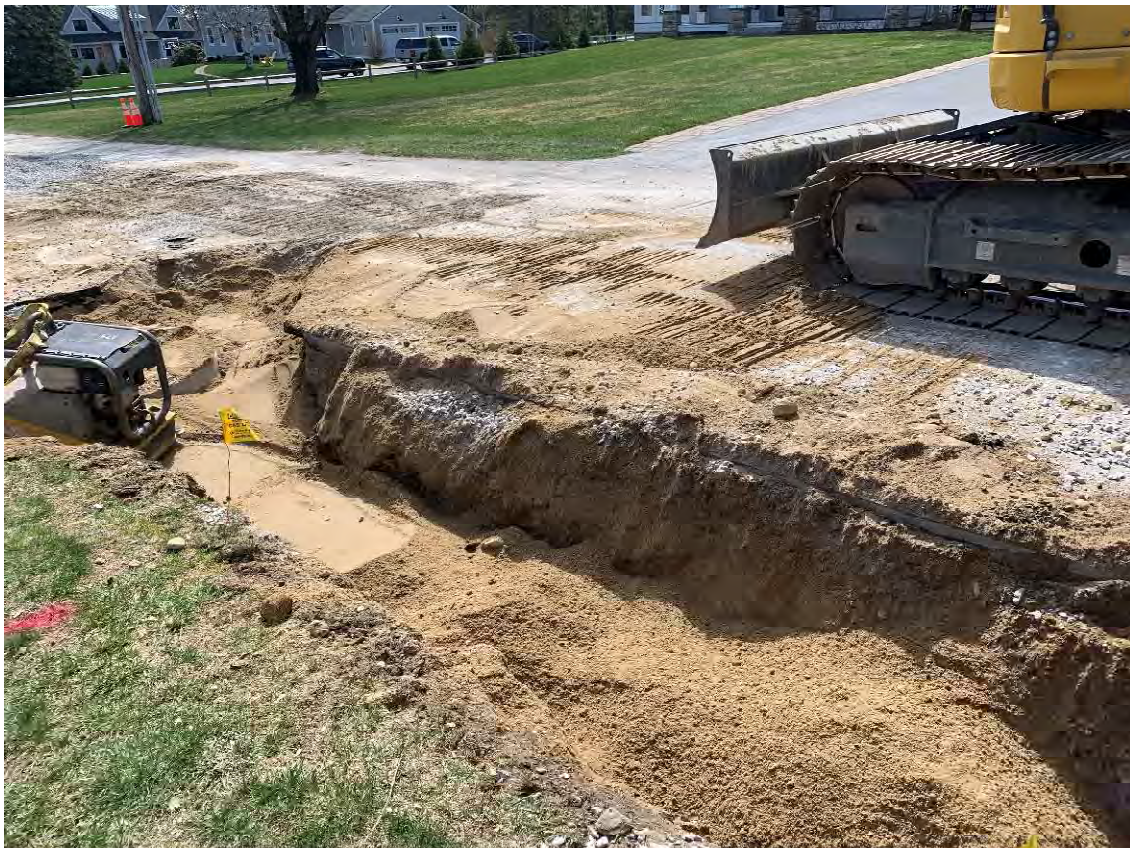
- Upon installing the 20-foot segment towards CB 5, CB 3 was backfilled with material consistent with MaineDOT 703.22 Type B Underdrain and compacted with a plate compactor. (Photo 4)

Photo 4 – CB 3 after it was backfilled with material consistent with MaineDOT 703.22 Type B Underdrain, also shown is a plate compactor compacting around the catch basin.

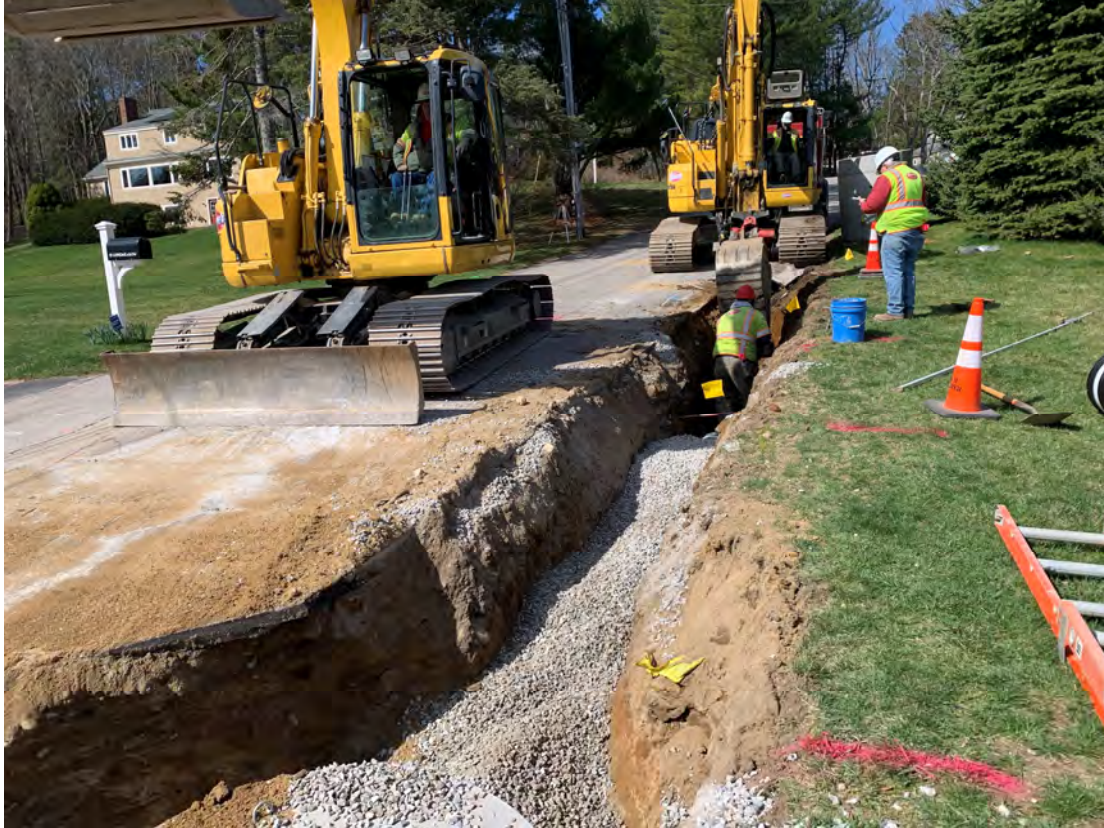
- Prior to leaving site in the morning, another 20-foot segment of 15" Perf. SD was installed on the 20-foot segment mentioned above. The two – 20-foot segments of 15" Perf. SD was embedded with material consistent with MaineDOT 703.22 Type C ¾" Crushed Stone, approximately 1.75 feet above the spring line. (Photo 5) It appeared that MaineDOT 703.22 Type B Underdrain was used to backfill the trench to the subbase layer (Photo 6), then 18" of material consistent with MaineDOT 703.06 Type D was installed to existing grade.

Photo 5 – MaineDOT 703.22 Type C $\frac{3}{4}$ " Crushed stone placed approximately 1.75 feet above the spring line.

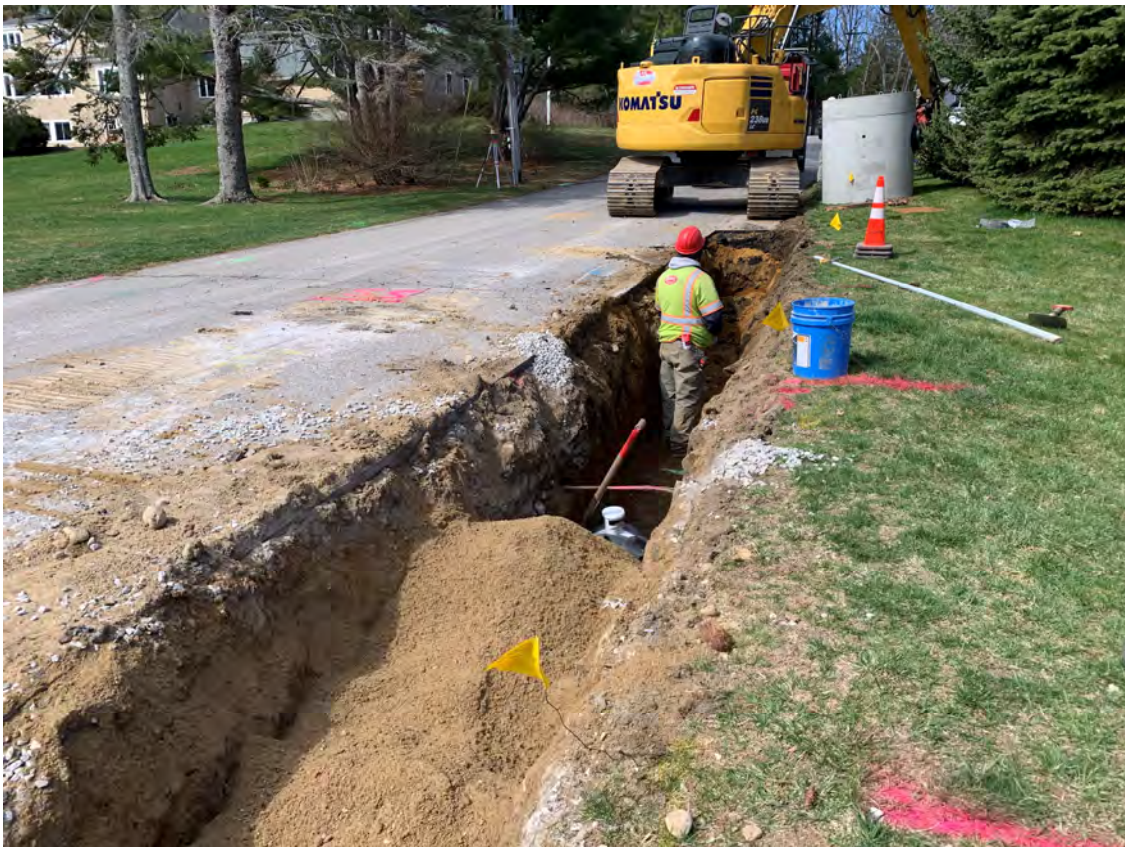
Photo 6 – MaineDOT 703.22 Type B underdrain placed in the trench to the subbase layer.

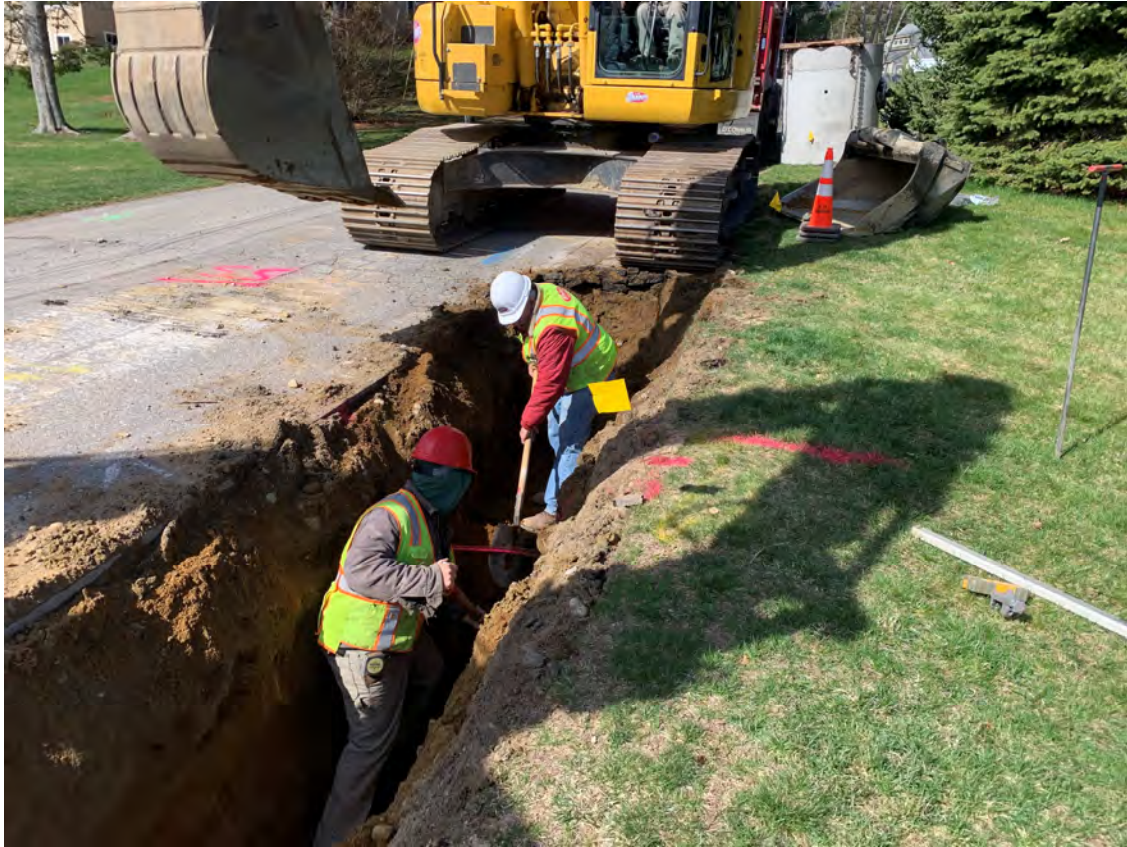
- Ledge rock did not appear to be present today.
- Crew members with A.H. Grover, Inc. makes efforts to avoid underground utilities.
 - Photo 7 shows Stewart and a crew member hand shoveling around underground utilities prior while excavating from CB 3 towards CB 5.
- A.H. Grover, Inc. makes efforts to communicate with homeowners.
- The table below reflects the approximate quantities as of the end of the day April 20, 2023:

Photo 7 – Stewart and Crew member hand shoveling around underground utility.
