FIELD OBSERVATION REPORT

Project: Longmeadow Rd & Ole Musket Rd – Drainage Improvements
Client: Town of Cumberland
GP Field Rep: Sam Foglio (SF) – AM
Kassey Northrop (KN) – PM
Weather: Clear, Sunny
Time onsite: 9:30 AM – 10:30 AM/ 1:30 PM – 2:30 PM
Contractor: A.H. Grover, Inc.
Distribution: File; Town of Cumberland

GP Project No: 3656
Visit Date: April 21, 2023
Report Date: April 24, 2023
Temp. Range: 45-48°F

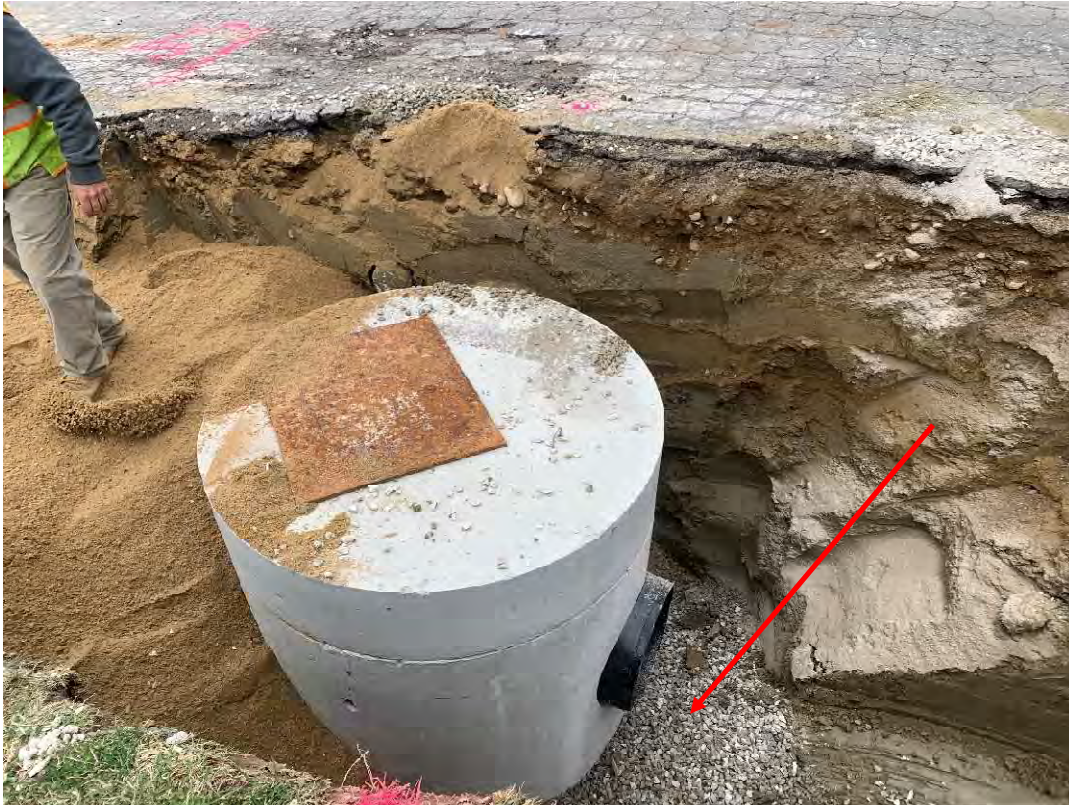
- While on site, CB 5 was placed on what appeared to be a ¾" stone base. (Photo 1) The 33.3 feet of 15" Perf. SD described above was installed to CB 5, then backfilled with material consistent of MaineDOT 703.22 Type B Underdrain to approximately 18" below the existing grade and compacted with efforts of a plate compactor. (Photo 2)

Photo 1 – CB 5 placed on material that appears to be $\frac{3}{4}$ " crushed stone (pointed out in red).

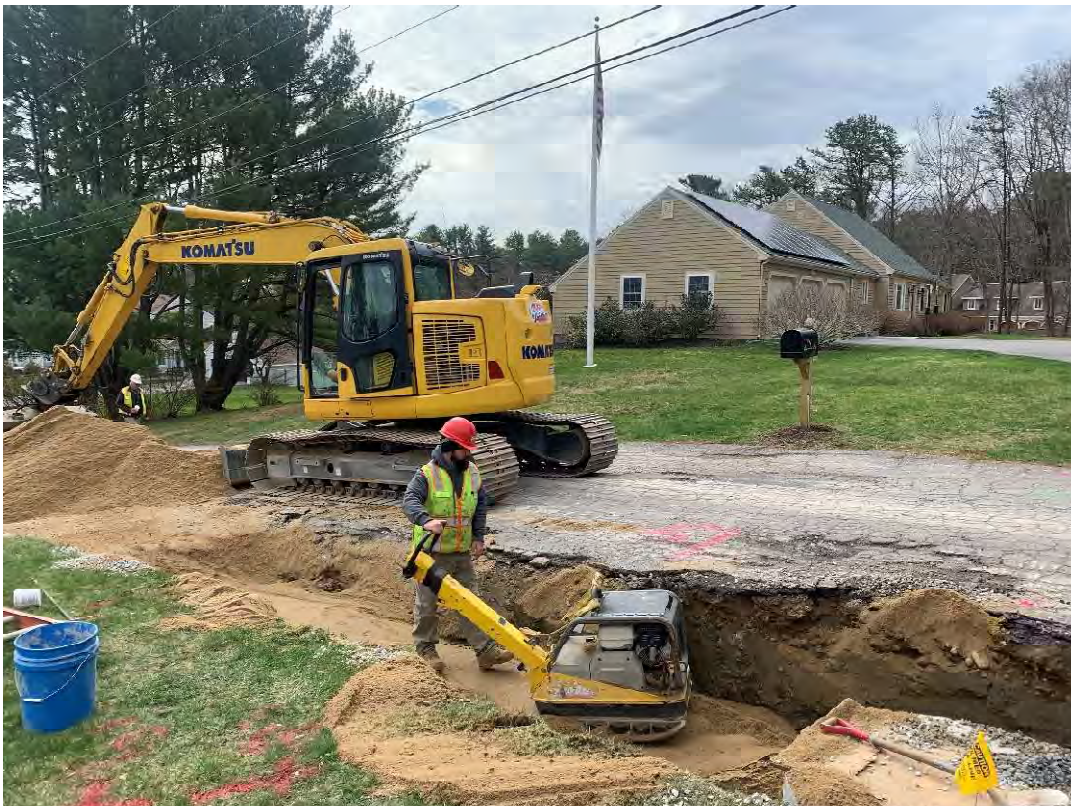
Photo 2 – 15" Perf. SD backfilled with MaineDOT 703.22 Type B Underdrain to approximately 18" below existing grade and compacted with efforts of a plate compactor.

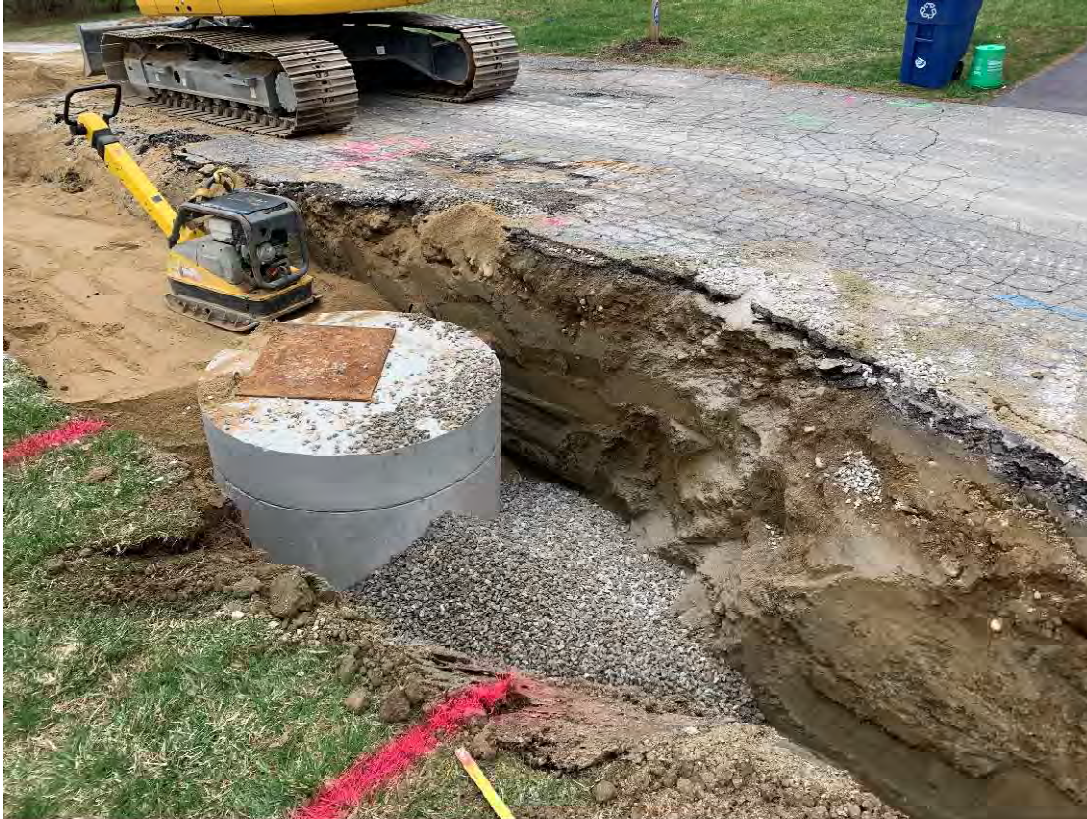
- A 20-foot segment of 15" Perf. SD was installed with material consistent with MaineDOT 703.22 Type C ¾" Crushed Stone from CB 5 towards CB 3 prior to backfilling CB 5. The 20-foot segment was backfilled with the ¾" crushed stone, approximately 1.75 feet from the spring line. (Photo 3) Material that appeared to be MaineDOT 703.22 Type B Underdrain was used to backfill CB 5 and the 20-foot segment of pipe to approximately 18" below existing grade. (Photo 4)

Photo 3 – 20-foot segment of 15" Perf. SD out of CB 5 backfilled with $\frac{3}{4}$ " crushed stone approximately 1.75 feet from the spring line.

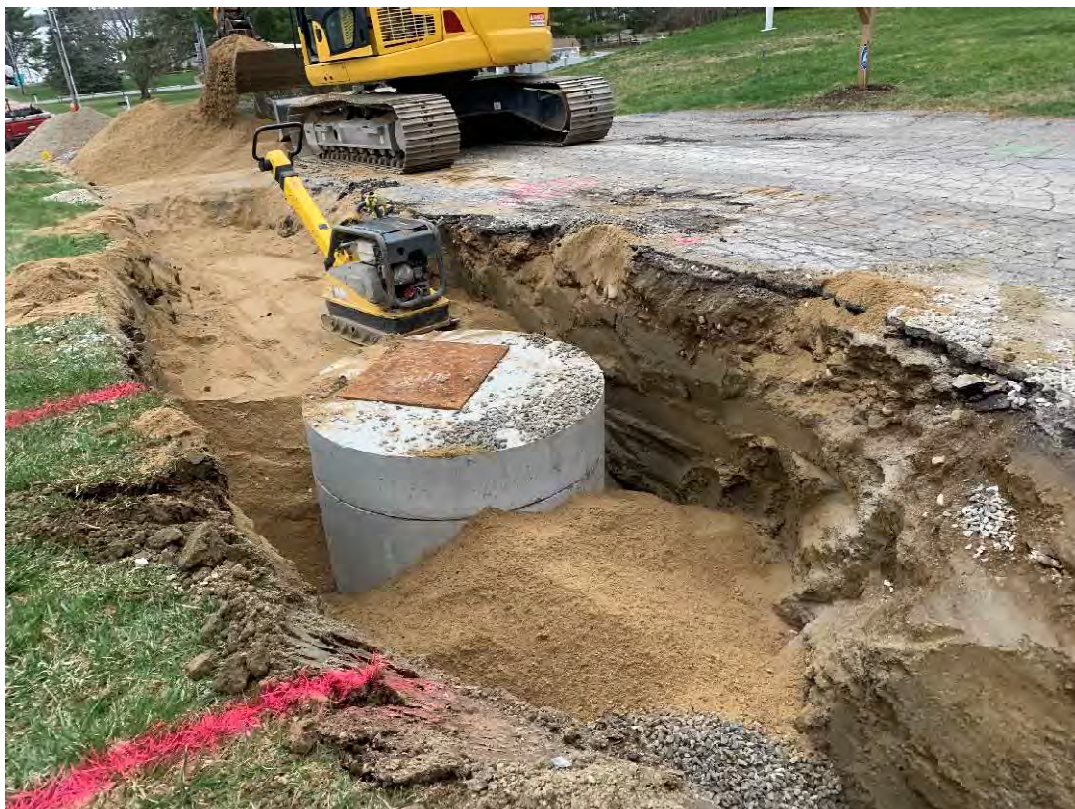
Photo 4 – CB 5 and the 15" Perf. SD being backfilled with MaineDOT 703.22 Type B Underdrain.

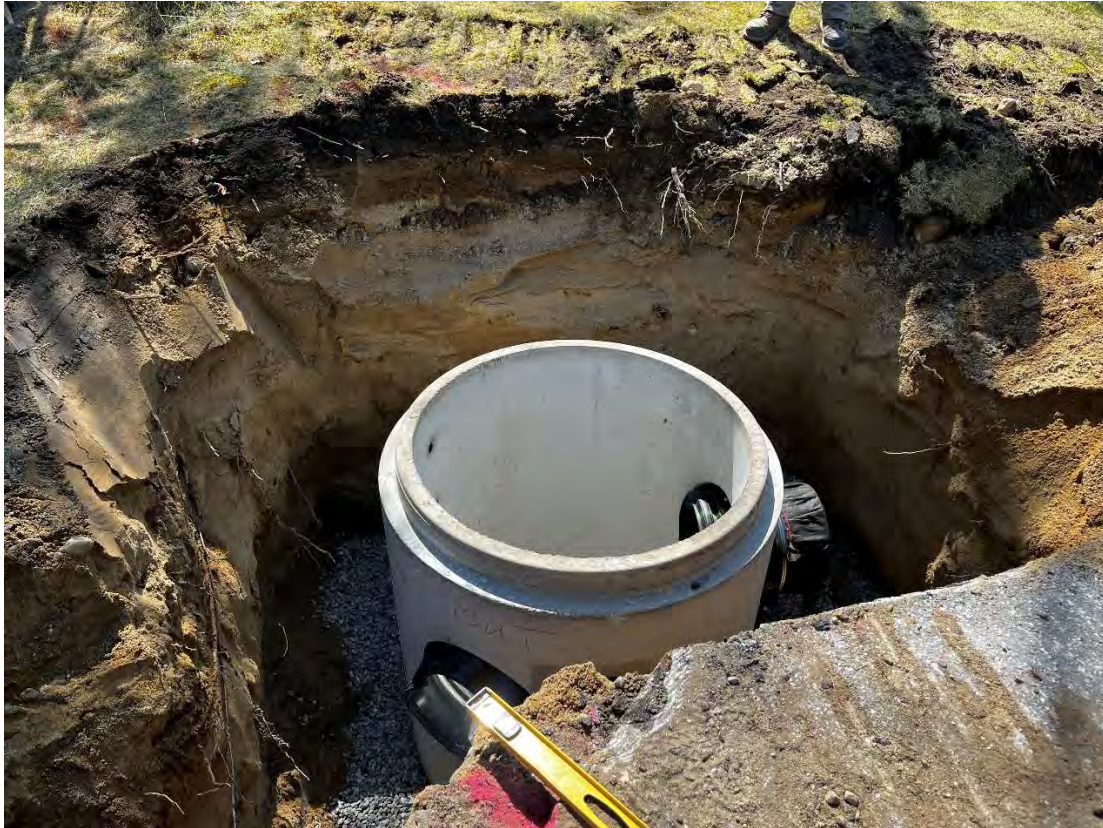
- The 15" Perf. SD appeared to be installed with the same efforts as described above.
 - CB 6 was installed on what appeared to be a ¾" stone base. (Photo 5)

Photo 5 – CB 6 installed on a $\frac{3}{4}$ " crushed stone base.

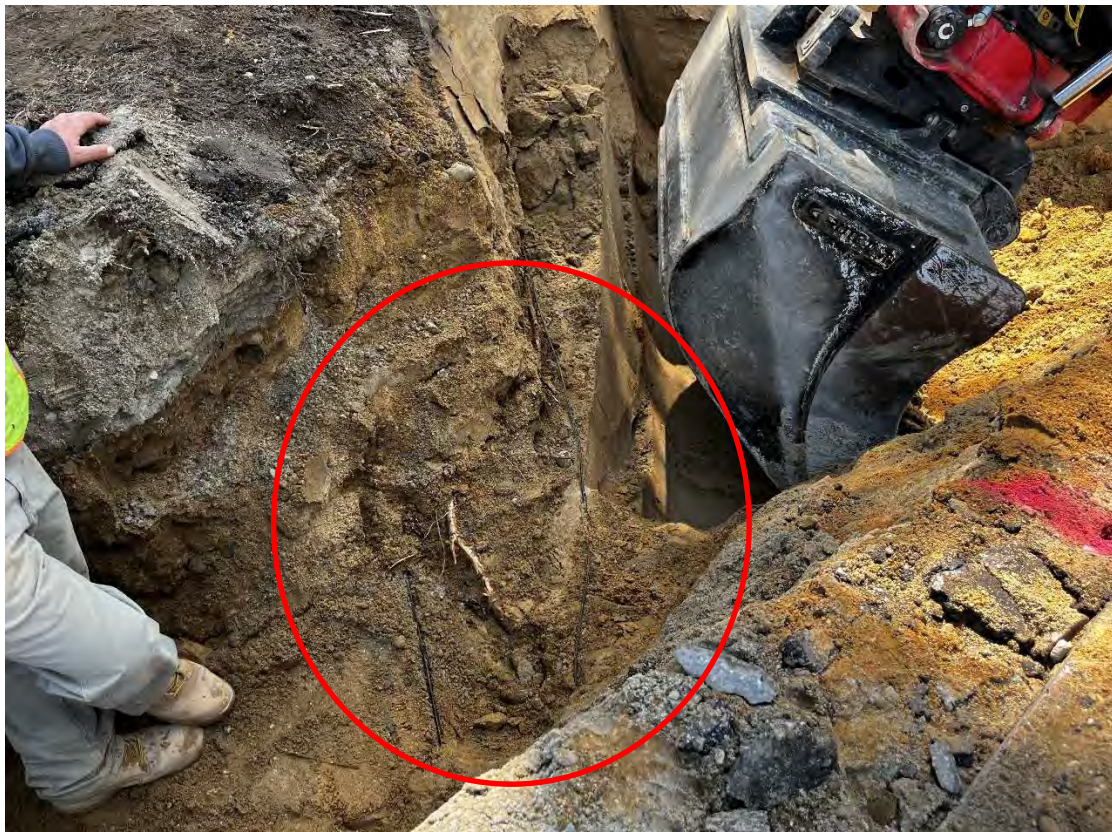
- Photo 6 shows a direct burial of conduit, embedded with sand at 8 Longmeadow Road, avoided by hand shoveling.
- A.H. Grover, Inc. makes efforts to communicate with homeowners.

Photo 6 – Direct burial of conduit (circled in red) at 8 Longmeadow Road.

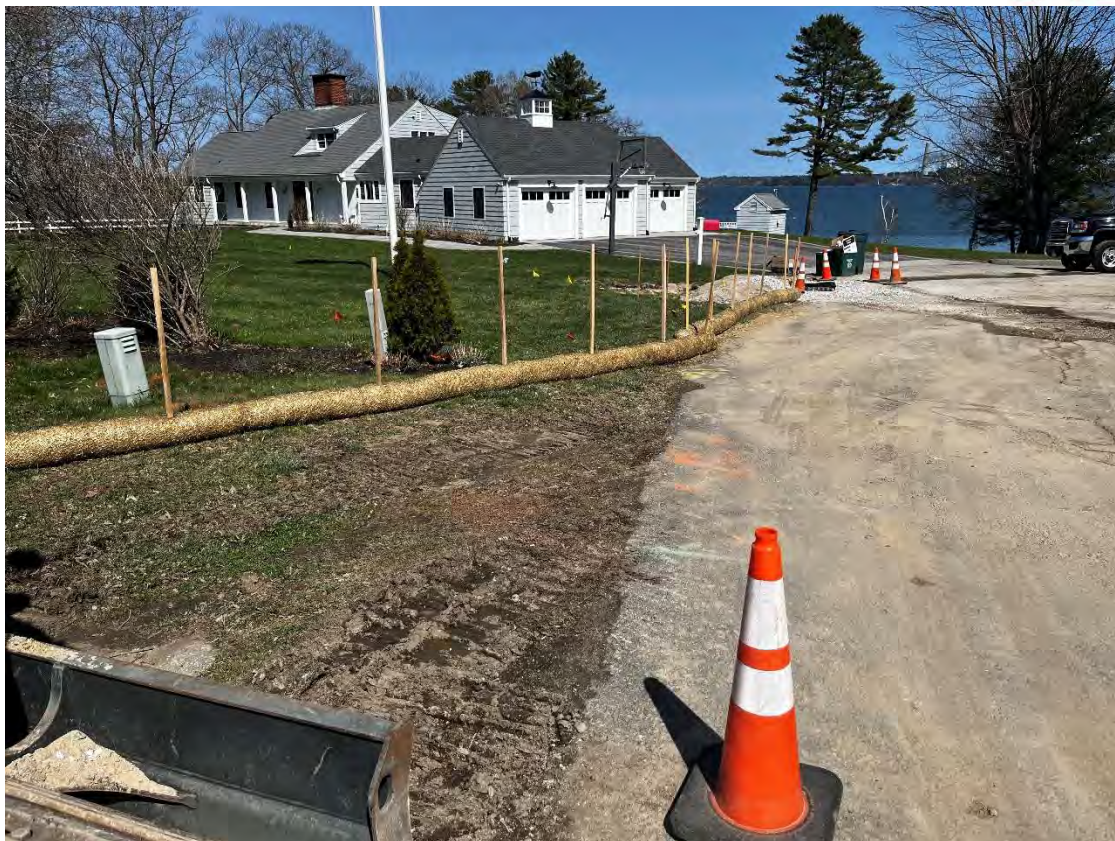
- Temporary erosion and sedimentation control measures were installed.
 - Straw Wattle and Anchors with 24" stakes were installed around the perimeter of the northern portion of the cul-de-sac area. (Photo 7)

Photo 7 – Straw wattle installed around the perimeter of the northern portion of the cul-de-sac.
