# FIELD OBSERVATION REPORT

Project: Tuttle Road, Main Street, and Blanchard Road Downtown Sidewalk Improvements Client: Town of Cumberland GP Field Rep: Kassey Northrop (KN) Weather: Sunny Time onsite: 8:45 AM – 9:45 AM/ 12:45 PM – 1:45 PM Contractor: Glidden Excavating & Paving, Inc. (Glidden) Distribution: File; Town of Cumberland GP Project No: 3656.11 Visit Date: July 14, 2023 Report Date: July 17, 2023 Temp. Range: 72-75 °F

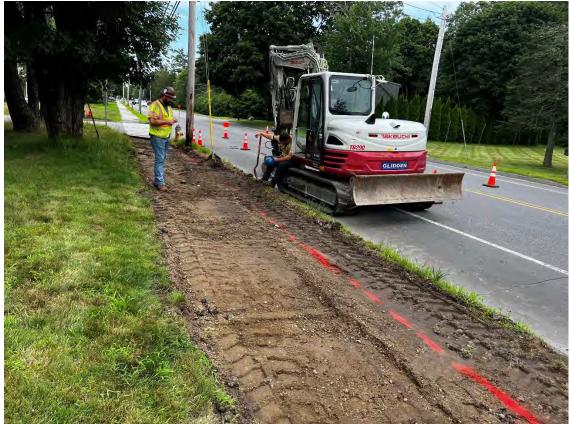
- Glidden continued to work towards the Blanchard Road/Tuttle Road intersection from the previous day's limit (driveway apron of 363 Main Street).
  - On arrival in the morning, a crew member operating the Takeuchi TB290 compact excavator had removed the existing pavement up to Hillcrest Drive (Photo I).

Photo I – Existing pavement removed to Hillcrest Drive.

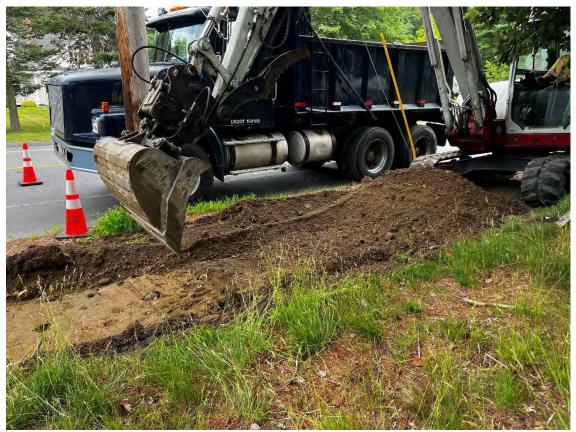
- Unsuitable material was observed upon removal of the pavement between 363 Main Street and Hillcrest Drive. Per plan, this section was called out to be full-depth reconstruction and while on site, Glidden began to remove approximately 12" of the unsuitable material (Photo 2). A crew member was observed to be using a laser level and survey rod to ensure proper grade while excavating (Photo 3).

Photo 2 – Top 12" of existing gravels excavated.

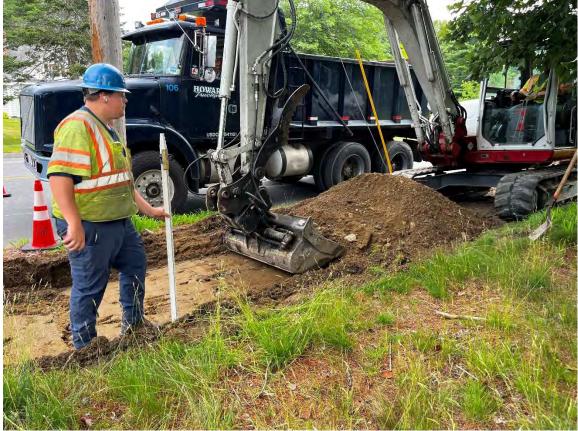
Photo 3 – Crew member holding survey rod with laser level.

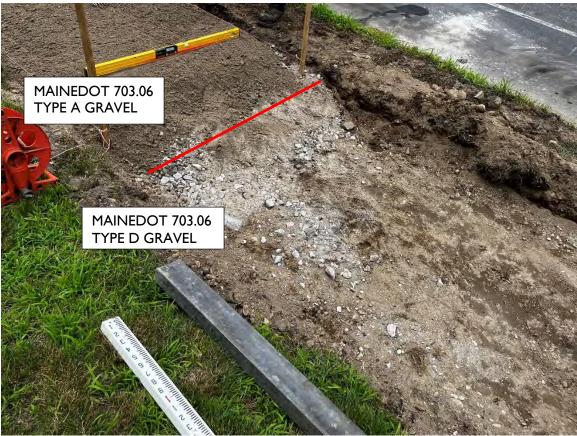
- Upon arrival in the afternoon, Glidden had installed subbase gravel consistent with MaineDOT 703.06 Type D at a depth of approximately 9" per detail within the full-depth reconstruction section between 363 Main Street and Hillcrest Drive and was actively shimming base gravels consistent with MaineDOT 703.06 Type A at a depth of approximately 3" (Photo 4).

Photo 4 – Subbase and base gravel installed in full-depth reconstruction section.

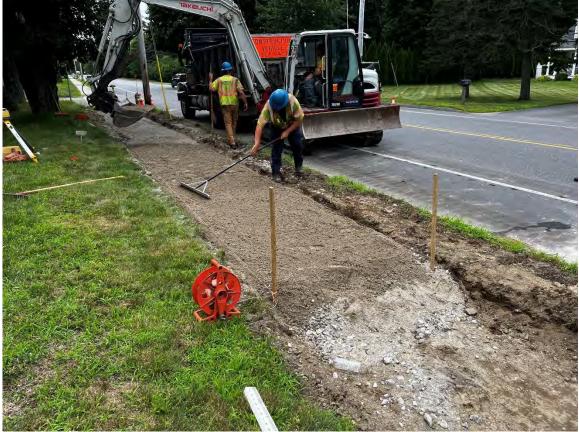
- An excavator operator placed material consistent with Type A gravel with the bucket of the excavator while other crew members used a rake to fine grade the gravels (Photo 5). A smart level was observed to be used to ensure grade at various locations upon fine grading the base gravels (Photo 6).

Photo 5 – Excavator operator placing Type A gravel with bucket, other crew member fine grading with rake.

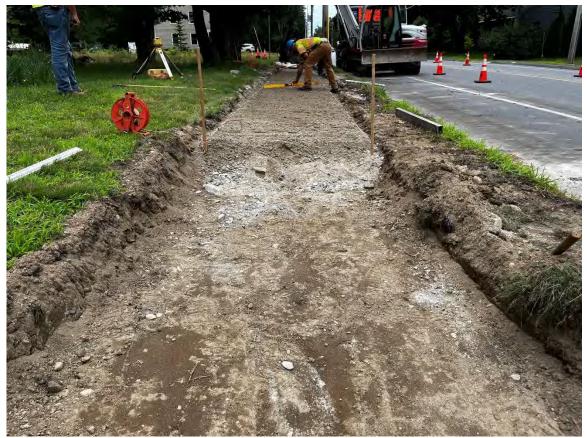
Photo 6 – Smart level used by crew member.

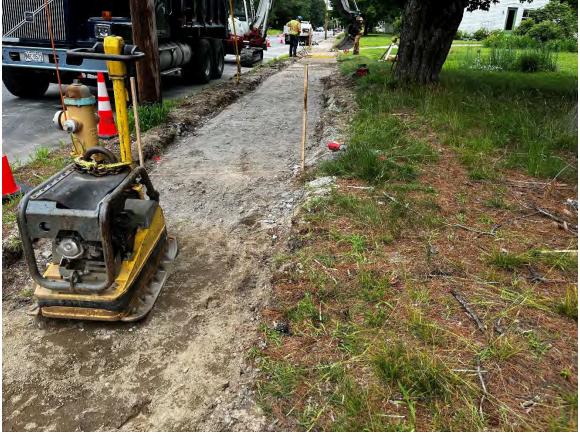
- Glidden appeared to compact gravels with efforts of a Wacker Neuson Plate Compactor and an Ingersoll-Rand DD-24 5-ton roller (Photo 7).
  - Crew worked to install the rest of the subbase and base gravel within the full-depth reconstruction section between 363 Main Street and Hillcrest Drive before ending the workday. No additional pavement was removed past Hillcrest Drive today.

Photo 7 – Wacker Neuson Plate Compactor used for compaction efforts.
