WEEKLY CONSTRUCTION REPORT

PROJECT: MIDDLE ROAD IMPROVEMENTS

PERIOD ENDING: WED., 11 Oct. 2017

CLIENT: TOWN OF CUMBERLAND

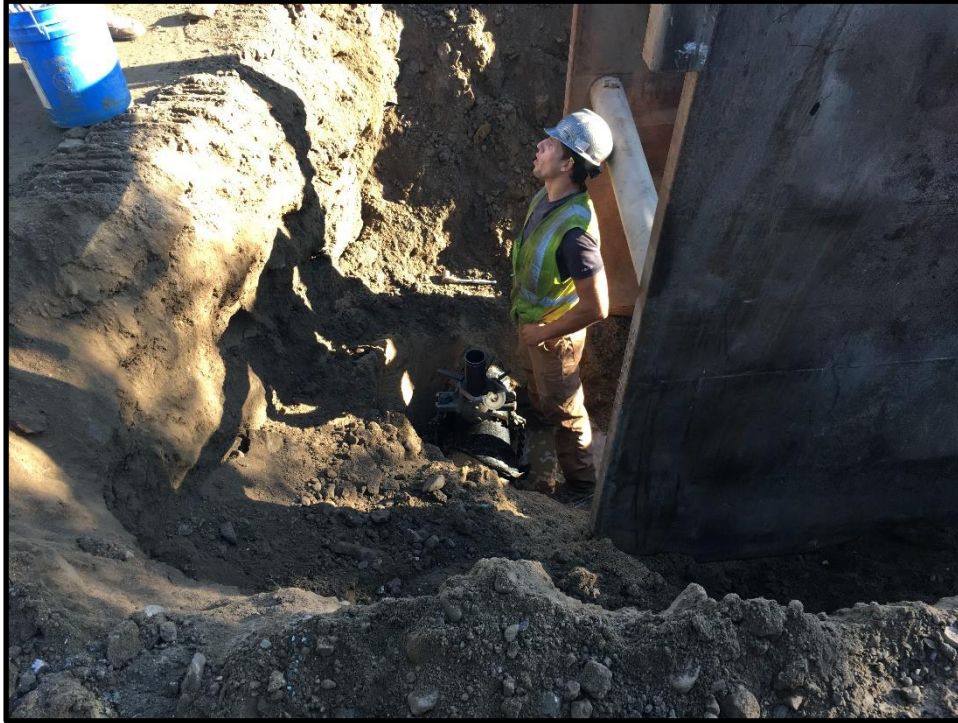
Photograph 1 – Thursday, October 5th - Preparing to tap the 12-inch water main extension to receive the 1-inch corporation stop valve and copper water service line.

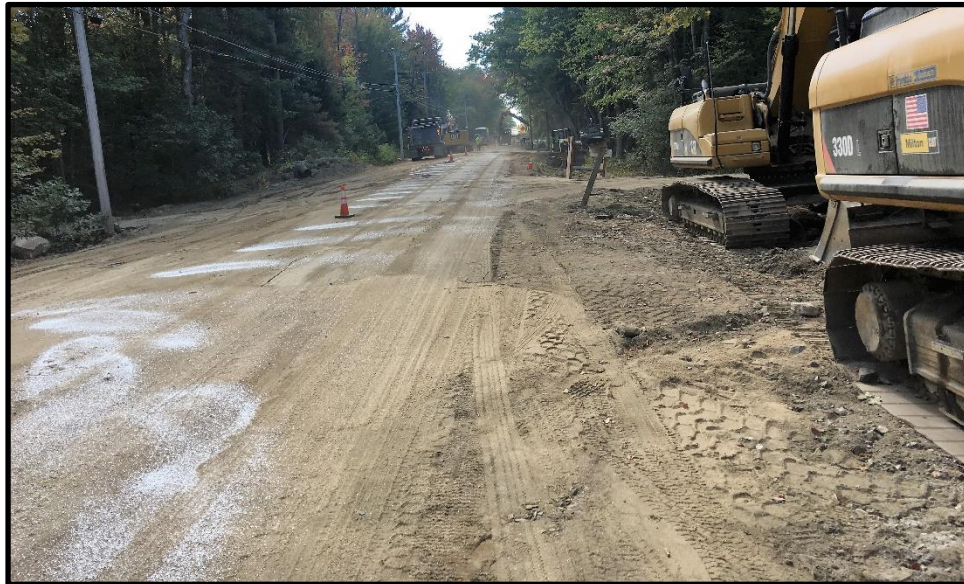
Photograph 2: Thursday, October 5th - Overall work zone. Unloading retaining wall block to the right of the road and installing a "short side" water service at Waterfall Way on the left side of the road. In the foreground, freshly broadcasted calcium chloride for dust control on the left and idle excavators parked on right.

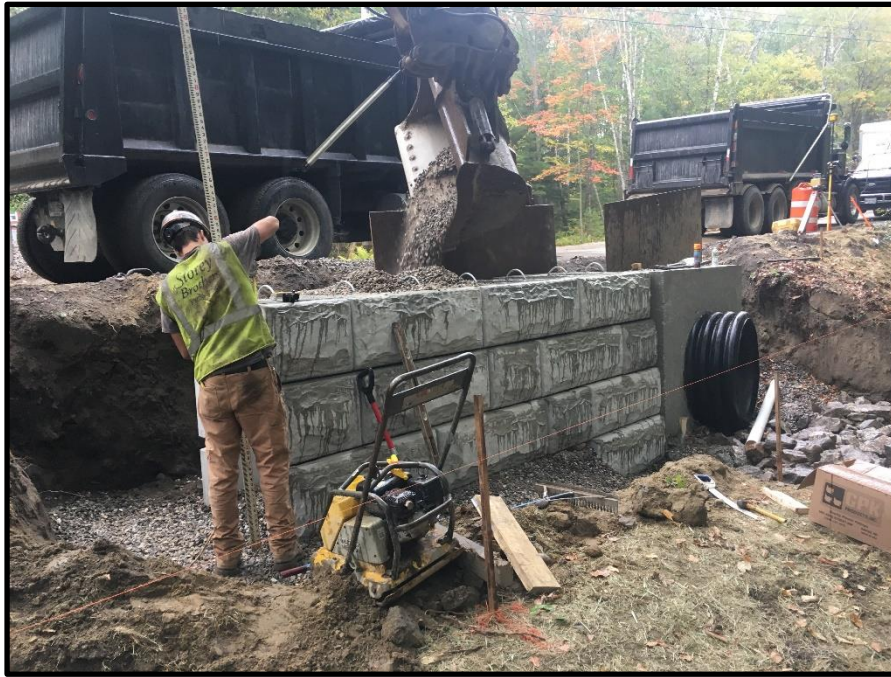
Photograph 3 - Friday, October 6th – Placing precast blocks of the retaining wall, checking alignment and backfilling with crushed stone. Here crew is working on the northern half of the wall.

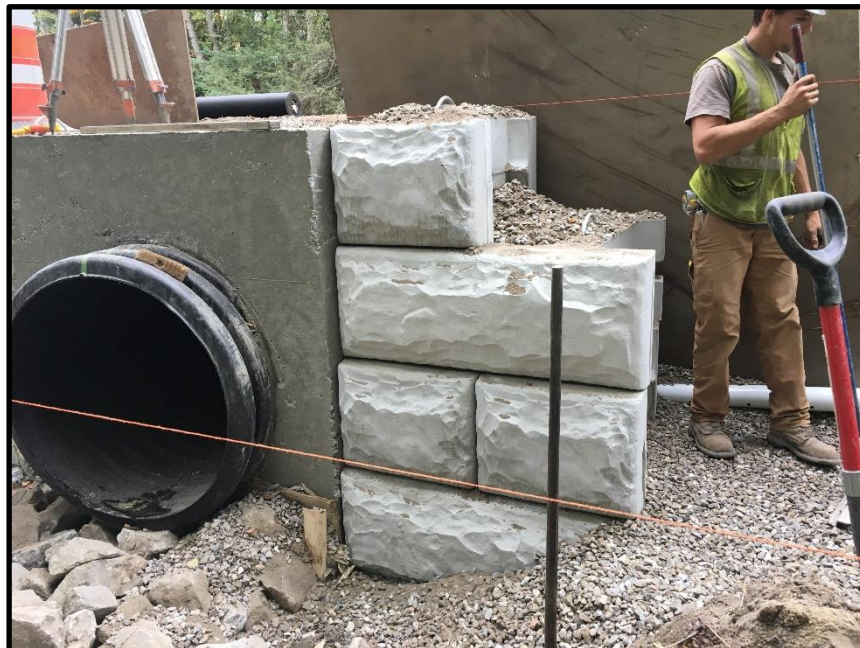
Photograph 4 - Friday, October 6th – Starting the southern half of the wall and preparing the base for the next block. PVC underdrain for the wall shown behind worker.

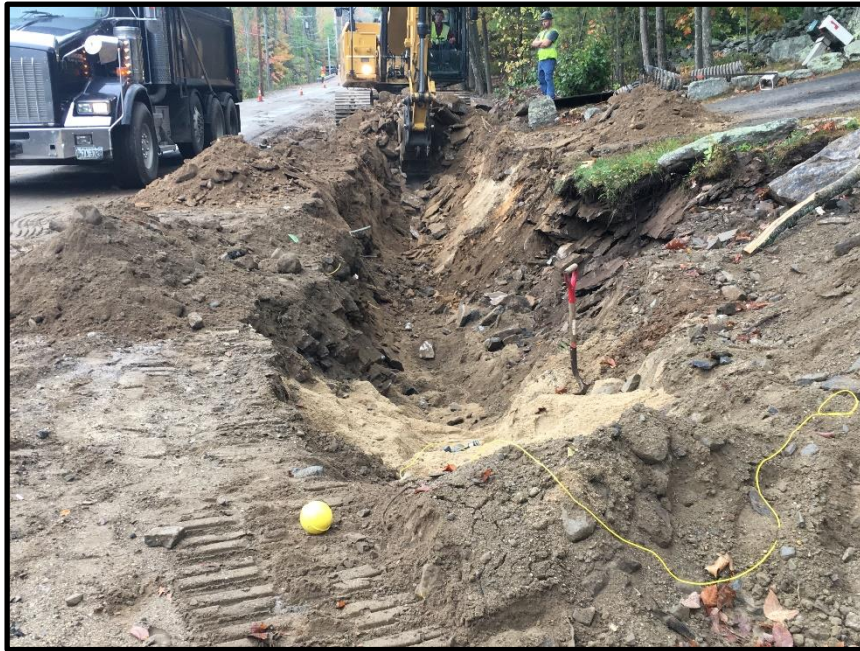
Photograph 5 – Monday, October 9th – Initial excavation to install natural gas main in areas previously skipped due to ledge. Here in front of 70 Middle Road.

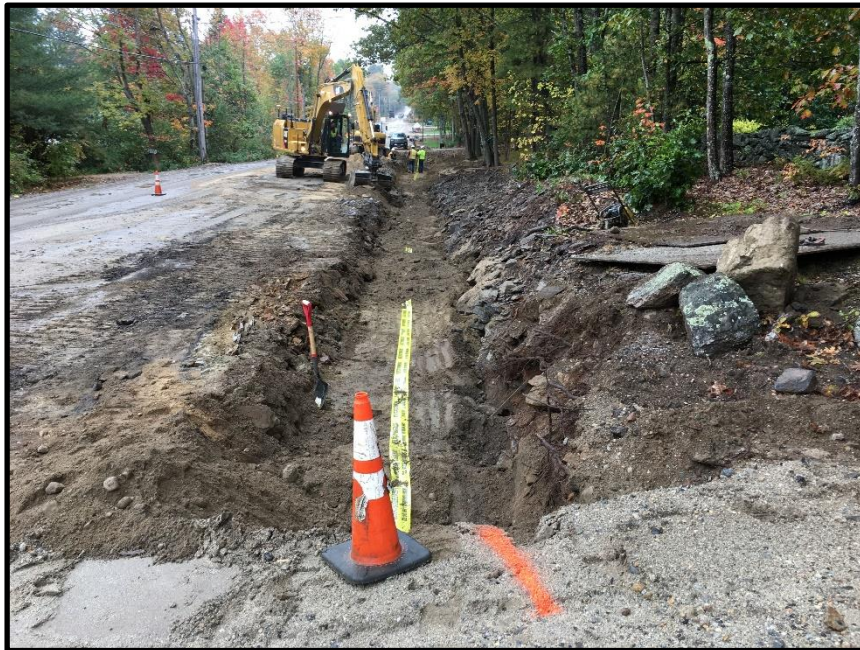
Photograph 6 - Monday, October 9th - By mid-afternoon the crew was backfilling gas trench using 2 excavators to place sand over the gas main (in the background) followed by second excavator backfilling to grade for drainage swale with native material.

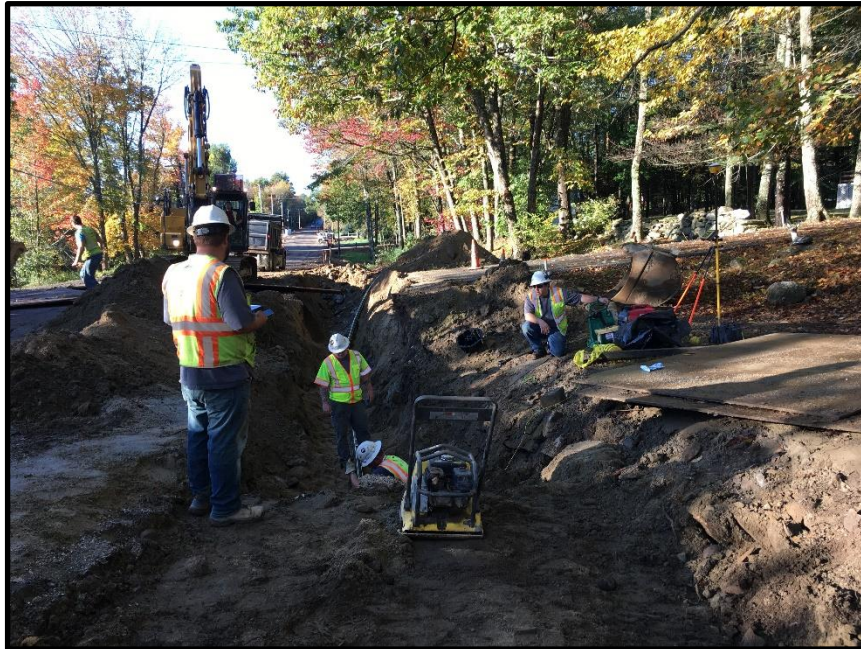
Photograph 7 – Tuesday, October 10th - Initial excavation to complete the gap in the natural gas main installation skipped earlier due to ledge near 58 Middle Road.

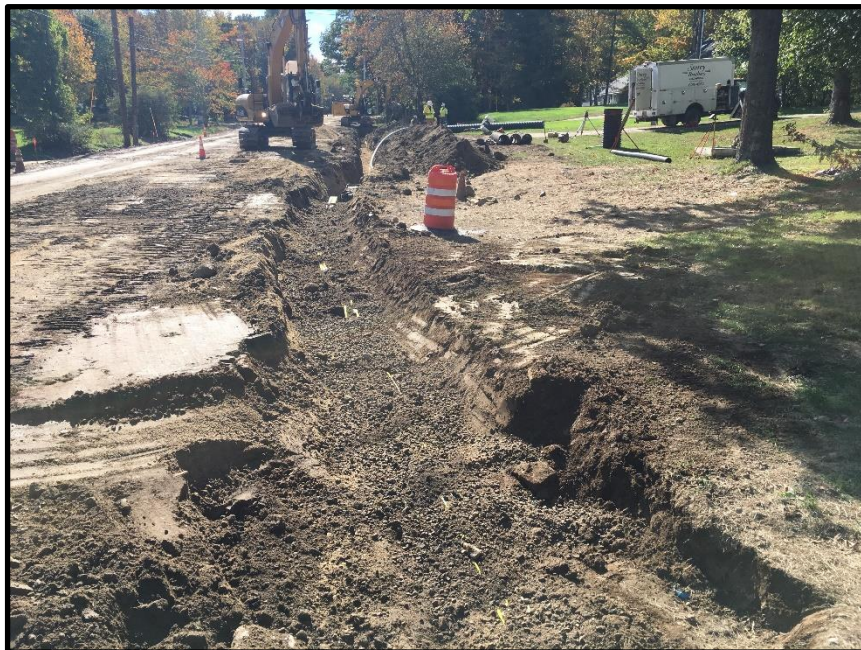
Photograph 8 - Tuesday, October 10th – After the gap in the gas main installation was installed, the crew resumed where the installation has previously stopped at STA 24+40 (just south of Range Way). The jog in the alignment of the gas main trench is due to the retention of the 12-inch underdrain in front of 54 Middle Road.

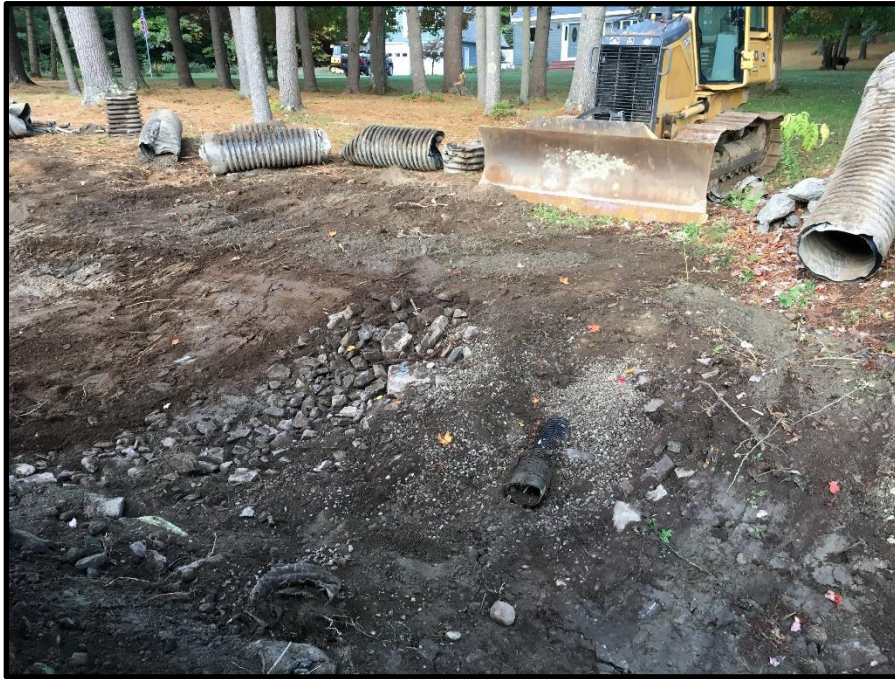
Photograph 9 – Wednesday, October 11th – Undocumented underdrain exposed in front of 44 Middle Road discharging to swale.

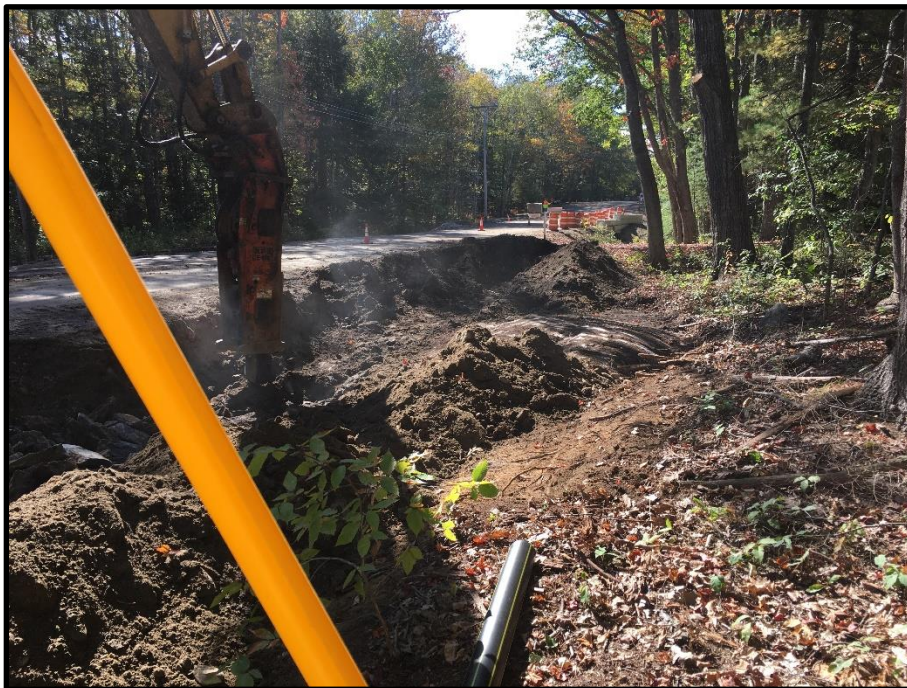
Photograph 10 – Wednesday, October 11th – A section of ledge between 38 and 34 Middle Road that was not blasted had to be removed with the hoe ram before the crew could connect to the previously install main behind the retaining wall.
