**DAILY CONSTRUCTION REPORT**

Date: Friday, 10-13-2017  
(Day 121)

**PROJECT:** Middle Road Improvements  
**CLIENT:** Town of Cumberland  
**CONTRACTOR:** Storey Brothers  
**PROJECT MANAGER:** Dan Diffin, P.E.

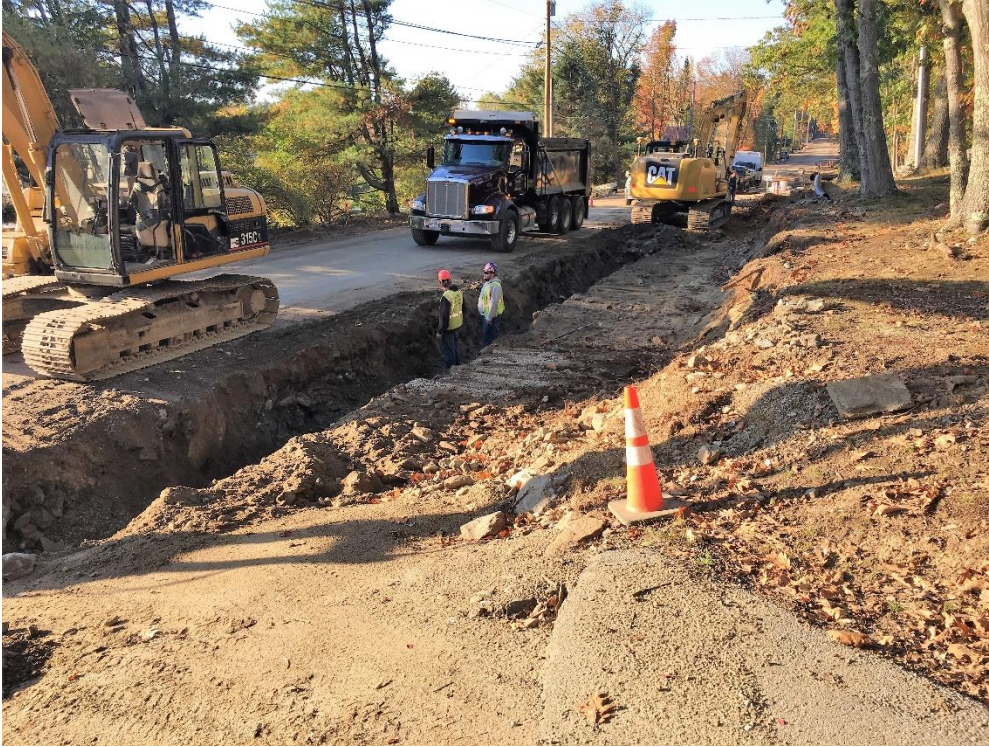
Photo 1 – Crew began the day installing 6-inch underdrain from STA 35+50 (south of #72 driveway) southward.

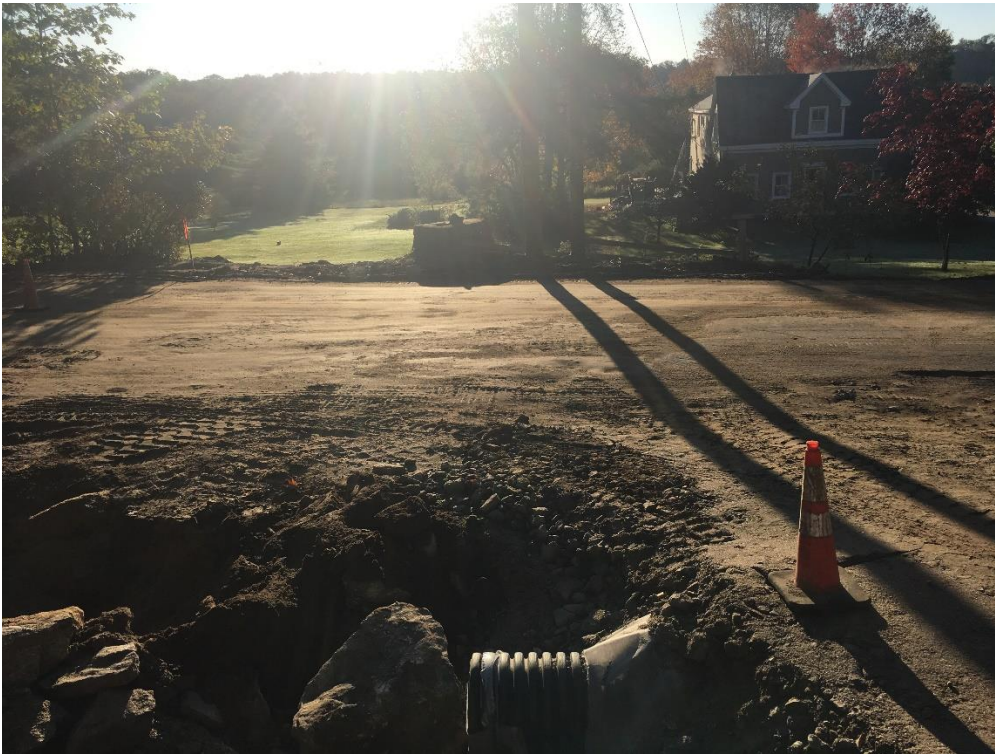
Photo 2 – While installing underdrain the crew also replaced driveway culverts along the route. Above is the inlet of the driveway culvert for 70 Middle Road. Across the road is the stump of the large oak tree next to Pole #307 in front of 67 Middle Road.

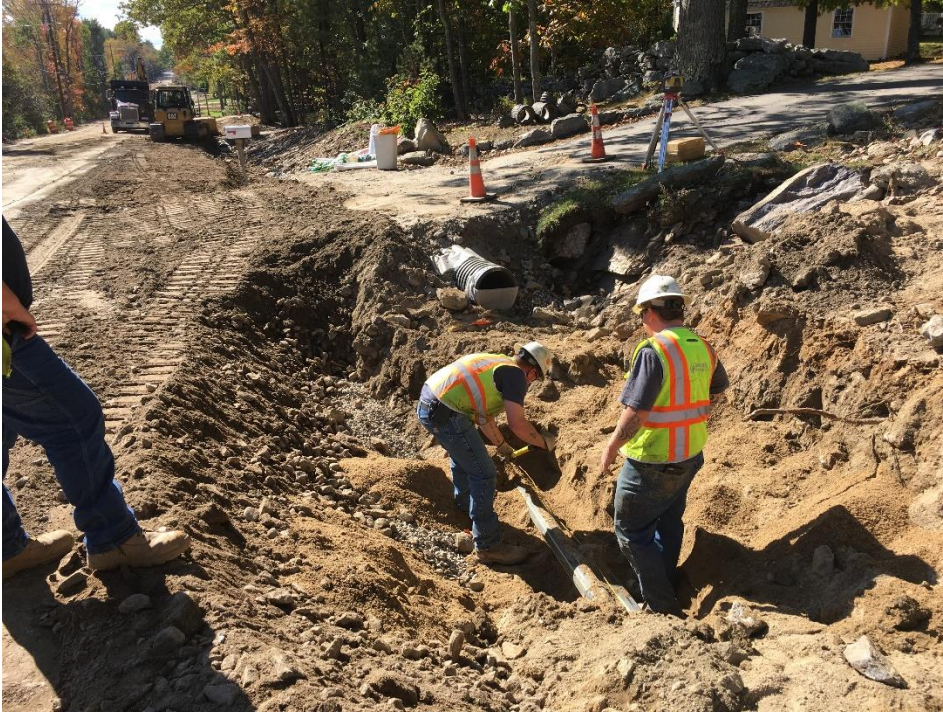
Photo 3 – Summit in front of 72 Middle Road (STA 36+00) preparing to bring the rest of the installed gas main online southward to 31 Middle Road (STA 14+00).

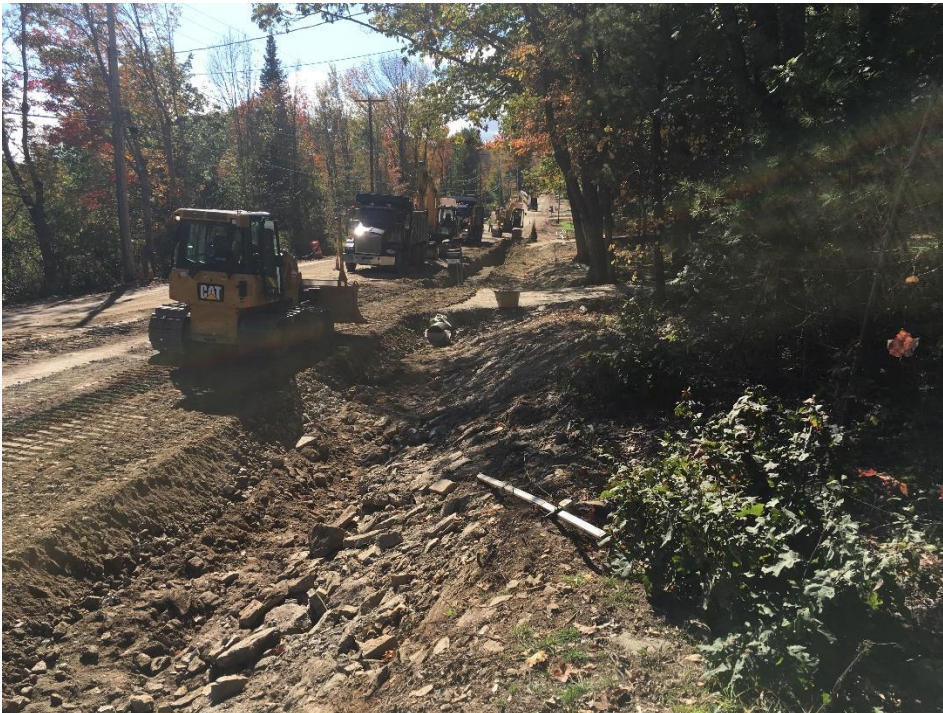
Photo 4 – View looking south depicting the underdrain installation process. The excavator in the background excavates the trench to the proper grade. A second excavator places bedding stone from the dump truck as the pipe is installed followed by stone above the pipe. Gravel from dump trucks is then dropped by the edge of the road and placed by the dozer.
