**DAILY CONSTRUCTION REPORT**

Date: Tuesday, 10-17-2017  
(Day 123)

**PROJECT:** Middle Road Improvements  
**CLIENT:** Town of Cumberland  
**CONTRACTOR:** Storey Brothers  
**PROJECT MANAGER:** Dan Diffin, P.E.

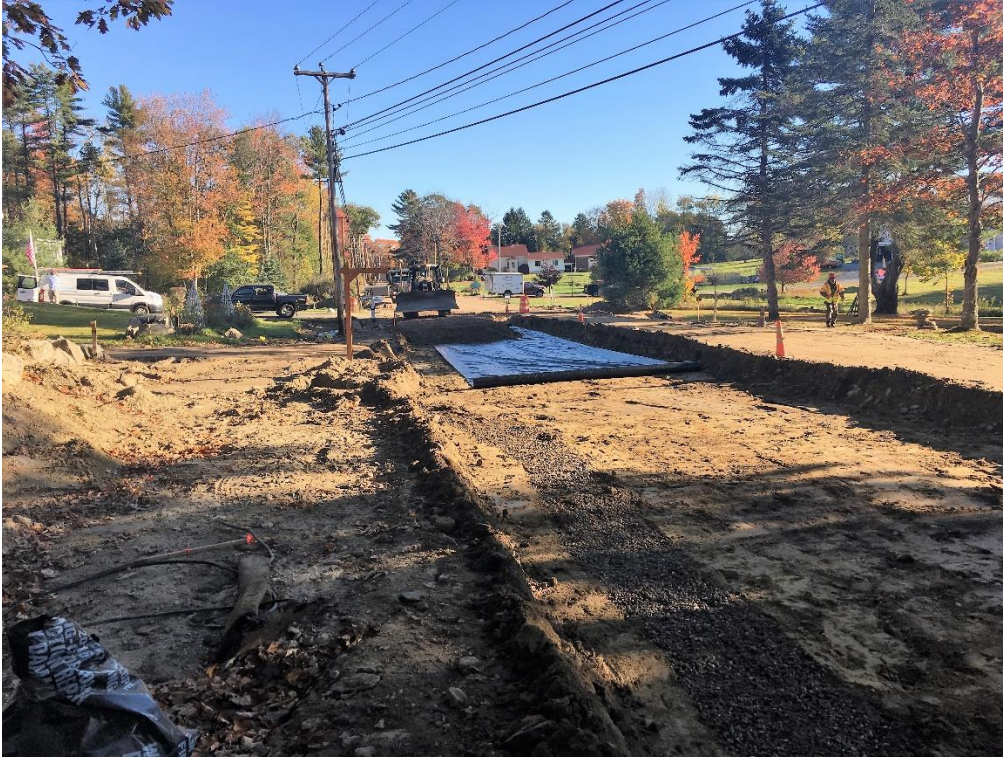
Photo 1 – Initial placement of new gravel at the beginning of the day at STA 39+00 over geotextile fabric following the box cut of the existing gravel. Crushed stone trench of the previously installed 6-inch underdrain in the foreground.

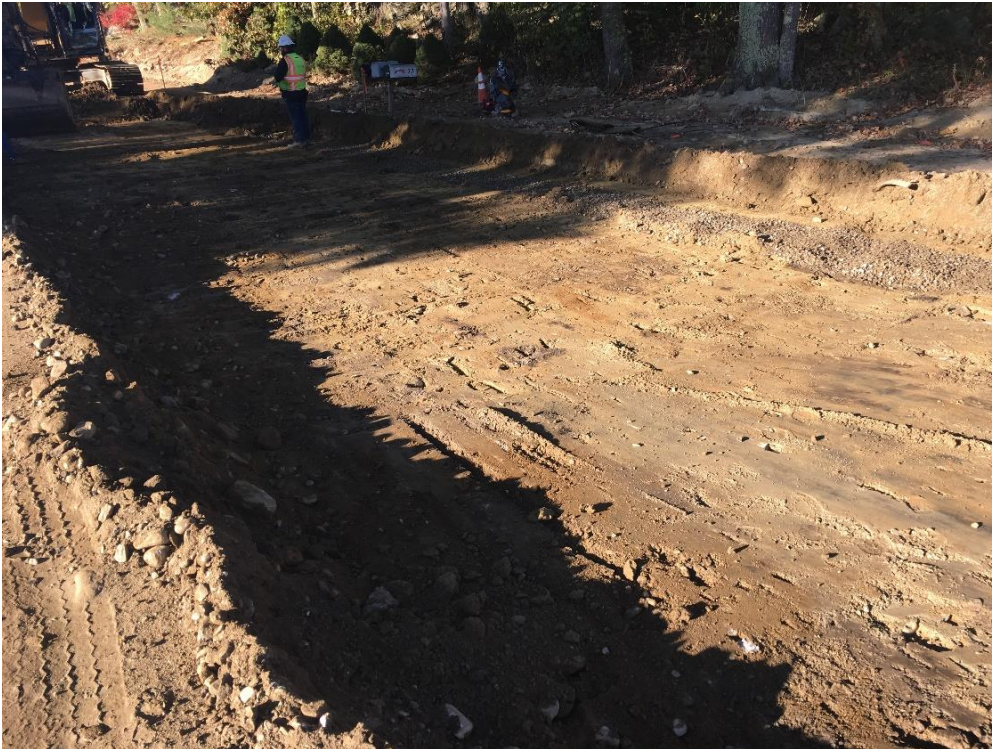
Photo 2 – View of the road subgrade in the vicinity of STA 38+00. Subgrade a stiff dry consolidated silty clay.

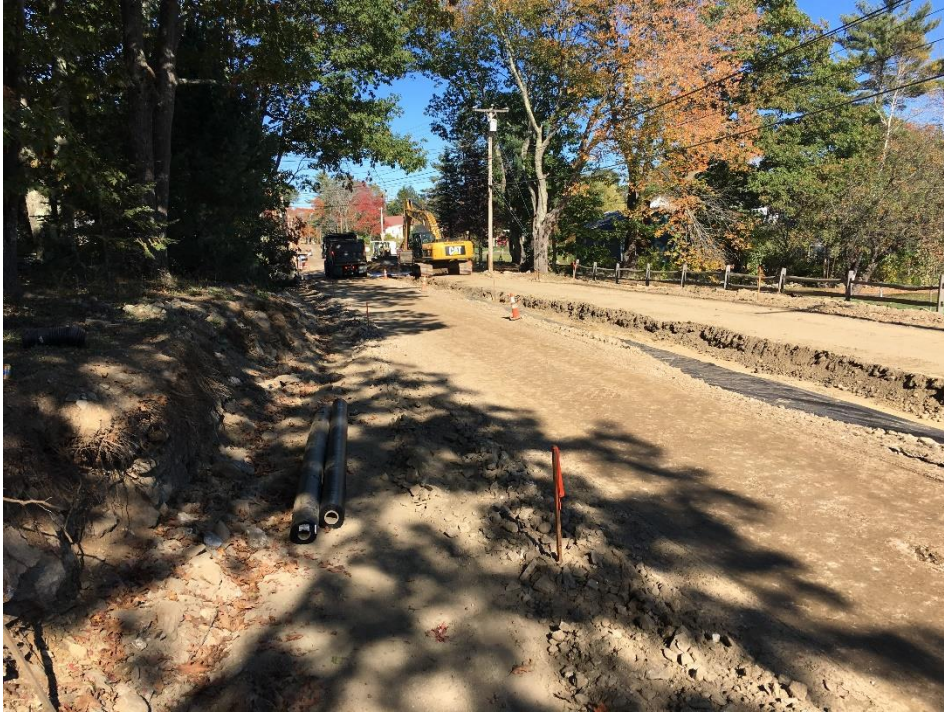
Photo 3 – In the afternoon the crew switched to the northbound lane to box cut and place new gravel in a southerly direction to match up with the southbound lane to STA 35+50 excavated in the morning.

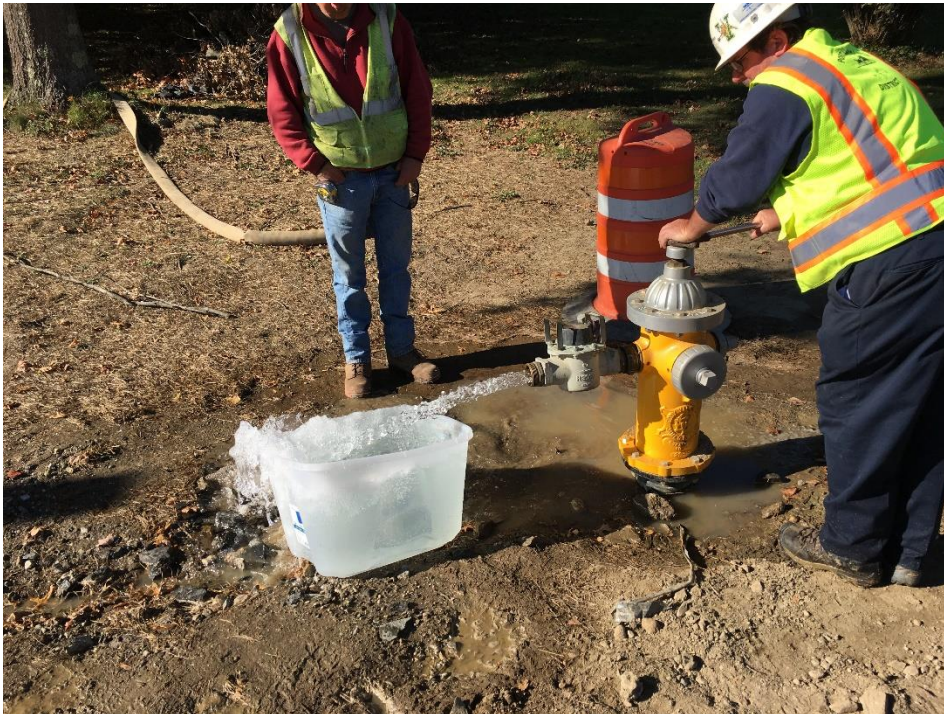
Photo 4 – Rob Story (Storey Brothers) and Jeff McGill (Portland Water District) flushed and visually inspected the water from the hydrant at STA 27+00 (54 Middle Road). After brief discoloration, the flush became clear and did not return after a second flush. It is planned to excavate and inspect the hydrant branch.
