DAILY CONSTRUCTION REPORT

Date: Wednesday, 10-18-2017

PROJECT:Middle Road ImprovementsWEATHER:AM: Sunny Clear PM: P. CloudyCLIENT:Town of CumberlandTEMP:AM: 40'sPM: Upper 60'sCONTRACTOR:Storey BrothersWIND:AM: Light breeze PM: Calm

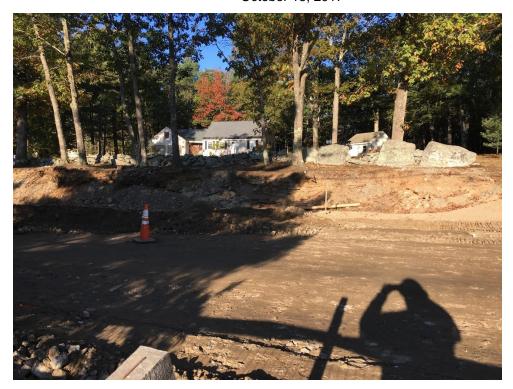
Photo 1 – Began the box cut at STA 35+50 (south edge of 72 Middle Road Driveway) in the southbound lane working southward.

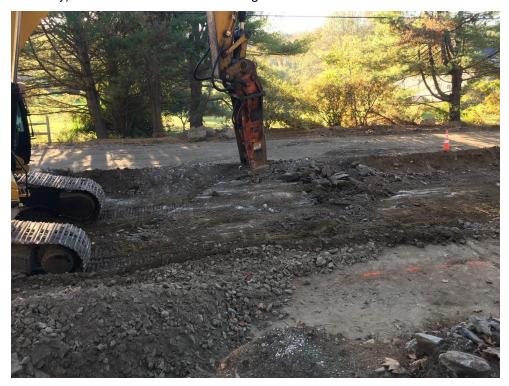
Photo 2 – Early into the box cut a small mound of ledge was encountered near the center of the road at STA 35+25. The size of the mound was approximately 20'x7'x1' and yielded fairly quickly to the hoe ram given the earlier blasting along each edge of the road for water and underdrain/gas.

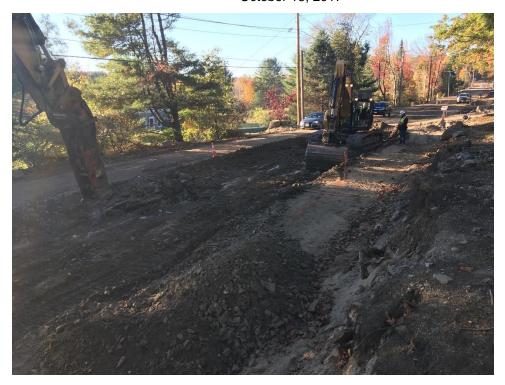
Photo 3 – South of the ledge hump in Photo 1, the subgrade was approximately the top of ledge to approximately 70 Middle Road where the subgrade transitioned to a firm dry silty tan clay.

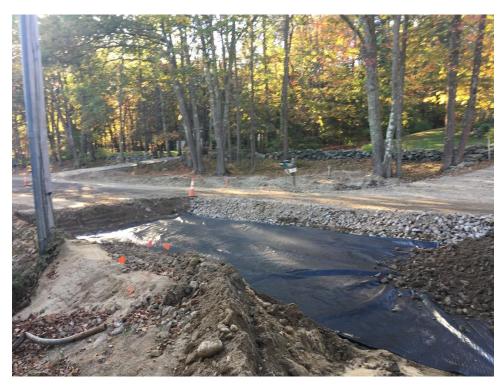
Photo 4 - At the end of the day the box cut finished up on the east side of road at STA 32+75 to match up with the west side near the southern edge of the 62 Middle Road driveway.
