DAILY CONSTRUCTION REPORT

Date: Thursday, 10-19-2017
(Day 125)

PROJECT: Middle Road Improvements
CLIENT: Town of Cumberland
CONTRACTOR: Storey Brothers
PROJECT MANAGER: Dan Diffin, P.E.

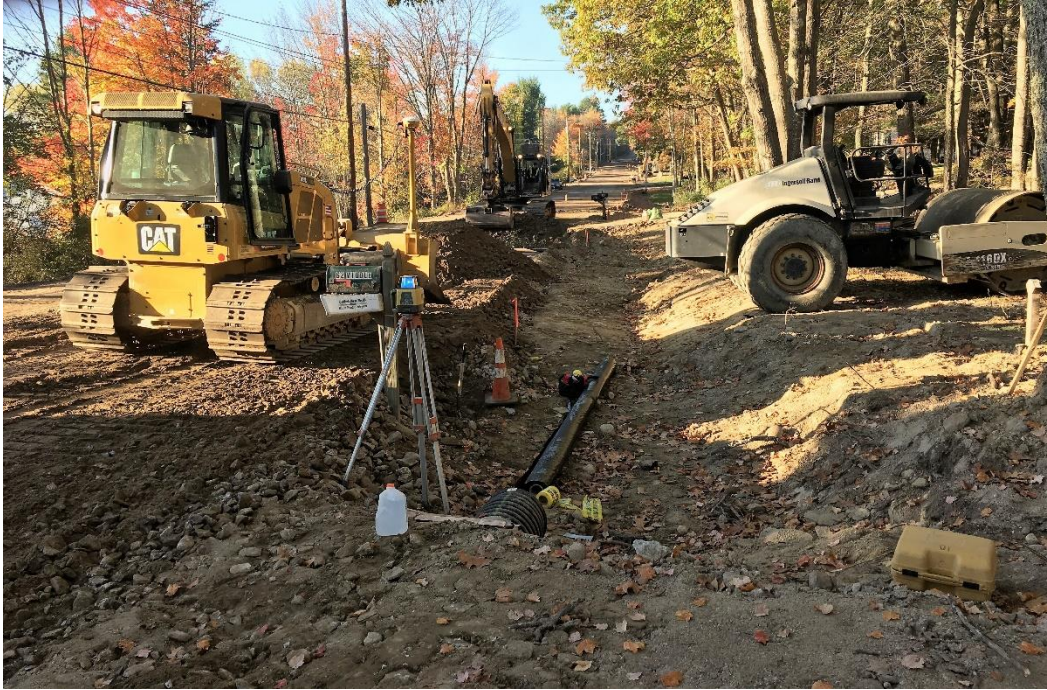
Photo 1 – Began the box cut at STA 32+75 (south edge of 62 Middle Road Driveway) in the southbound lane working southward.

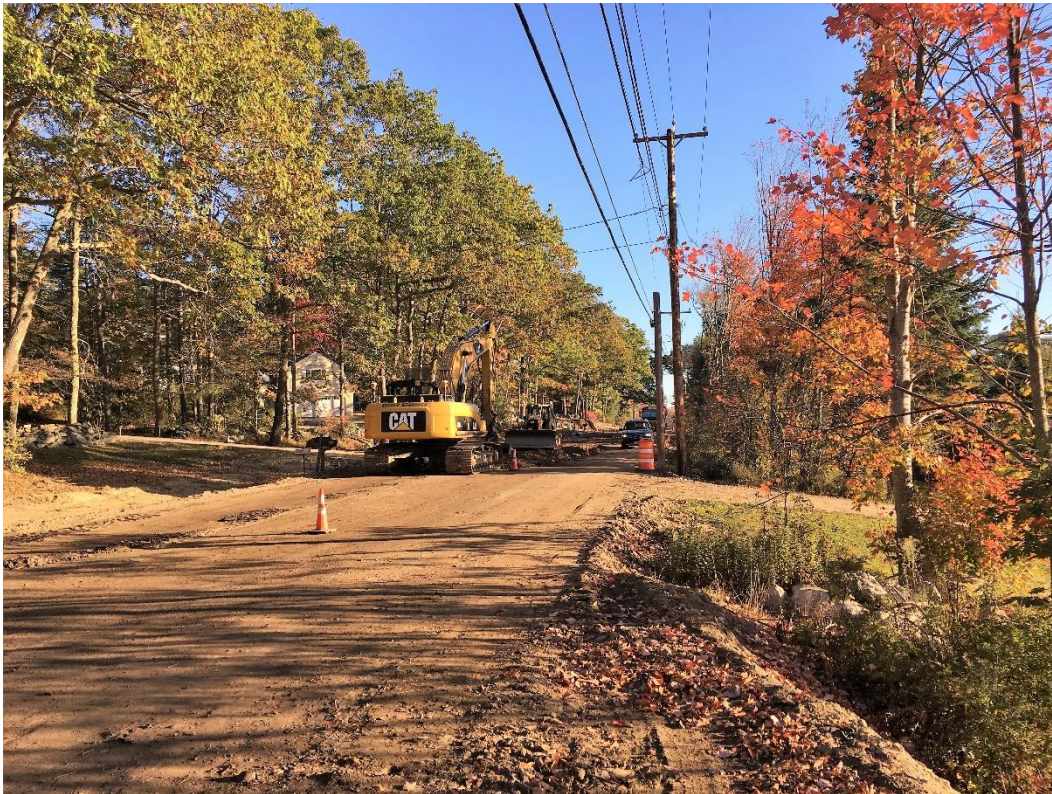
Photo 2 – Box cutting and placing new base gravel at STA 31+75 along the west side of the road (in front of 58 Middle Road) approaching the southern end of the day's box cut at STA 31+00.

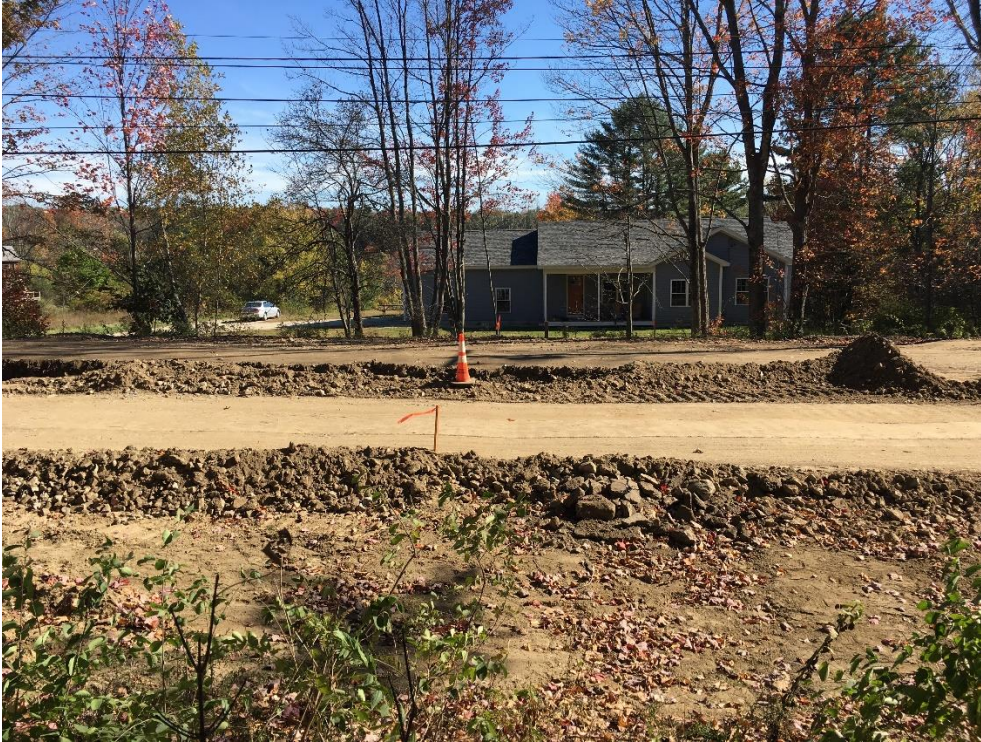
Photo 3 – Southern end of the day's box cut at STA 31+00 in front of 57 Middle Rd. (meeting up with 400-foot section previously box cut to STA 27+00). Crew then switched to east side of the road at STA 32+75 and worked southerly to match up to this point.

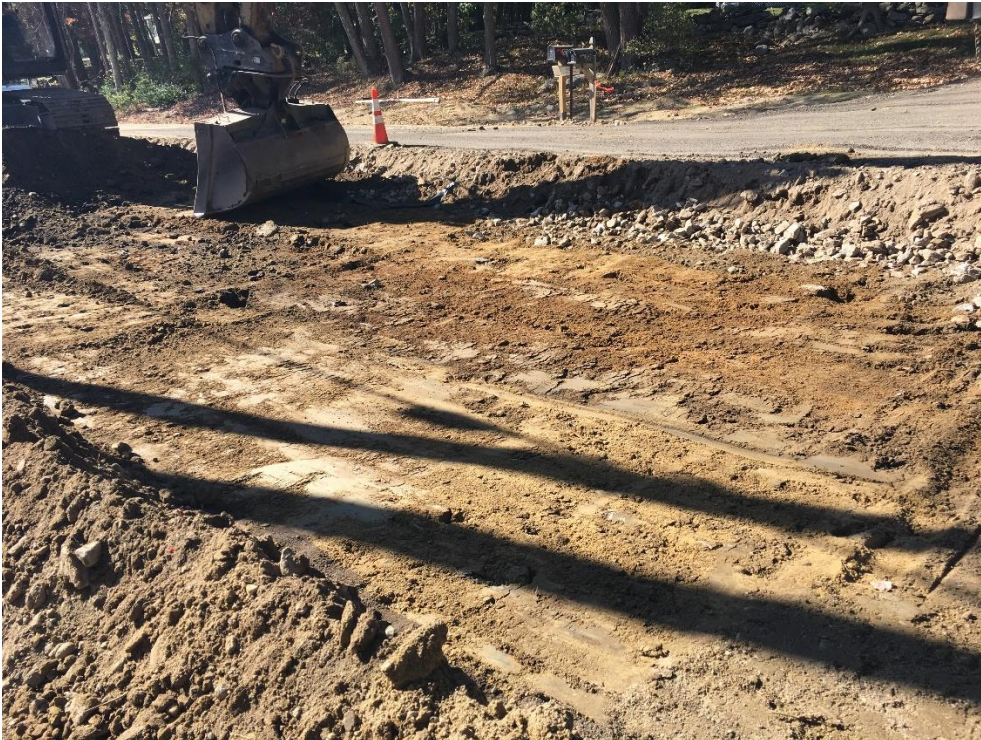
Photo 4 – View of subgrade at STA 31+50 showing a hard, dry silty clay in the northbound lane near the end of the day. This was typical for the day.
