**DAILY CONSTRUCTION REPORT**

Date: Friday, 10-20-2017  
(Day 126)

**PROJECT:** Middle Road Improvements  
**CLIENT:** Town of Cumberland  
**CONTRACTOR:** Storey Brothers  
**PROJECT MANAGER:** Dan Diffin, P.E.

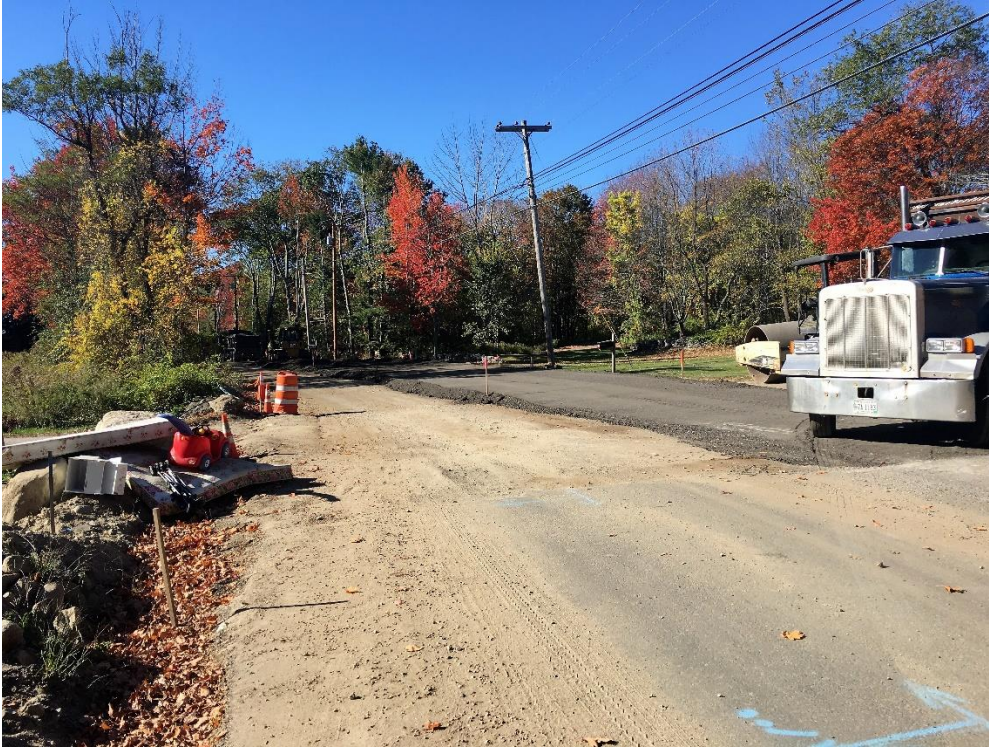
Photo 1 – Began the day at STA 49+50 placing surface gravel (pavement millings) in the southbound lane in a southerly direction.

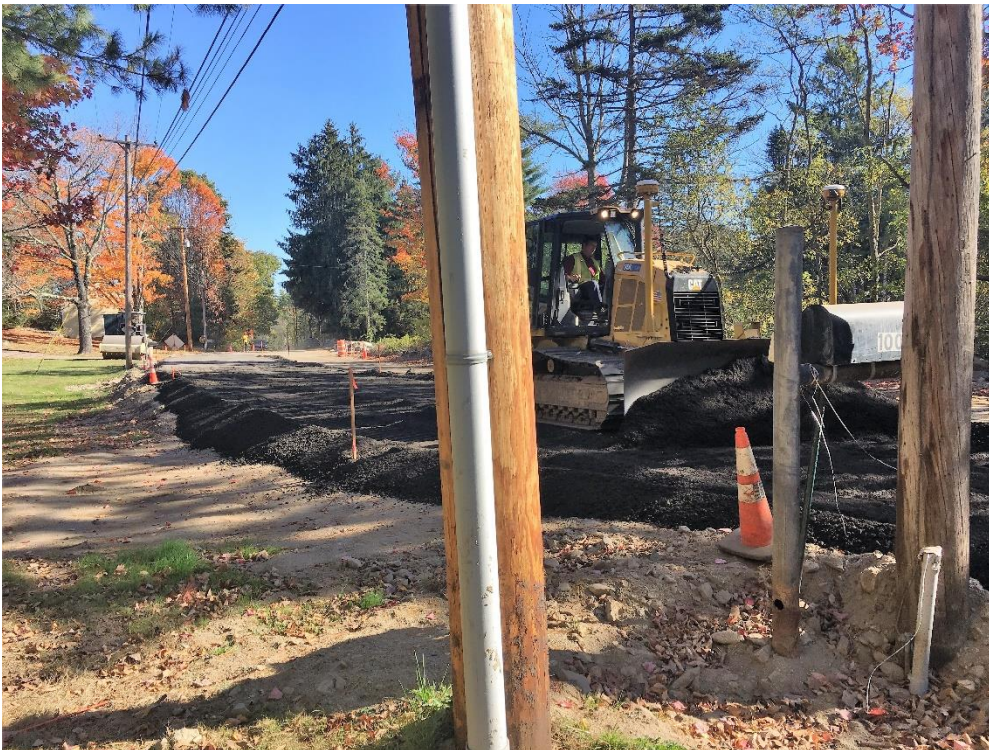
Photo 2 – GPS equipped dozer and laser measured grade stakes used to set road to proper grade. Crew placed surface gravel for 900 feet of roadway to STA 40+50 just south of Storey Brook Lane.

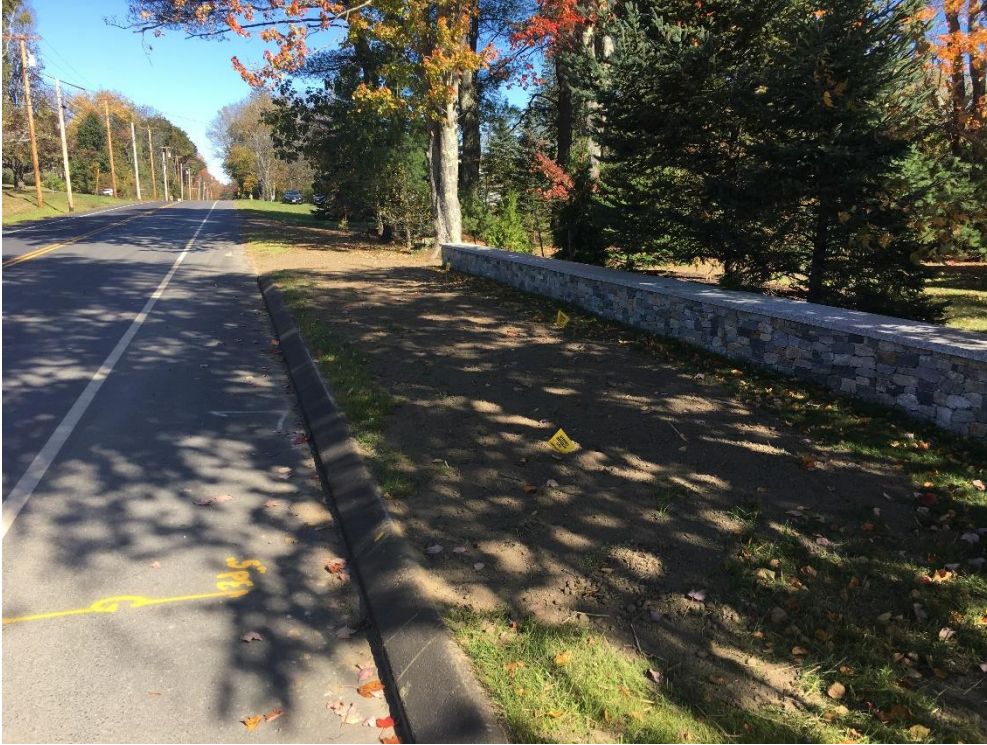
Photo 3 – View of 129 Middle Road after gas service installed by Summit Natural Gas in “completed section” of the project. Storey Brothers had previously seeded and established grass in these areas.

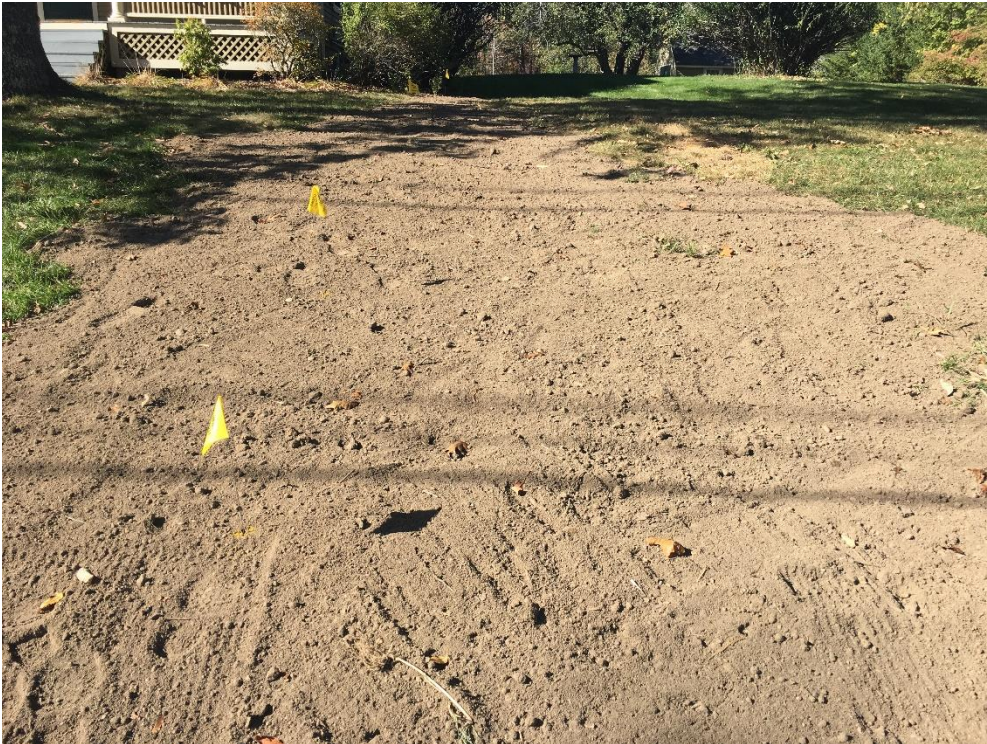
Photo 4 – View of 142 Middle Road after gas service installation. These areas should be stabilized so that soil is not transported into the project's storm drains.
