DAILY CONSTRUCTION REPORT

Date: Thursday, 09-14-2017

PROJECT: Middle Road Improvements WEATHER: Sunny, High Clouds

SEVEE & MAHER ENGINEERS, INC. CONSTRUCTION PHOTOS September 14, 2017

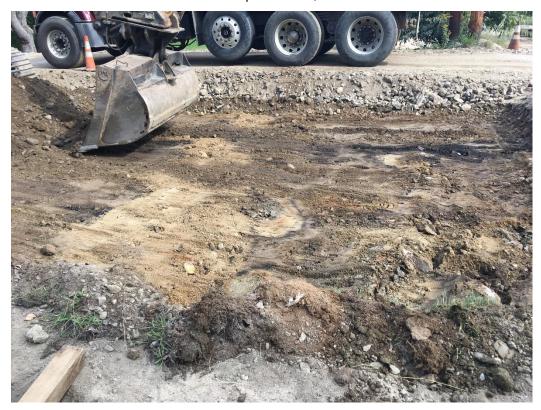
Exposed subgrade near STA 28+50, Left in the segment from STA 27+00 to STA 31+00 originally proposed for partial box cut. Excavated subgrade shown is near the interface of existing gravel and original subgrade consisting mostly of a silty sand with clay lenses.

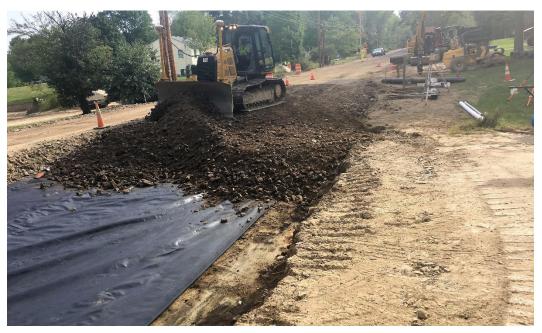
New Type D gravel being placed on geotextile fabric in front of Range Way at STA 28+00, Left. Gravel of exceptional quality (well graded with good angularity).
