## WEEKLY CONSTRUCTION REPORT

PERIOD ENDING: WED., 20 Sept. 2017

PROJECT: MIDDLE ROAD IMPROVEMENTS

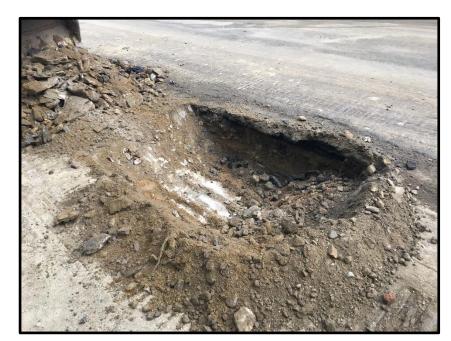
Photograph 3 – Friday, September 15<sup>th</sup> - Test Pit 3C at STA 35+30, 10' Left - Encountered ledge 18-inches below the top of the milled pavement. About 4 inches of pavement had been milled off leaving about 3 inches. This area is in a "full" box cut area.

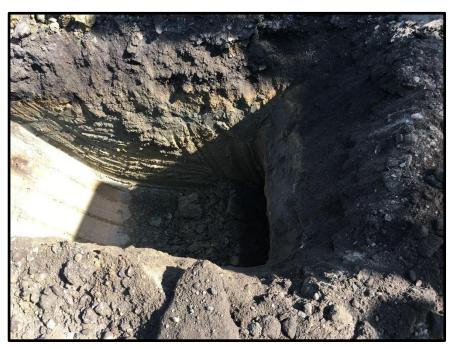
Photograph 4 - Friday, September 15<sup>th</sup> – Test Pit 9 at STA 47+50 10' Left – Did not reach ledge at a depth of 45 inches below the milled pavement. Gravel/clay interface was about 18 inches below top of the 2 inches of milled pavement remaining. This area was in a "partial" box cut area.

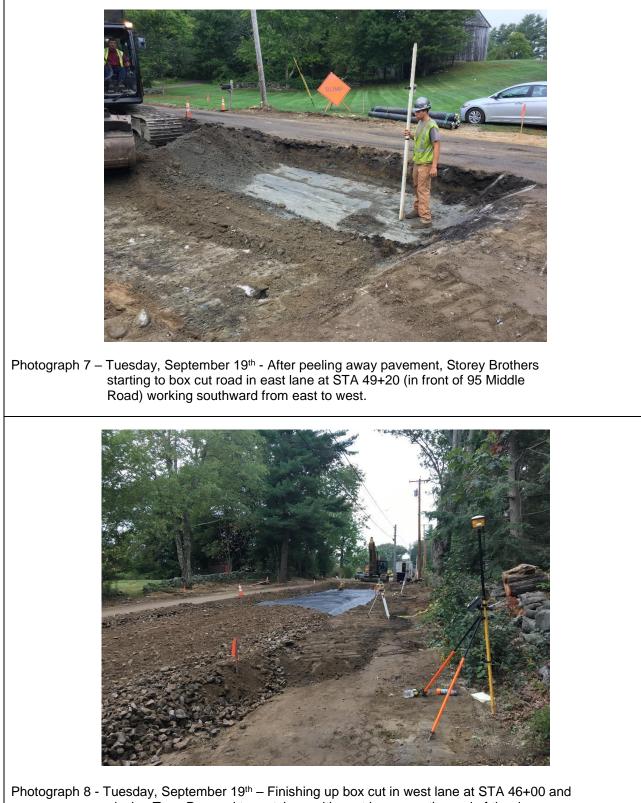
placing Type D gravel to match up with east lane near the end of the day.

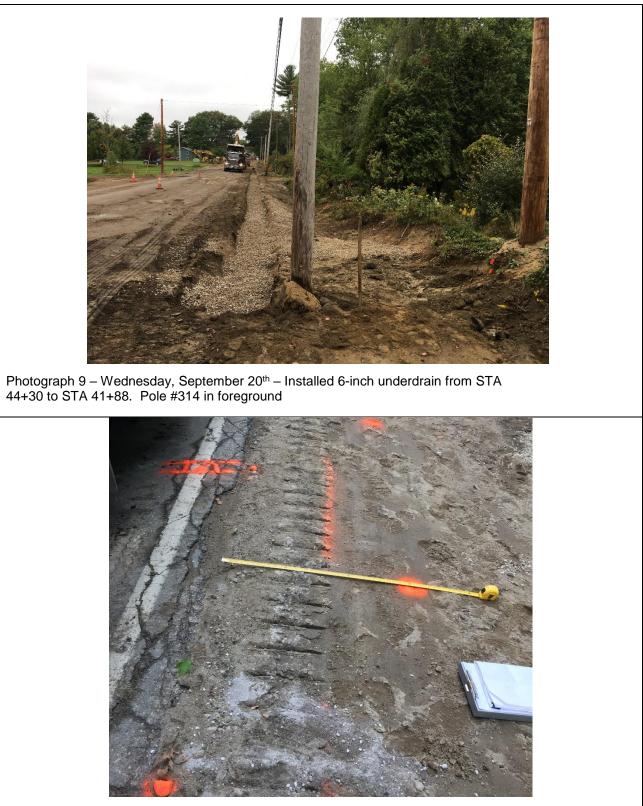
Photograph 10 – Wednesday, September 20th – Layout of alternating drill locations 3 feet wide and 7 feet longitudinally at Waterfall Way.
