DAILY CONSTRUCTION REPORT

Date: Wednesday, 06-21-2017

Middle Road Improvements Mostly Sunny PROJECT: **WEATHER: CLIENT:** Town of Cumberland Upper 70's TEMP: **CONTRACTOR:** WIND: Storey Brothers Windy Dan Diffin, P.E. **PROJECT MANAGER: HUMIDITY:** Drv

SEVEE & MAHER ENGINEERS, INC. CONSTRUCTION PHOTOS June 21, 2017

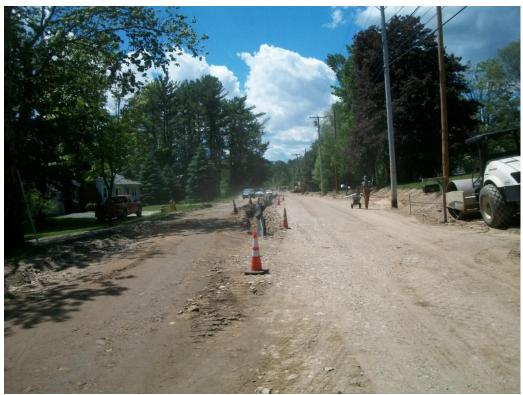
Started day at 69+25 in foreground. Reconstructed southbound lane on right.

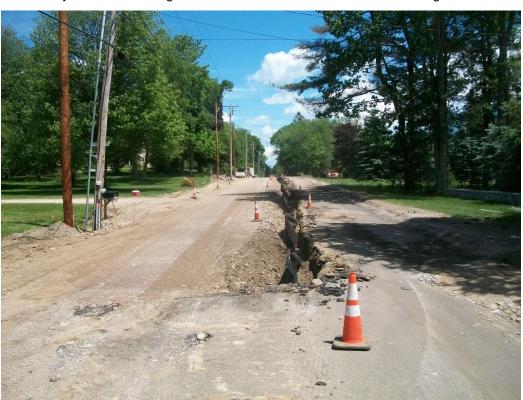
View of at end of southerly progress on the southbound lane before resuming reconstruction on the northbound lane in a northerly direction. Crew opened road to 2-way traffic during lunch.
