**WEEKLY CONSTRUCTION REPORT**

PROJECT: MIDDLE ROAD IMPROVEMENTS

PERIOD ENDING: FRI, 23 June 2017

CLIENT: TOWN OF CUMBERLAND

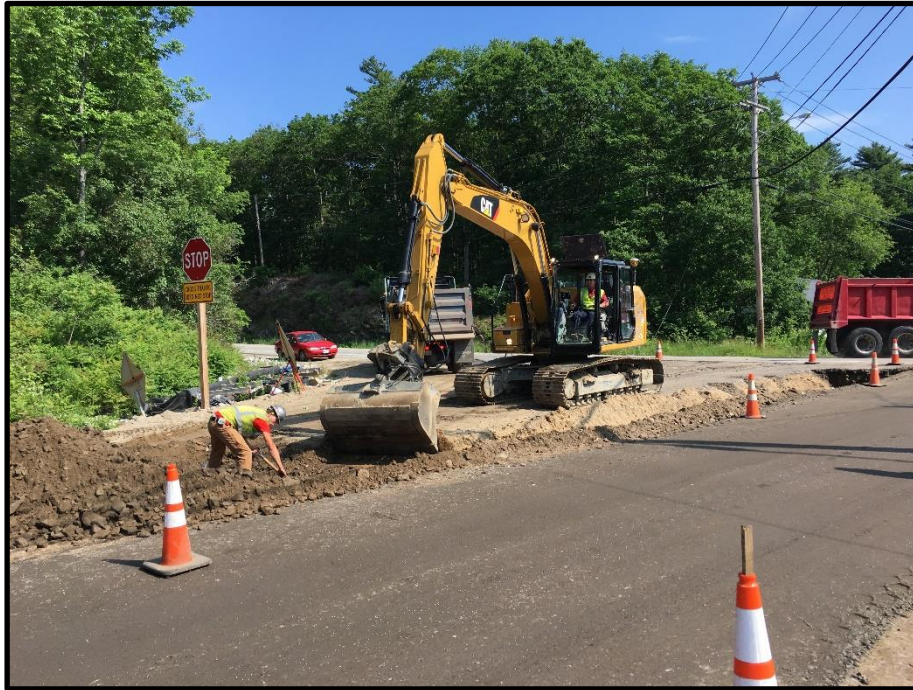
Photograph 1: Finishing up the western side of the project's northern terminus at the Tuttle Road intersection on the morning of Monday, June 19<sup>th</sup>.

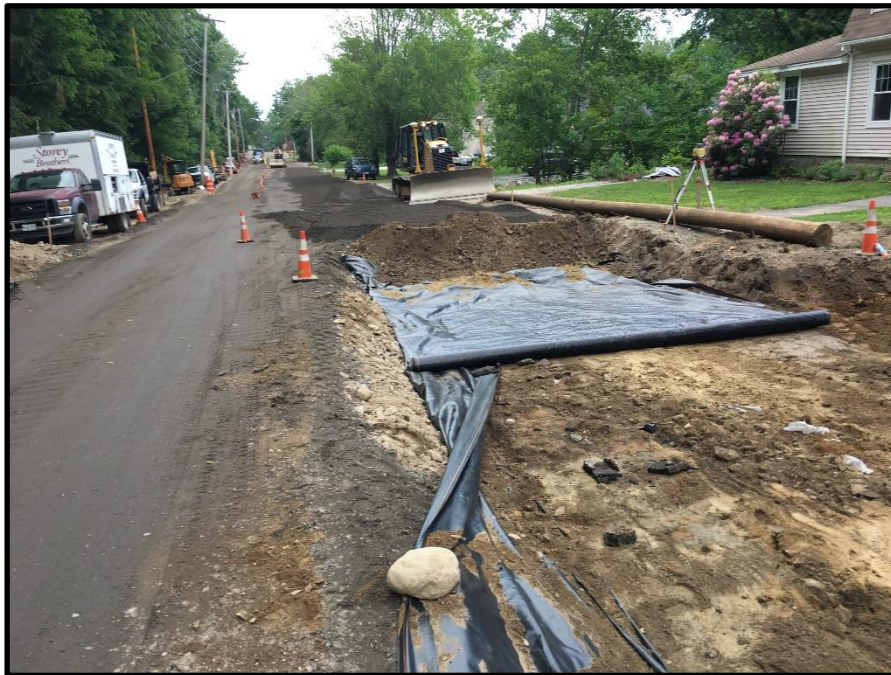
Photograph 2: Excavation to subgrade then placement of fabric, Type D Base Gravel, and reclaimed pavement during the afternoon of Monday, June 19<sup>th</sup>.

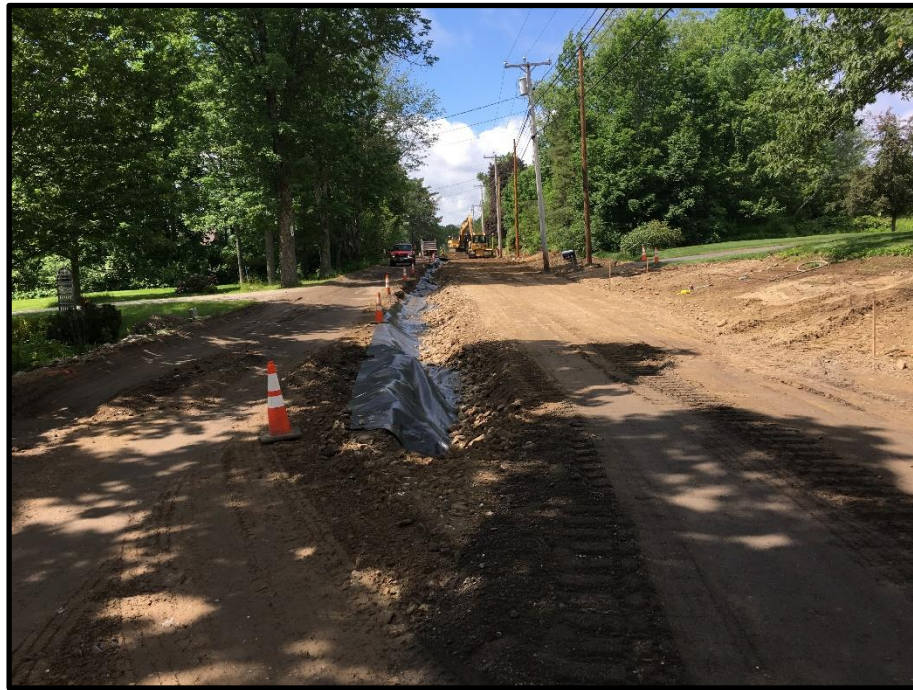
Photograph 3: Starting point of Tuesday, June 20<sup>th</sup> installation in foreground. Crew nearing turning point in background by mid day.

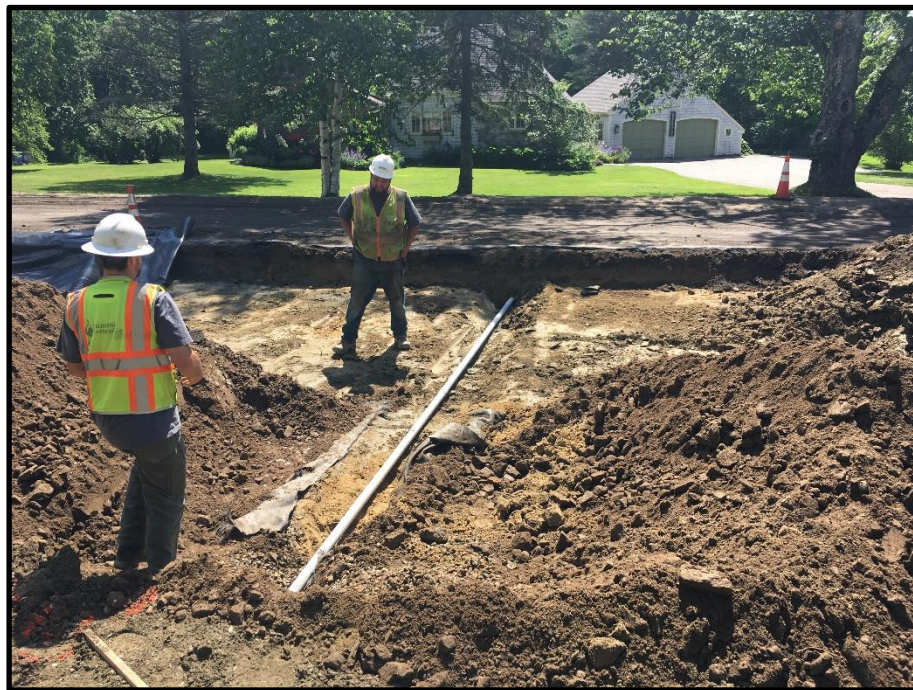
Photograph 4: Summit crew placing PVC conduit sleeve for future natural gas service to 137 Middle Road under silty clay subgrade of road prior to backfilling on the afternoon of Tuesday, June 20<sup>th</sup>.

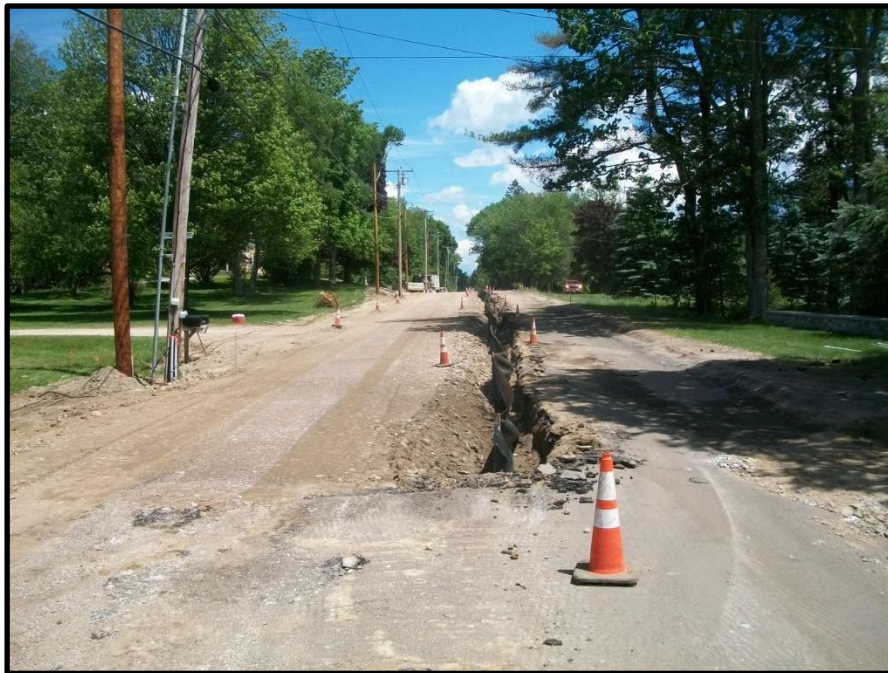
Photograph 6: View at end of southerly progress on the southbound lane on Wednesday, June 21<sup>st</sup> before resuming reconstruction on the northbound lane in a northerly direction. Crew opened road to 2-way traffic during lunch.

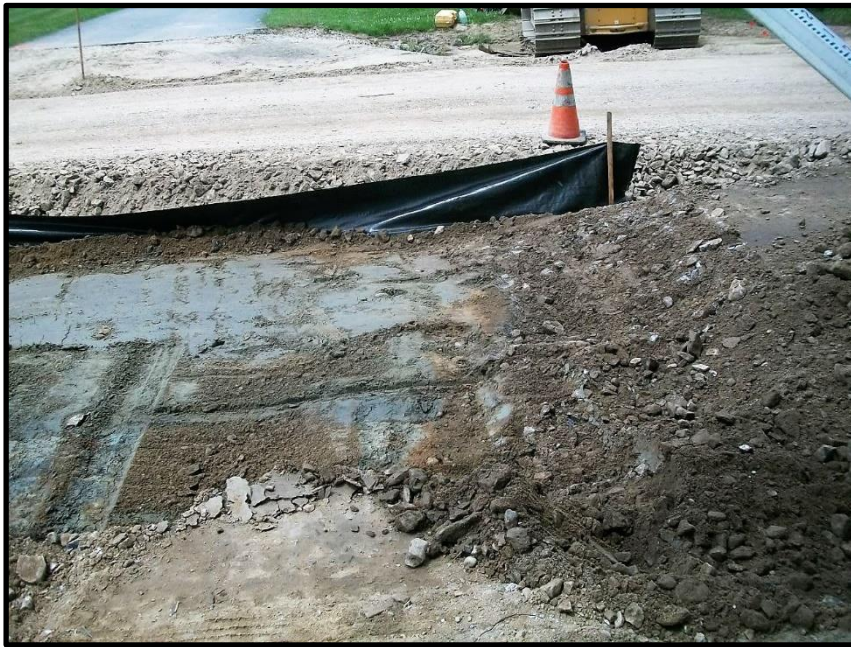
Photograph 7: Subgrade of bluish gray clay at the driveway for 129 Middle Road was typical of subgrade on Thursday, June 22<sup>nd</sup>.

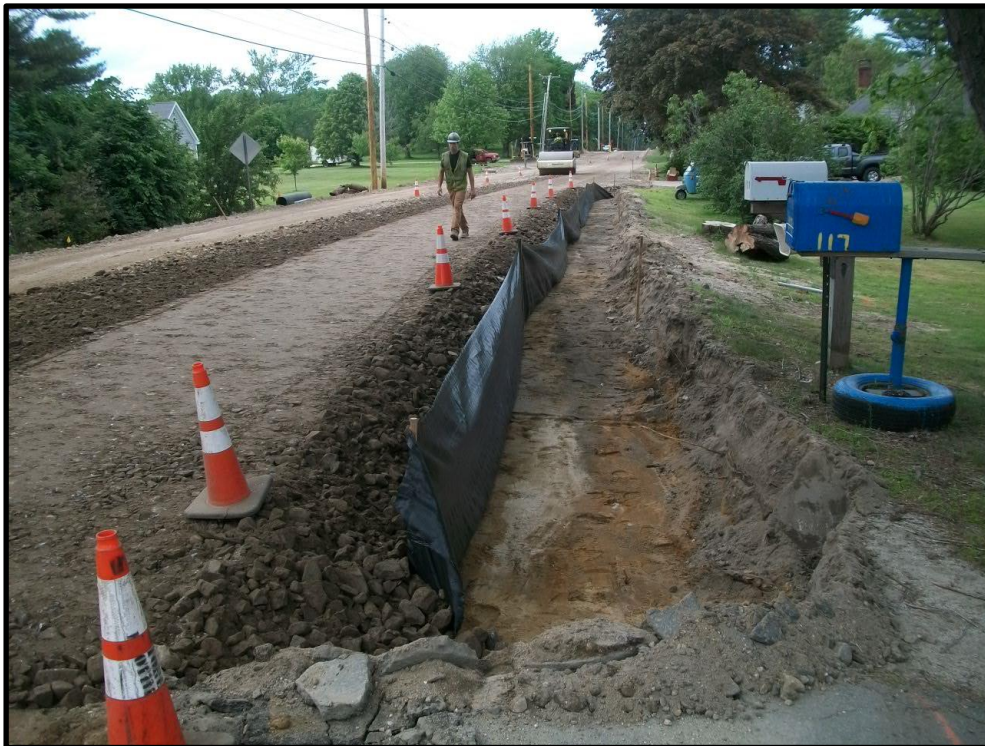
Photograph 8: View at end of Thursday, June 22<sup>nd</sup> looking north from the Casey driveway. Eastern edge of the road remained open so the remaining underdrain can be installed.

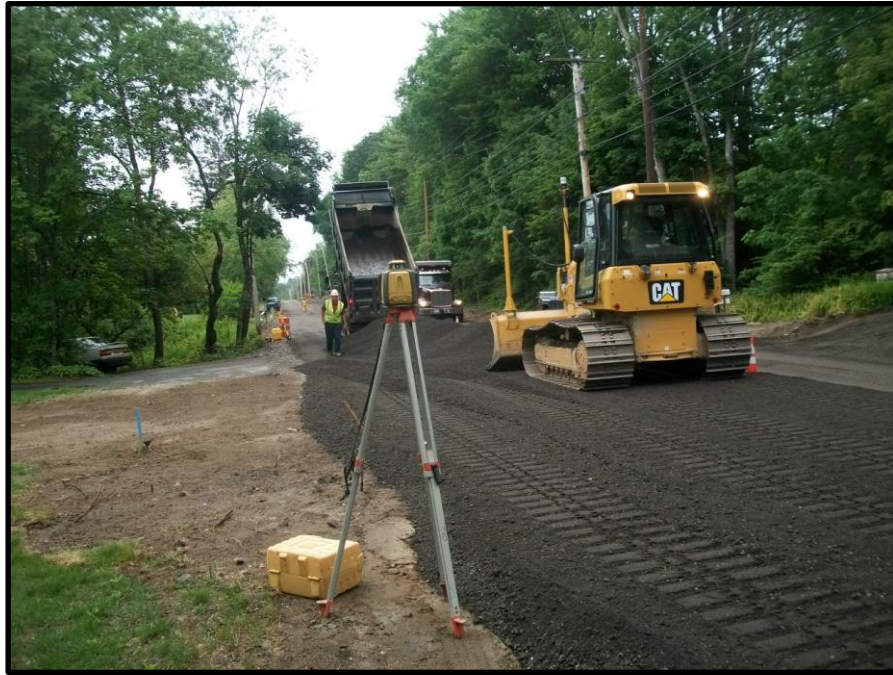
Photograph 9: On Friday, June 23<sup>rd</sup> the crew began to place screened reclaimed pavement that was milled from the road the previous week that is being used as the surface gravel layer.

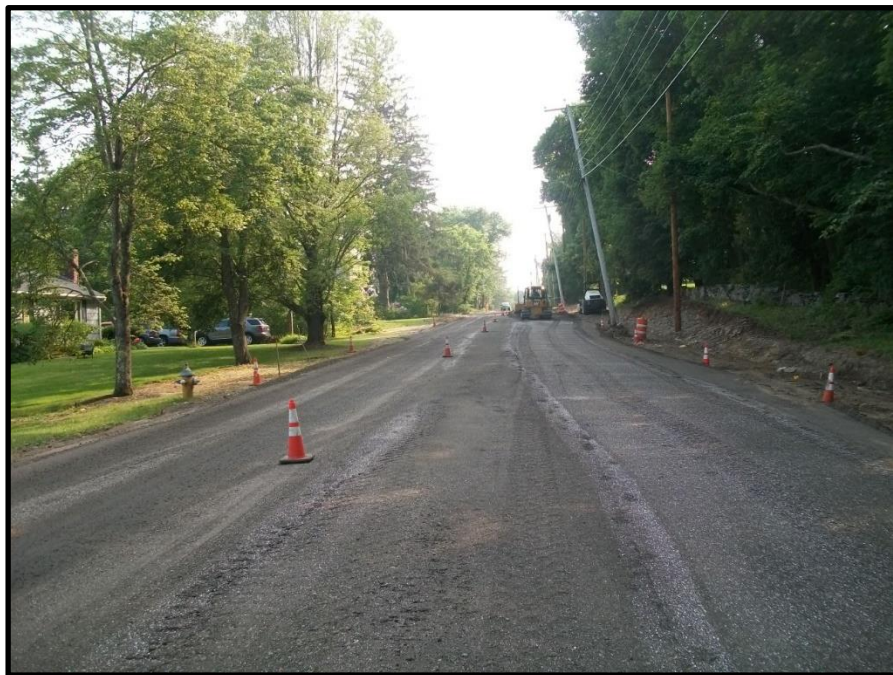
Photograph 10: View near the end of the day Friday, June 23<sup>rd</sup> looking southward from 153 Middle Road.
