**WEEKLY CONSTRUCTION REPORT**

PROJECT: MIDDLE ROAD IMPROVEMENTS

PERIOD ENDING: FRI, 26 May 2017

**TOWN OF CUMBERLAND  
MIDDLE ROAD IMPROVEMENTS  
PHOTOGRAPHS (May 22 - May 26)**

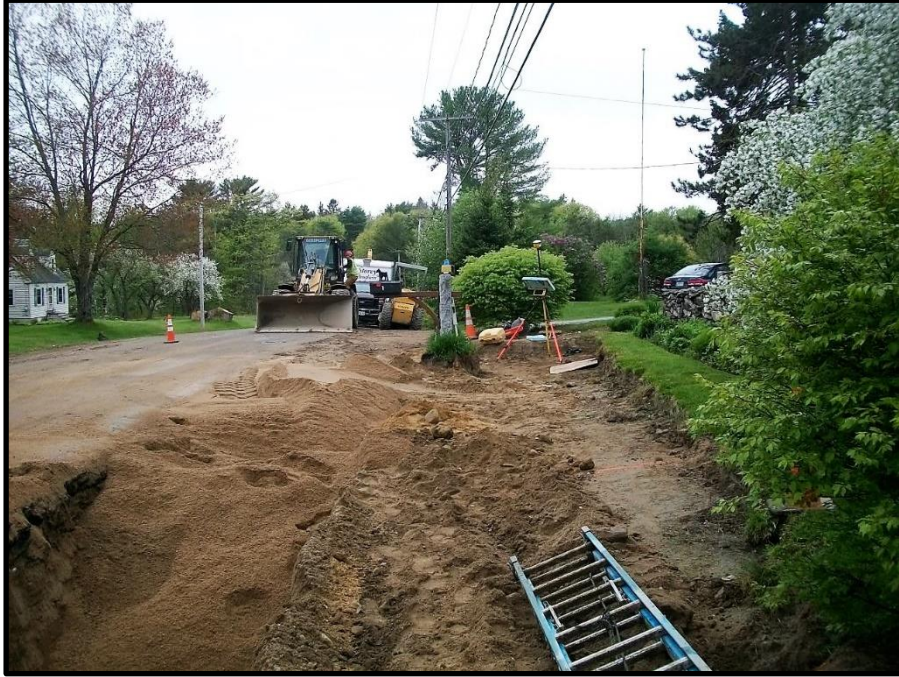
Photograph 1: Installed 15-inch underdrain and placed sand backfill over fabric at 122 Middle.

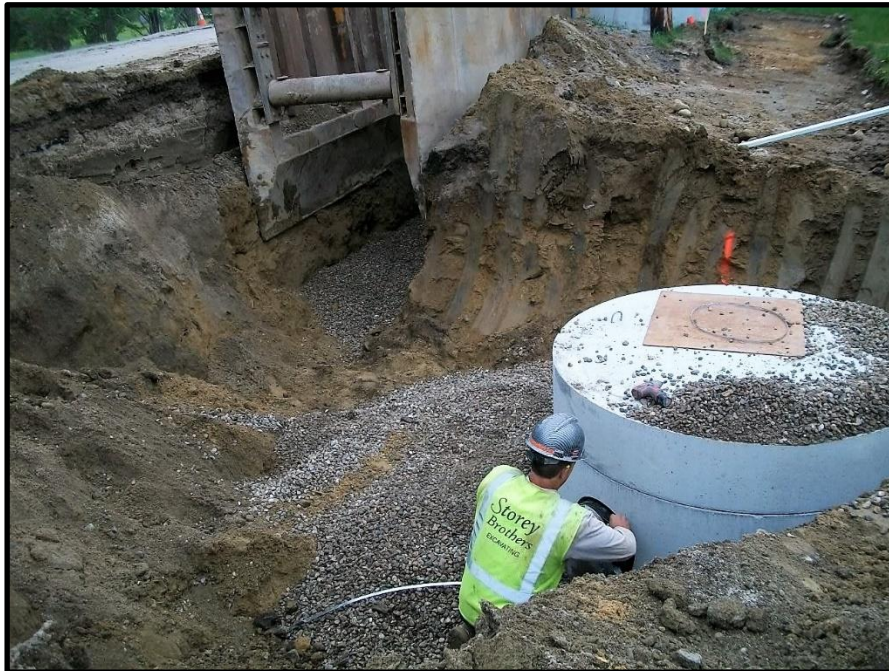
Photograph 2: At the end of the day placed filter fabric over openings in CB-6B prior to placing backfill at STA 63+50.

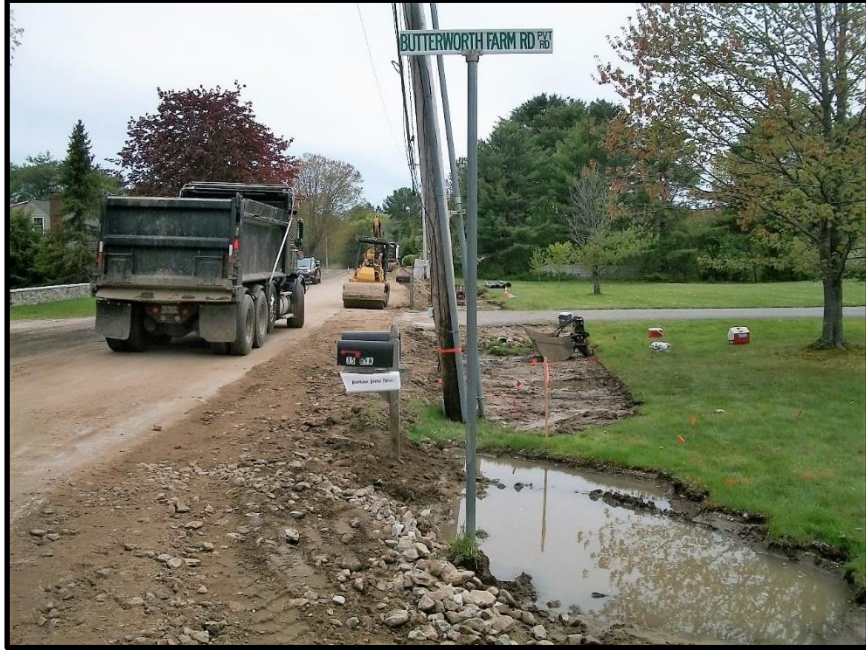
Photograph 3: Compacted Type D gravel placed over crushed stone to grade behind underdrain installation.

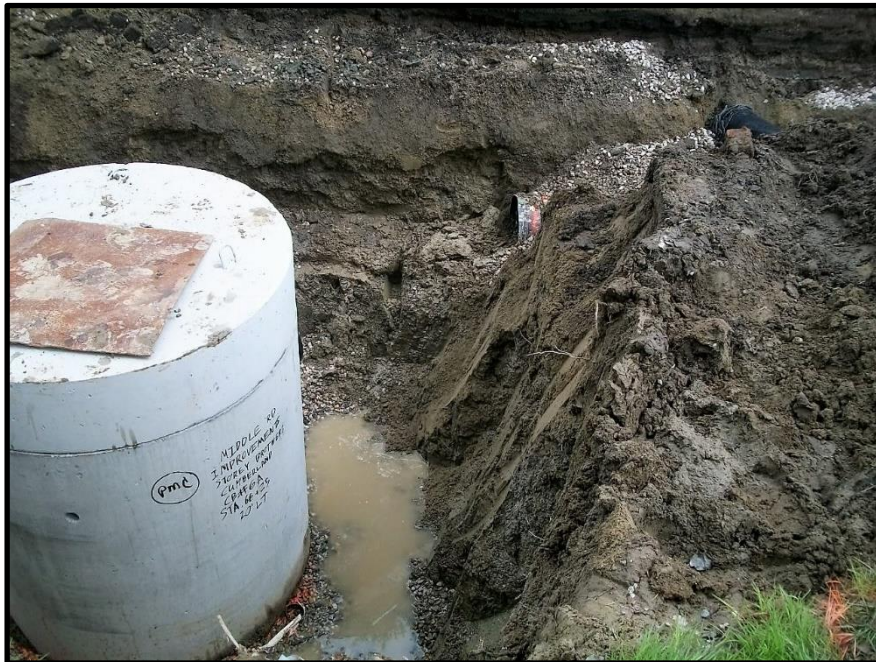
Photograph 4: Catch Basin CB-6A installed per plan prior to connection of 12-inch underdrain outlet.

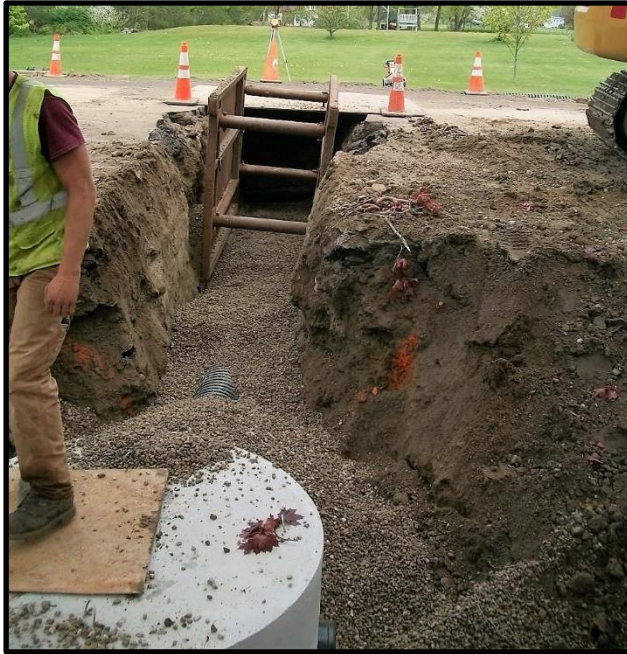
Photograph 5: 12-inch storm drain crossing road between CB-6E (foreground in front of Maloney lot) and CB-6B (far side of road in front of Soule lot).

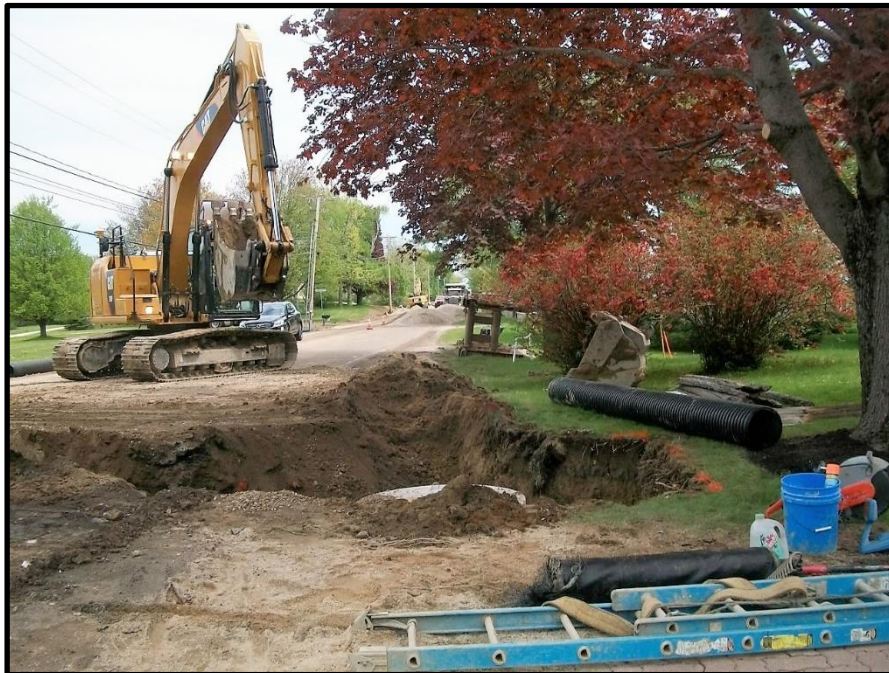
Photograph 6: From CB-6E looking north prior to the installation of CB-6D and CB-6C.

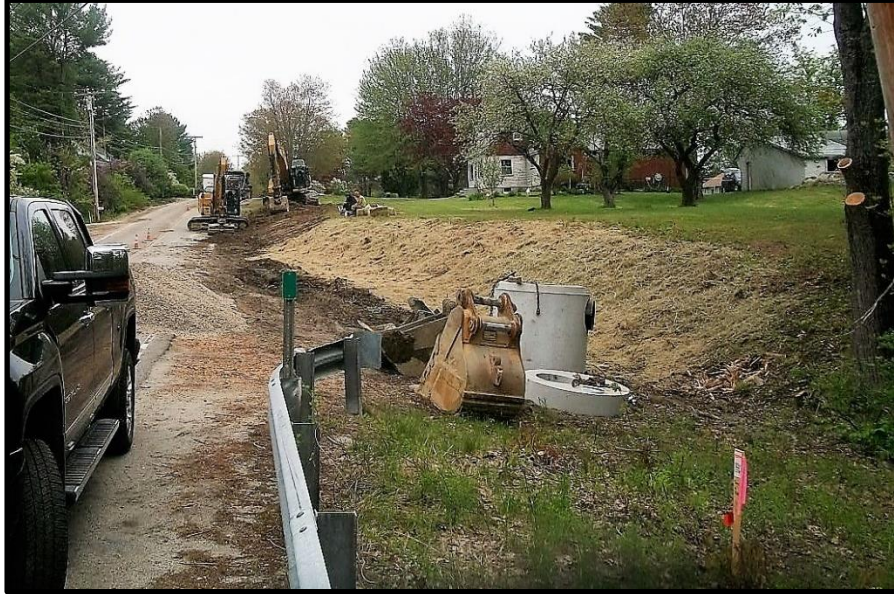
Photograph 7: Stump removal and geotextile reinforced slope at 117 Middle Road (Casey) prior to installation of catch basin CB-5G.

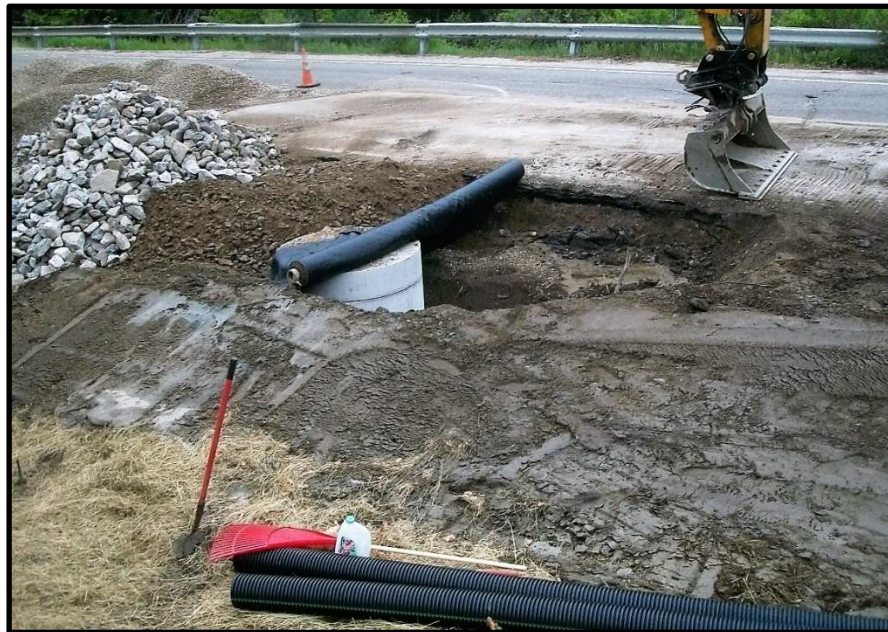
Photograph 8: Catch basin CB-5G at STA 57+15 and rip rap outlet prior to the installation of 6-inch underdrain (foreground) from the inlet uphill (northward).

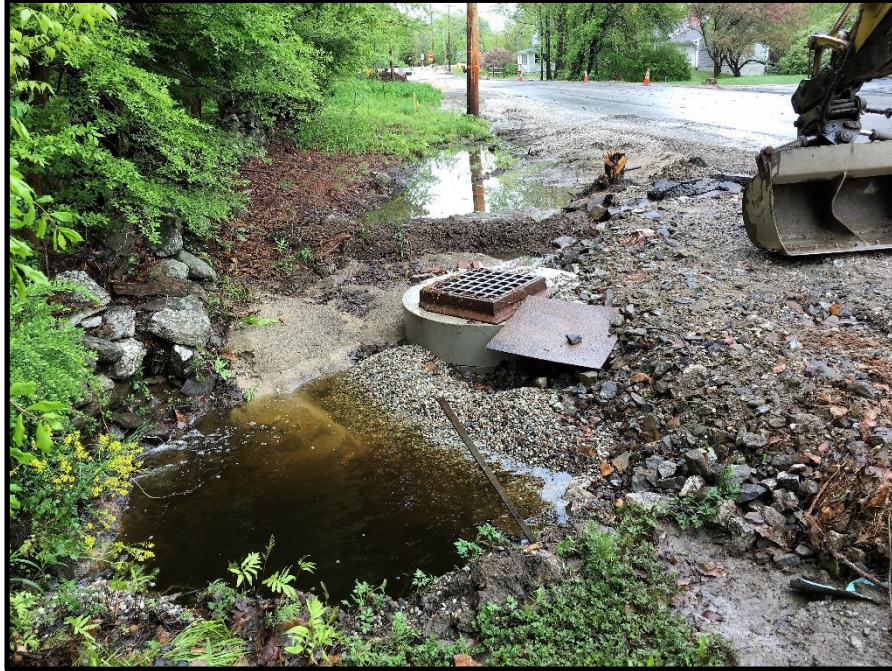
Photograph 9: Due to ponding after heavy overnight rains May 25-26<sup>th</sup> a grate was placed over the opening of the structure for CB-7E at STA 78-28 to improve surface drainage.

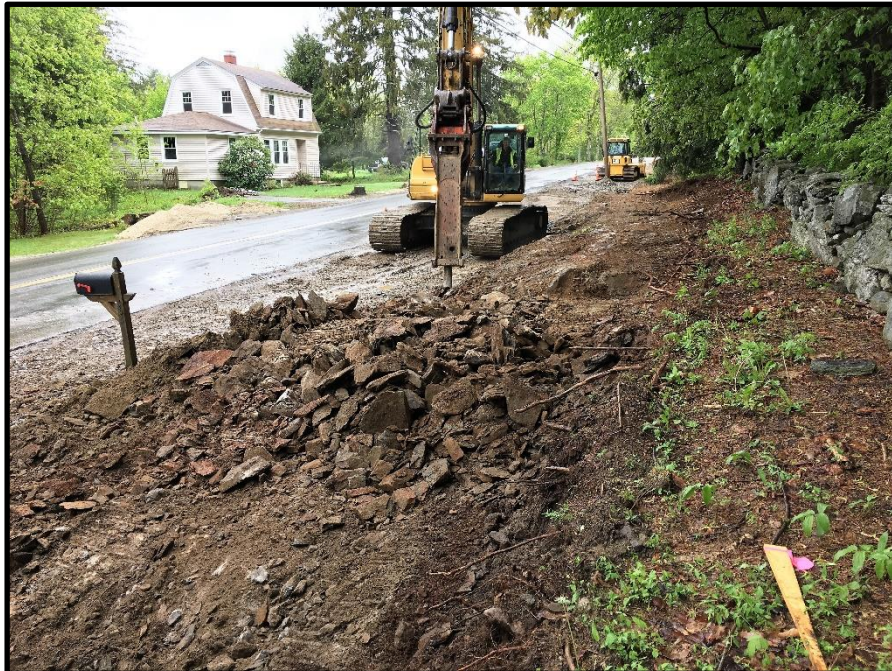
No ledge removal associated work conducted this week. The ledge removed Friday was associated with previous backslope work.

Photograph 10: Work Friday, May 26<sup>th</sup> was largely limited to ledge removal across the road from 147 & 151 Middle Road.
