FIELD OBSERVATION REPORT

Project: Gas Main – Cumberland-Falmouth-Yarmouth
Client: Towns of Cumberland, Falmouth and Yarmouth
GP Field Rep: Benjamin Grondin (BG)
Weather: Cloudy
Temp. Range: 70-80°F
Time onsite: Multiple visits

GP Project No: 1636.87
Visit Date: August 1, 2017
Report Date: August 2, 2017

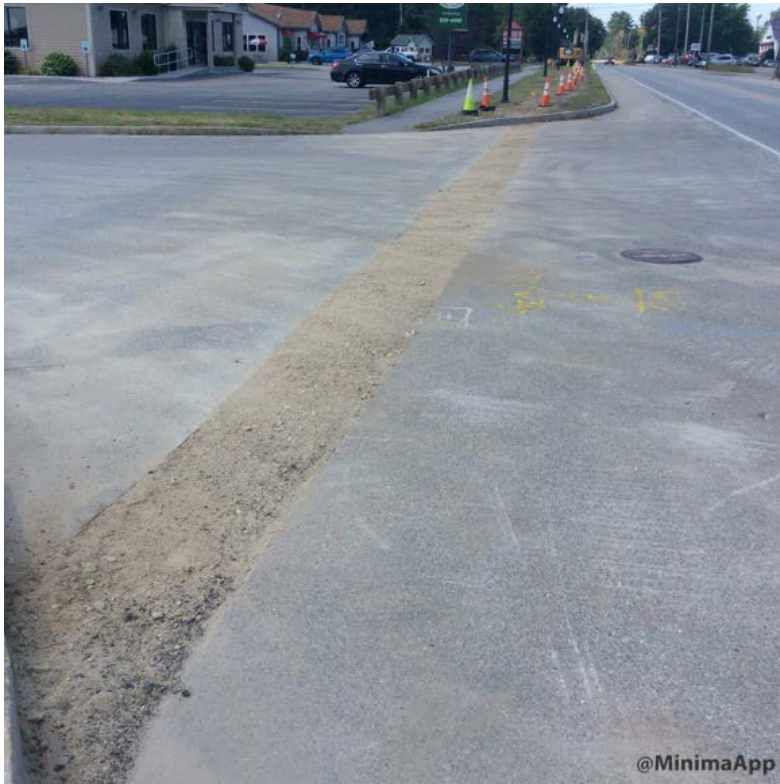
Gravel pit driveway trench backfilled with gravel

- It appeared the driveway crossing trench was backfilled with a well compacted gravel. The trench in the esplanade area in front of the Westside Animal Hospital appeared to be backfilled with existing material with adequate compaction.
- The driveway crossing trench to the gravel pit was left gravel due to the size of the trench. The gravel trench will be monitored and corrective action will be taken when necessary.
- Crew clean worksite and traffic returned to normal at approximately 3:00 PM.

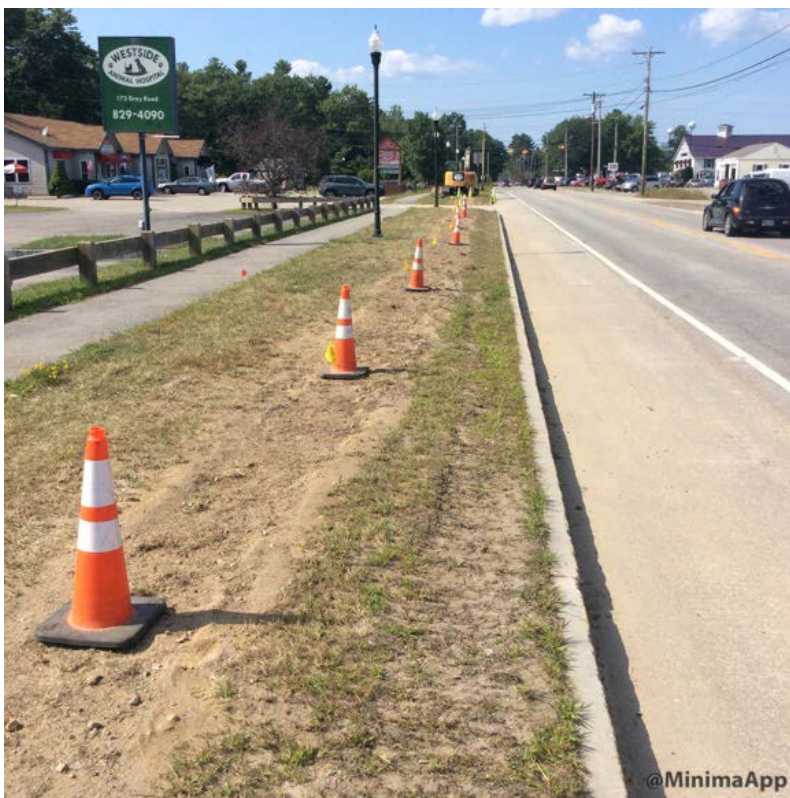
Esplanade backfilled
