GP Project No: 3656

Visit Date: April 11, 2023

## FIELD OBSERVATION REPORT

Project: Longmeadow Rd & Ole Musket Rd – Drainage Improvements

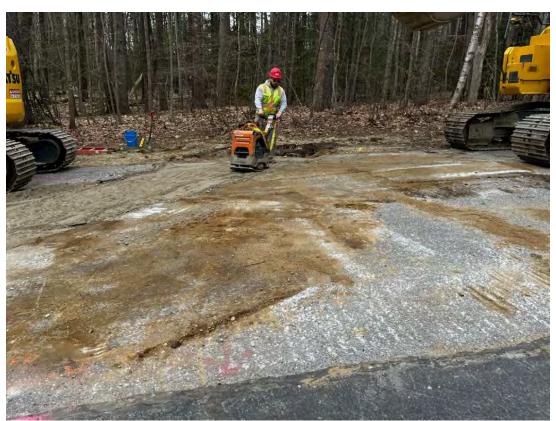
- Suitable excavated material and material consistent with MDOT 703.22 Type B Underdrain was installed as backfill to the subbase layer. Approximately 18" of subbase consistent with MDOT 703.06 was installed on the underdrain layer and compacted with efforts of a Plate Compactor. (Photo 1)

Photo I – Subbase in trench area compacted with plate compactor.

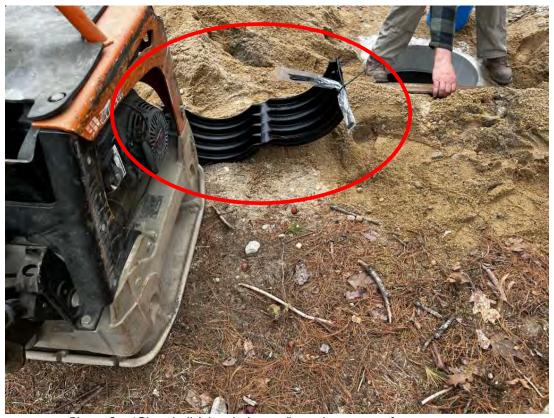
- 'Clamshells' are used at the joints of pipe segments to secure the connection. (Photo 2)
  - A.H. Grover, Inc. continues to avoid the existing underground utilities.

Photo 2 – 'Clamshells' (circled in red) used at joints of pipe segments.

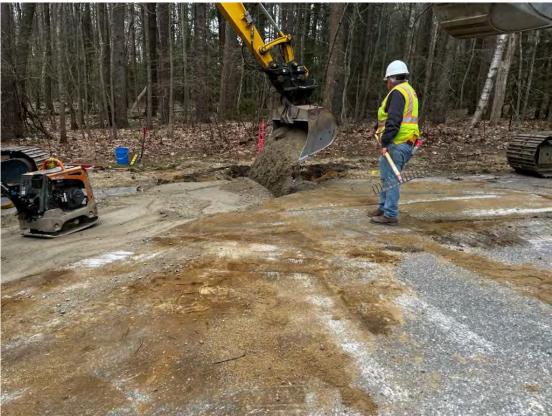
- Upon locating the actual locations of underground utilities prior to installing CB #20, it was determined that CB #20 could be installed between the gas line and water main, approximately one foot off the water main, on the curb line. This was done to reduce the 'bird bath' proposed in this area. (Photo 3)

Photo 3 – CB #20 being backfilled, installed on the proposed curb line.

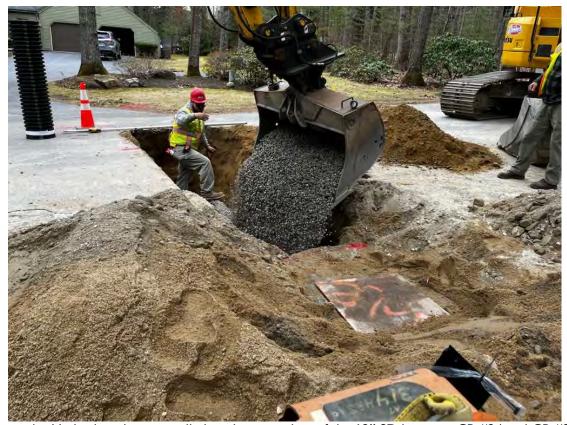
- CB #25 was installed prior to arrival in the afternoon. The backfill used to install CB #25 appeared to be MDOT 703.22 Type B Underdrain.
  - CB #24 was excavated to the bottom of the barrel section to install 12" SD between CB #24 and CB #25. The 12" SD appeared to be embedded with MDOT 703.22 Type C ¾" Crushed Stone to the spring line of the pipe. (Photo 4) MDOT 703.22 Type B appeared to be used as backfill to the subbase layer. Approximately 18" of material consistent with MDOT 703.06 Type D was installed and compacted with the same efforts as stated above.

Photo 4 – Underdrain being installed to the spring line of the 12" SD between CB #24 and CB #25.

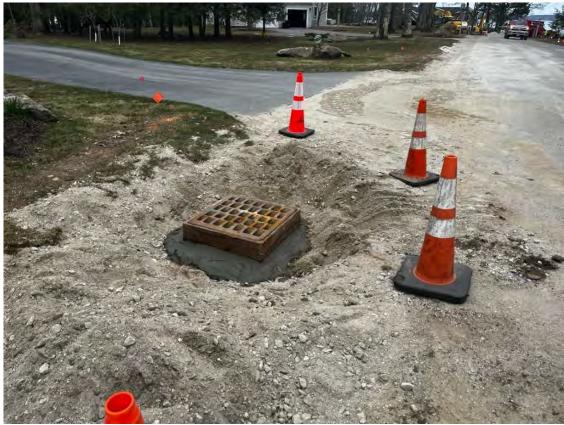
- Crew from A.H. Grover, Inc. installed the collars, frame and covers on CB's #24 and #25. (Photos 5&6). Traffic cones were placed around CB's #24 and #25 to direct traffic away until the frame areas can be backfilled.

Photo 5 – Collar, frame and cover installed on CB #24. Cones directing traffic away are also pictured.

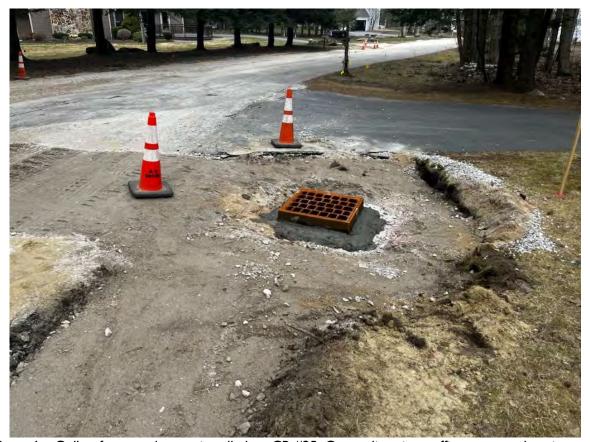
Photo 6 – Collar, frame and cover installed on CB #25. Cones directing traffic away are also pictured.
