## **DAILY FIELD OBSERVATION REPORT**

Project: Route 1 Roadway Improvements  
Client: Town of Cumberland  
GP Field Rep: Benjamin Grondin (BG)  
Weather: Cloudy / Some Rain  
Time onsite: 6:00 am –3:45 pm (BG)

GPCEI Project No: 1636.83  
Visit Date: June 9, 2017  
Report Date: June 9, 2017  
Temp. Range: 55-75°F

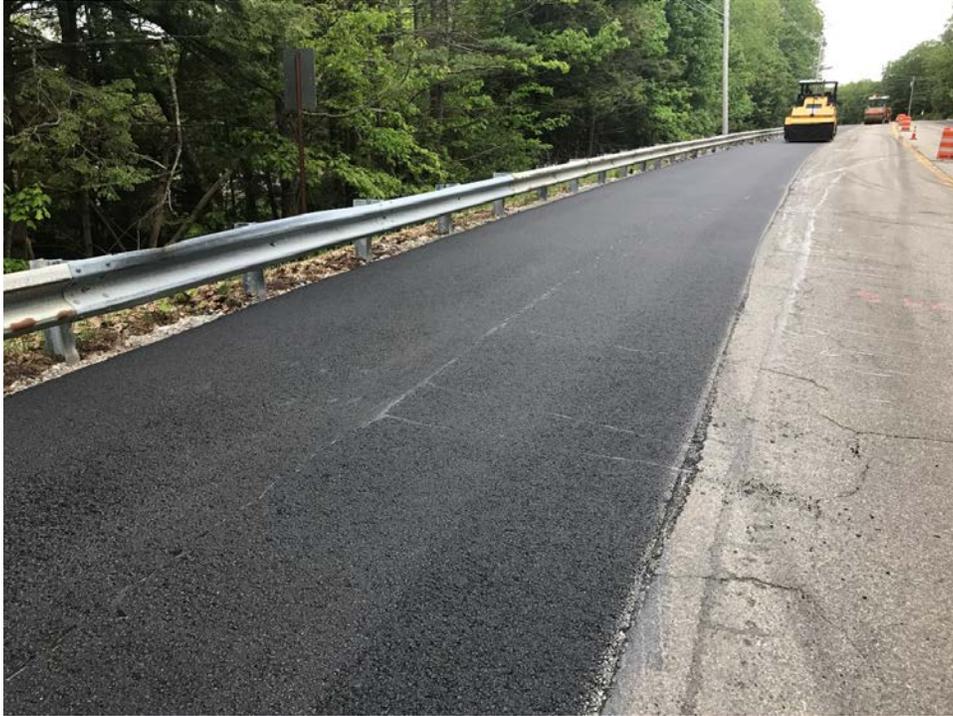
- 12.5mm HMA was compacted with 10-ton, rubber tire, and 15-ton roller.
- Crew finished placing 12.5mm HMA in NB shoulder at approximately 10:30 AM and moved to Powell Road. Due to the rollers and moving barrels, NB lane was not re-opened until approximately 11:30 AM.

Photo 1 – Rubber tire roller on NB shoulder of Route 1.

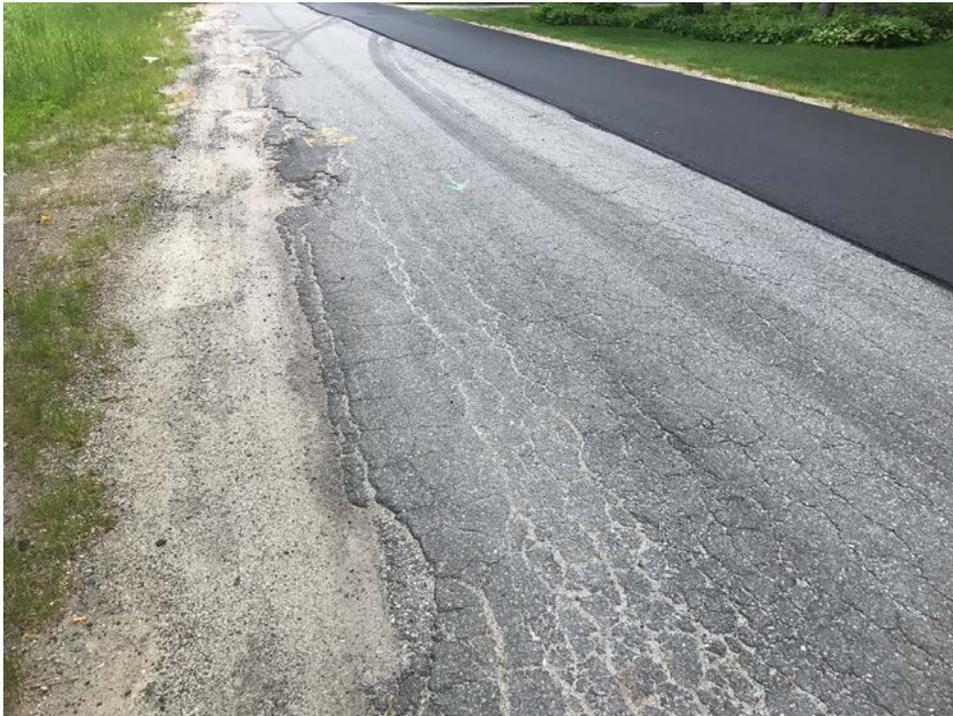
- Crew began shimming Powell road at approximately 11:45 AM with 9.5mm HMA.
- Existing pavement was cleaned and tacked prior to shimming Powell Road.
- 9.5mm HMA shim on Powell Road was compacted with a 10 ton roller only.

Photo 2 – Existing pavement condition and shim on Powell Road.

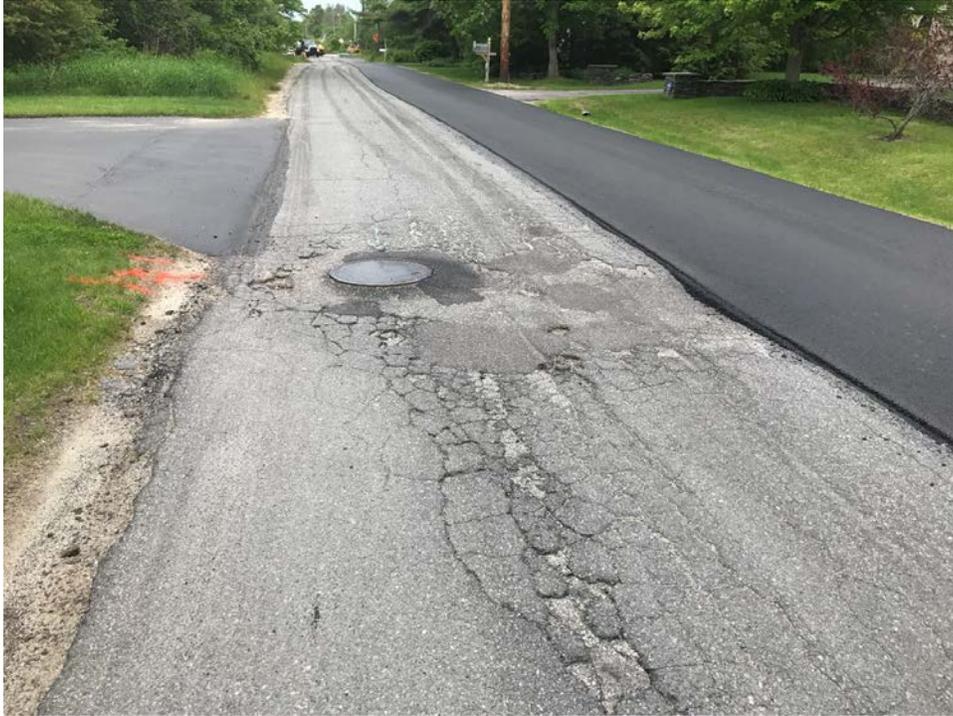
- Weather turned to light rain at approximately 12:45 PM. There was no standing water in the roadway and crew continued to shim Powell Road.
- Shim on Powell road ends approximately 150 feet before Route 88 intersection due to good pavement condition.

Photo 3 – Existing pavement condition and shim on Powell Road.

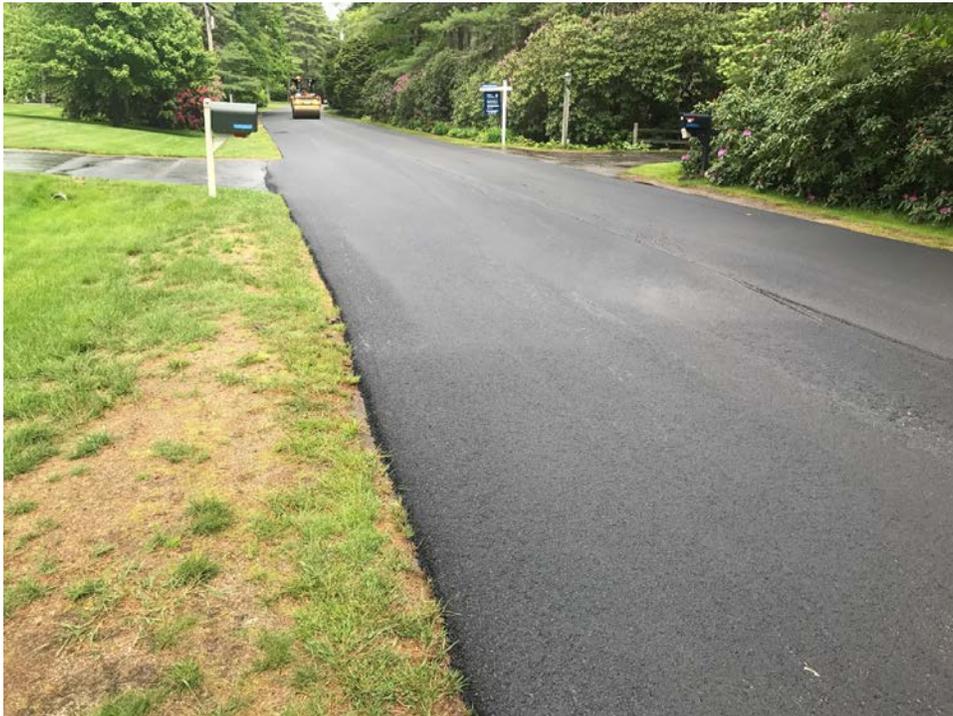
- Weather turned to a more steady rain for a brief period of time before turning to light rain again as crew moved to Ledge Road. Ledge Road appeared to be damp but did not have any puddles. Crew proceeded to shim Ledge Road.
- One lane closed on Ledge Road for paving with crew maintaining local traffic.
- Crew used blower to dry damp areas of ledge road prior to placing 9.5mm HMA.
- Ledge road was tacked prior to placing 9.5mm HMA with paving machine.
- 9.5mm HMA shim on Ledge Road was compacted with a 10 ton roller only.
- Crew completed shim on Ledge road and traffic returned to normal at approximately 3:30 PM.
- Approximately 69 ton was used on Ledge Road.
- All loads of 12.5mm HMA checked by BG generally conformed to the MDOT temperature specification range (275°F - 325°F).

Photo 4 – Shim being rolled on Ledge Road.
