FIELD OBSERVATION REPORT

GPCEI Project No: 1636.55

Visit Date: April 12, 2017

Project: Birch Lane Drainage Improvements

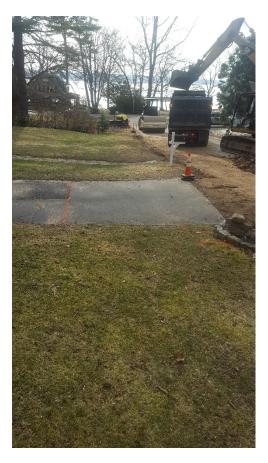
Marked saw cut in the driveway of HSE #28, looking east

- House # 28 driveway would be saw cut approximately 10' from the edge of the roadway.
 A "hump" would be constructed at the entrance to the driveway to keep the water at the curb line.

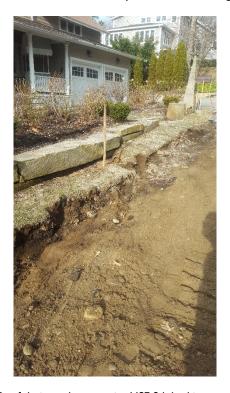
Roof drain outlet opposite HSE 24, looking west

- The house opposite #26 had an existing roof drain outlet that would drain behind the proposed curb. AJA directed RS not to install curb between the two driveways to the home. A small paved swale would be constructed to catch the roof drain outlet. The lower (crushed stone) driveway apron would be graded to carry the water from the swale to the curb line.

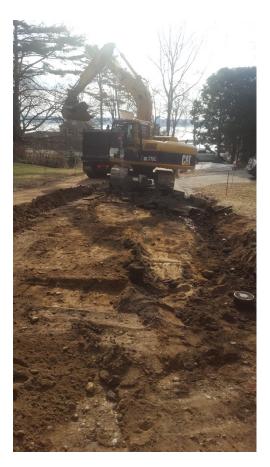
Box cutting the roadway, looking east
