## FIELD OBSERVATION REPORT

Project: Tuttle Road, Main Street, and Blanchard Road  
Downtown Sidewalk Improvements  
Client: Town of Cumberland  
GP Field Rep: Kassey Northrop (KN)  
Weather: Sunny  
Time onsite: 9:45 AM – 11:30 AM  
Contractor: Glidden Excavating & Paving, Inc. (Glidden)  
Distribution: File; Town of Cumberland

GP Project No: 3656.11  
Visit Date: August 1, 2023  
Report Date: August 1, 2023  
Temp. Range: 68-71 °F

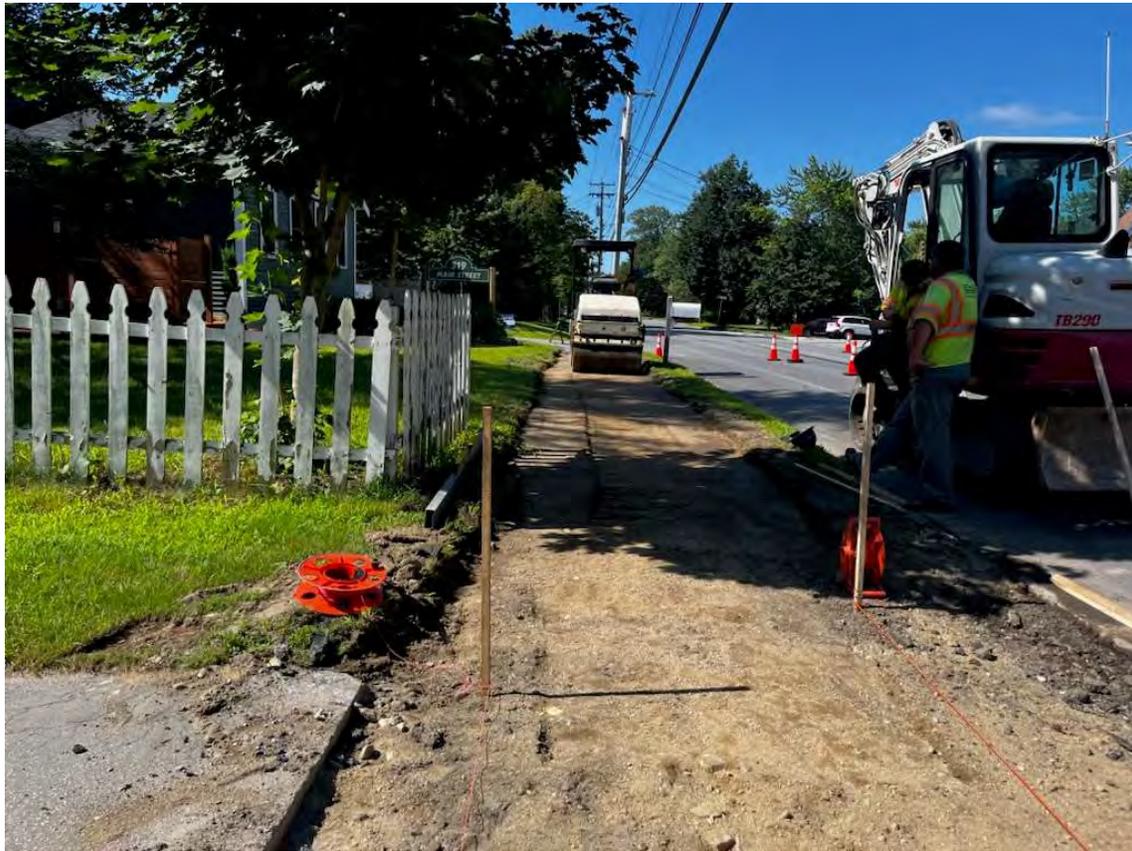
- Upon arrival in the afternoon, Glidden had removed the existing pavement at the driveway apron of 321 Main Street southerly to the driveway apron of 319 Main Street (Photo 1).

- A crew member compacted the existing subbase gravel from 321 Main Street to 319 Main Street with efforts of an Ingersoll-Rand DD-24 5-ton roller while on-site, prior to installing new base gravel as shown in photo 1.

Photo 1 – Removal of existing pavement to 319 Main Street standing from 321 Main Street.

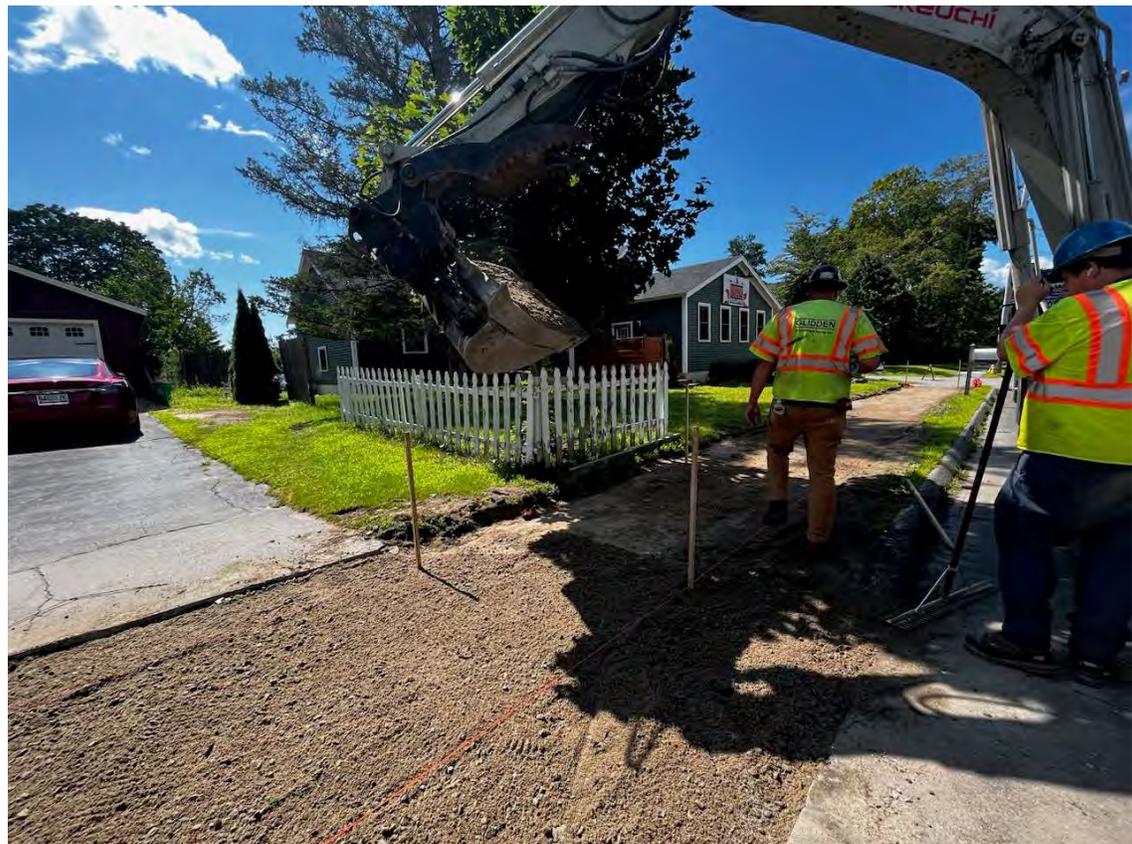
- While on site, Glidden had set up grade stakes for the string-line method within the limits described above and began to install base gravel consistent with MaineDOT 703,06 Type A (Photo 2). As shown in photo 2, an excavator operator placed base gravel with the bucket of a Takeuchi TB290 excavator within the sidewalk limits. Crew members then used a rake to grade the base gravel to the string line (Photo 3).

Photo 2 – Base gravel installed by excavator between sidewalk limits.

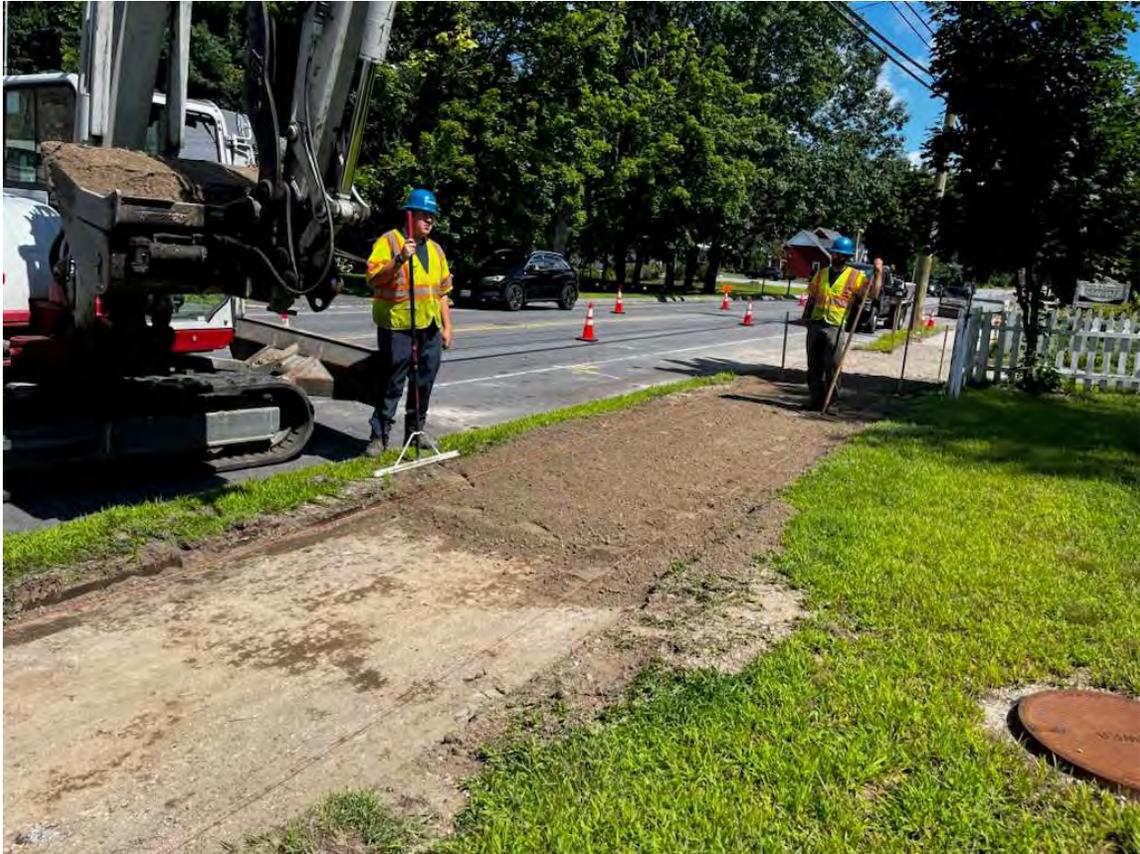
Photo 3 – Crew using rake to fine grade base gravels prior to compaction.

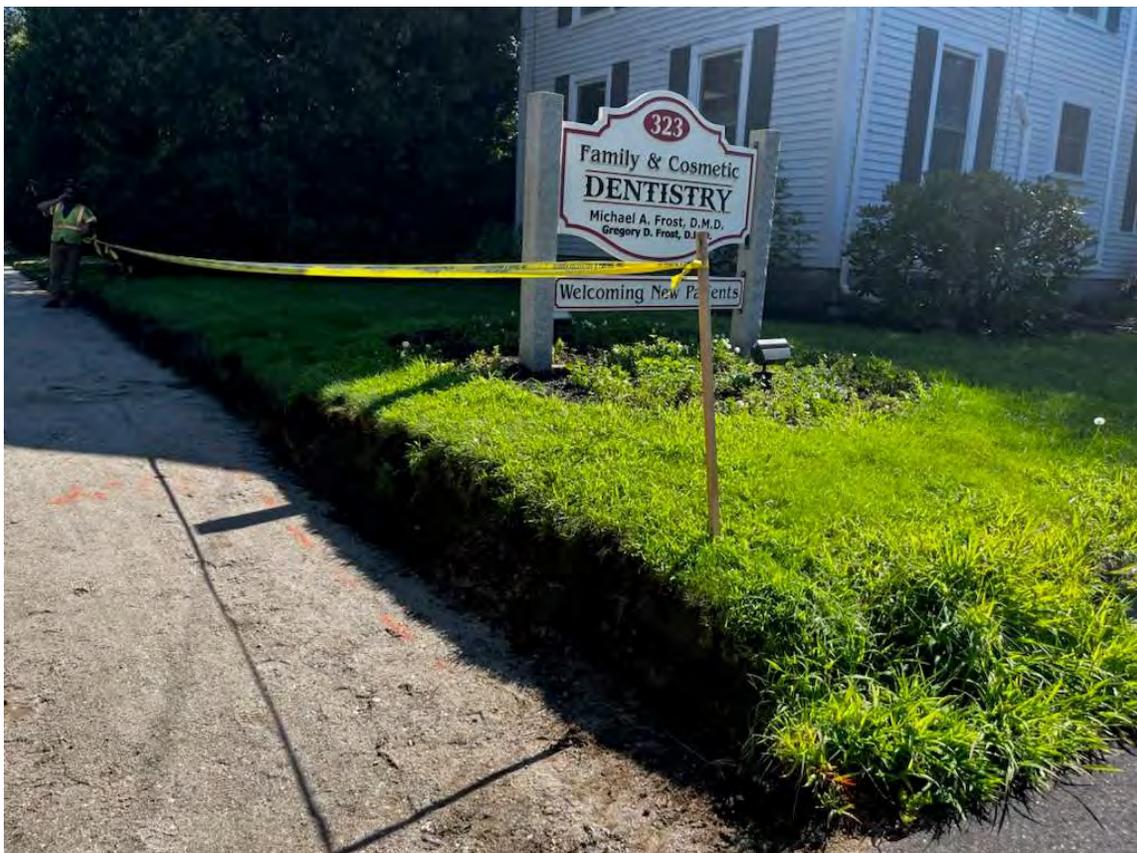
- Glidden had set up two stakes and caution tape at the edge of lawn at 323 Main Street (Family & Cosmetic Dentistry) as a precaution for the drop off until slipform bituminous behind curbing is replaced (Photo 4).

Photo 4 – Caution tape placed along lawn at 323 Main Street.
