## FIELD OBSERVATION REPORT

Project: Longmeadow Rd & Ole Musket Rd – Drainage Improvements  
Client: Town of Cumberland  
GP Field Rep: Kassey Northrop (KN)  
Weather: Overcast  
Time onsite: 7:45 AM – 4:30 PM  
Contractor: A.H. Grover, Inc.  
Subcontractor: Dayton Sand and Gravel  
Distribution: File; Town of Cumberland

GP Project No: 3656  
Visit Date: May 3, 2023  
Report Date: May 4, 2023  
Temp. Range: 44-49°F

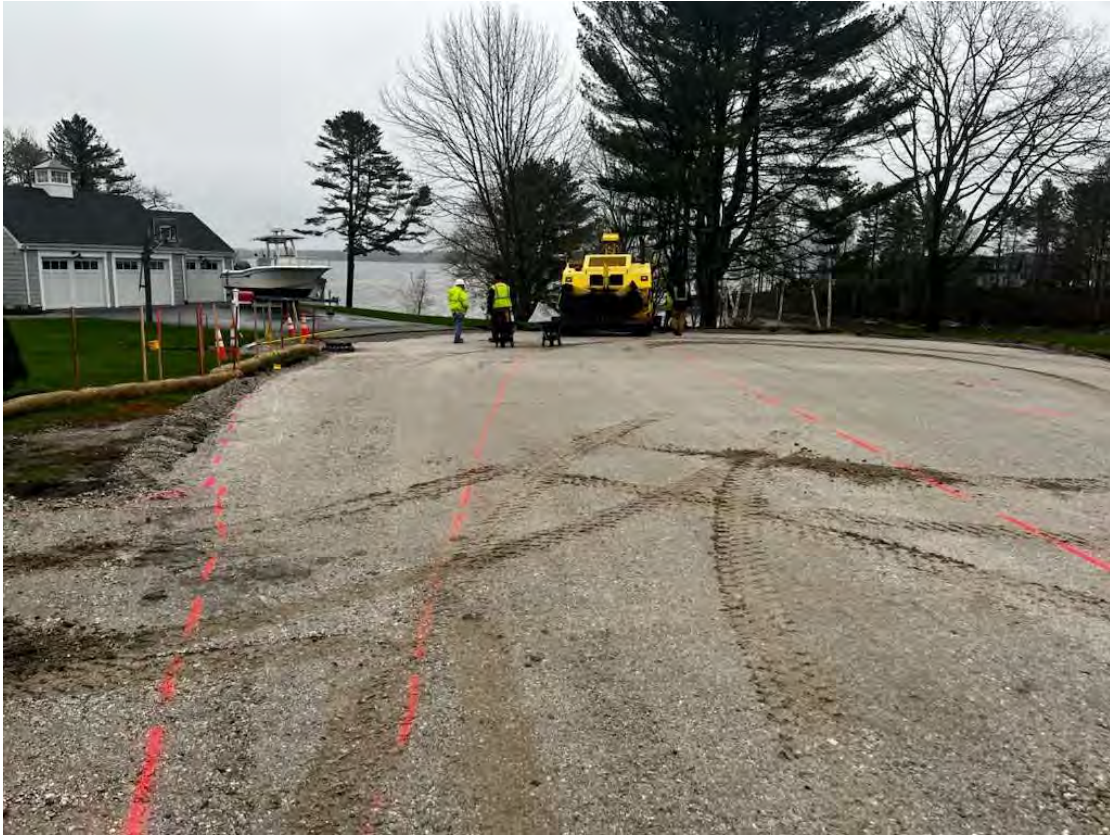
- Upon arrival in the morning, the cul-de-sac area had been fine graded and prepped for paving (Photo 1)
- Crew with Dayton Sand and Gravel, with the assistance of A.H. Grover, Inc. began placing 19.0 mm HMA around 8:20 AM in the pad area to the pump station, then began at the cul-de-sac.

Photos 1 – Cul-de-sac area fine graded and compacted upon arrival.

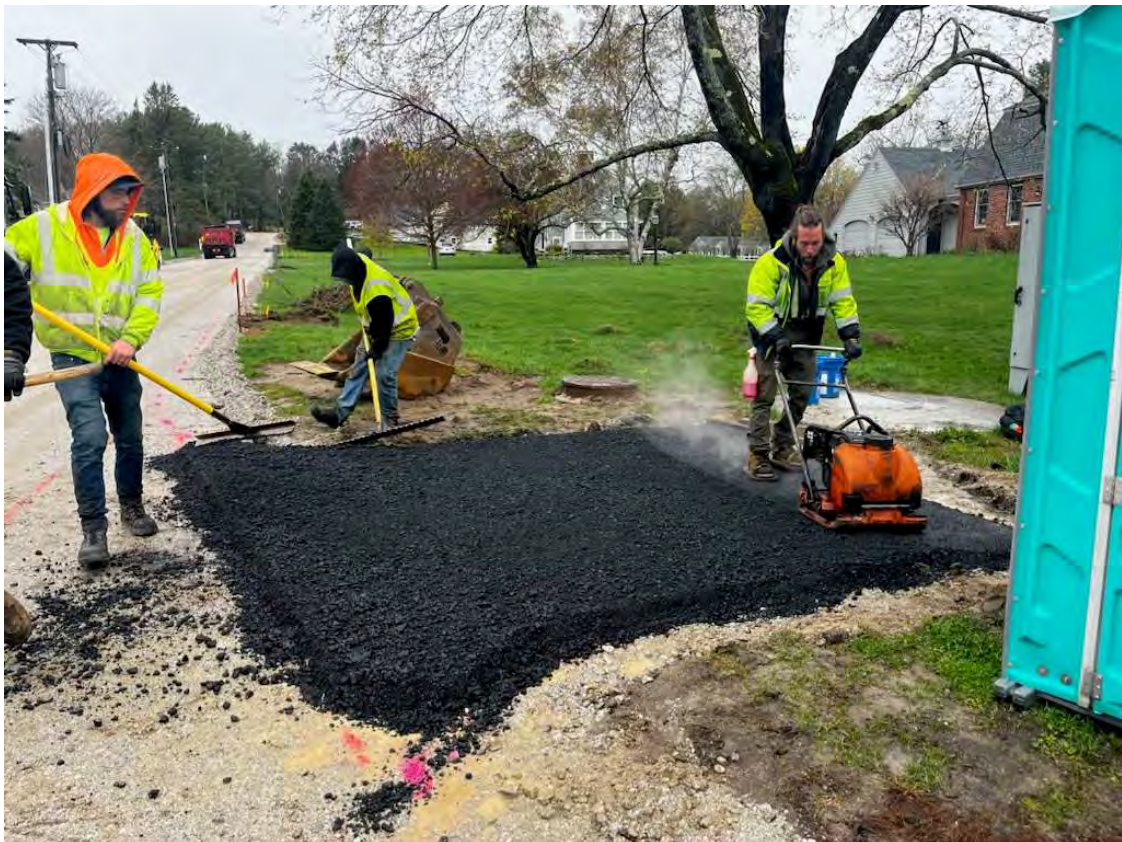
- The ambient air temperature at the start of paving was 48 °F.
  - Crew used a wheelbarrow to place the 19.0 mm HMA by hand at the pad to the pump station, then compacted the pad with efforts of a plate compactor. (Photo 2)

Photo 2 – Dayton Sand and Gravel crew compacting pad to pump station area.

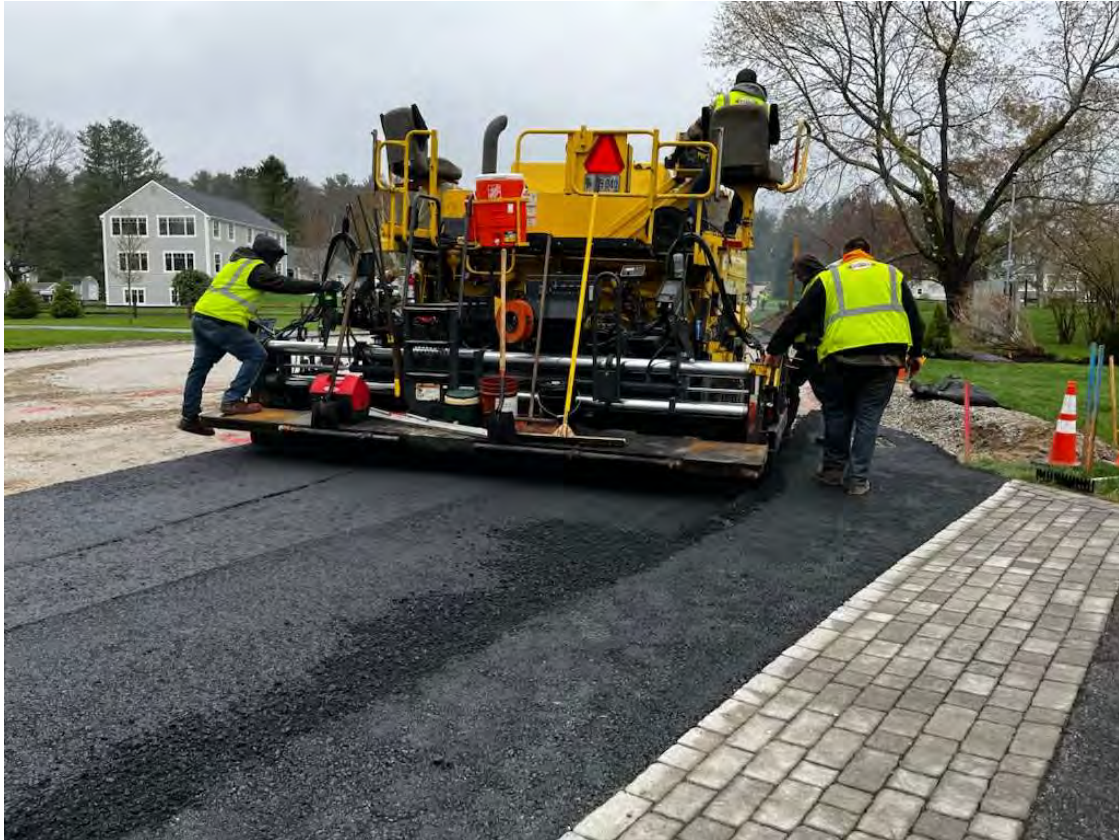
- A CR552 – Bomag paver was used to place the pavement the remainder of the day, and dump trucks were used to feed the hopper of the paver. (Photo 3)

Photo 3 – Crew using a CR552 – Bomag paver to place pavement.

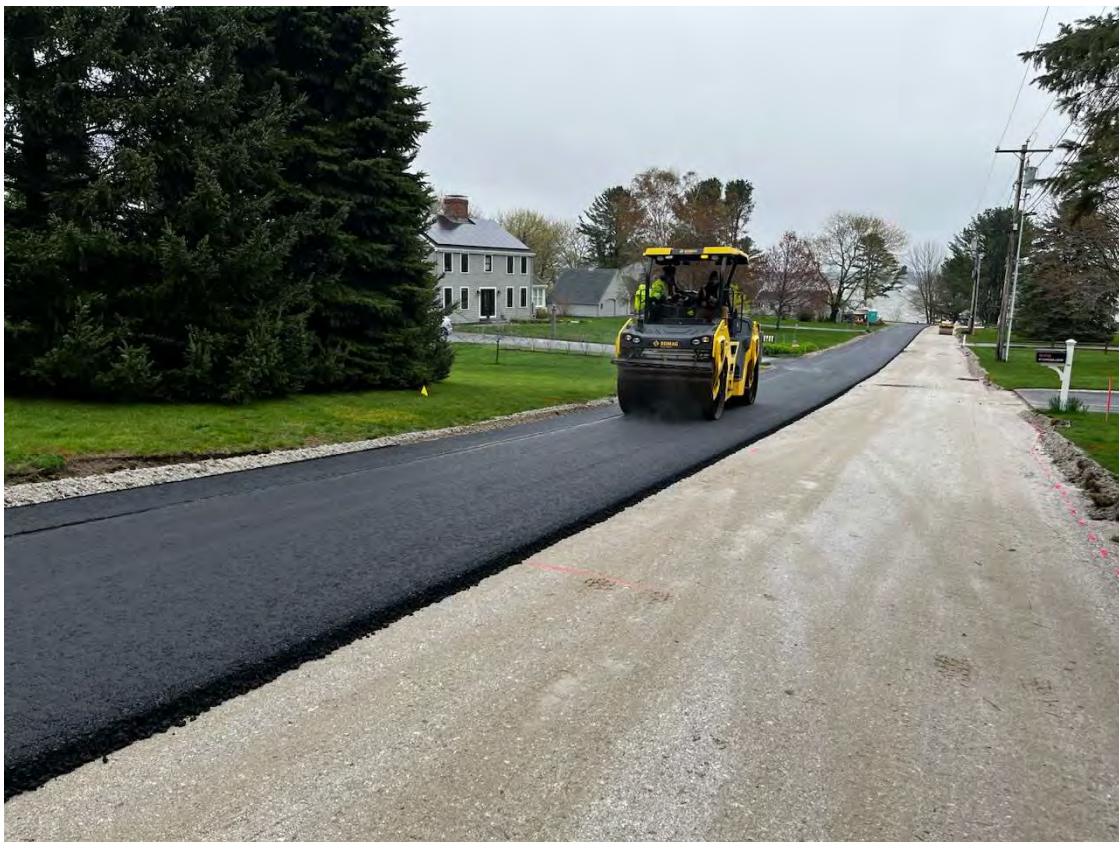
- Dayton Sand and Gravel supplied the 19.0 mm HMA.
  - HMA was compacted with efforts of a 10-ton BW161ADD Tango Vibratory roller, a 5-ton SAKAI SW502S-I Vibratory roller, and a 1-ton wacker neuson vibratory roller for finishing. (Photo 4)

Photo 4 – 10-ton roller used to compact 19.0mm HMA.

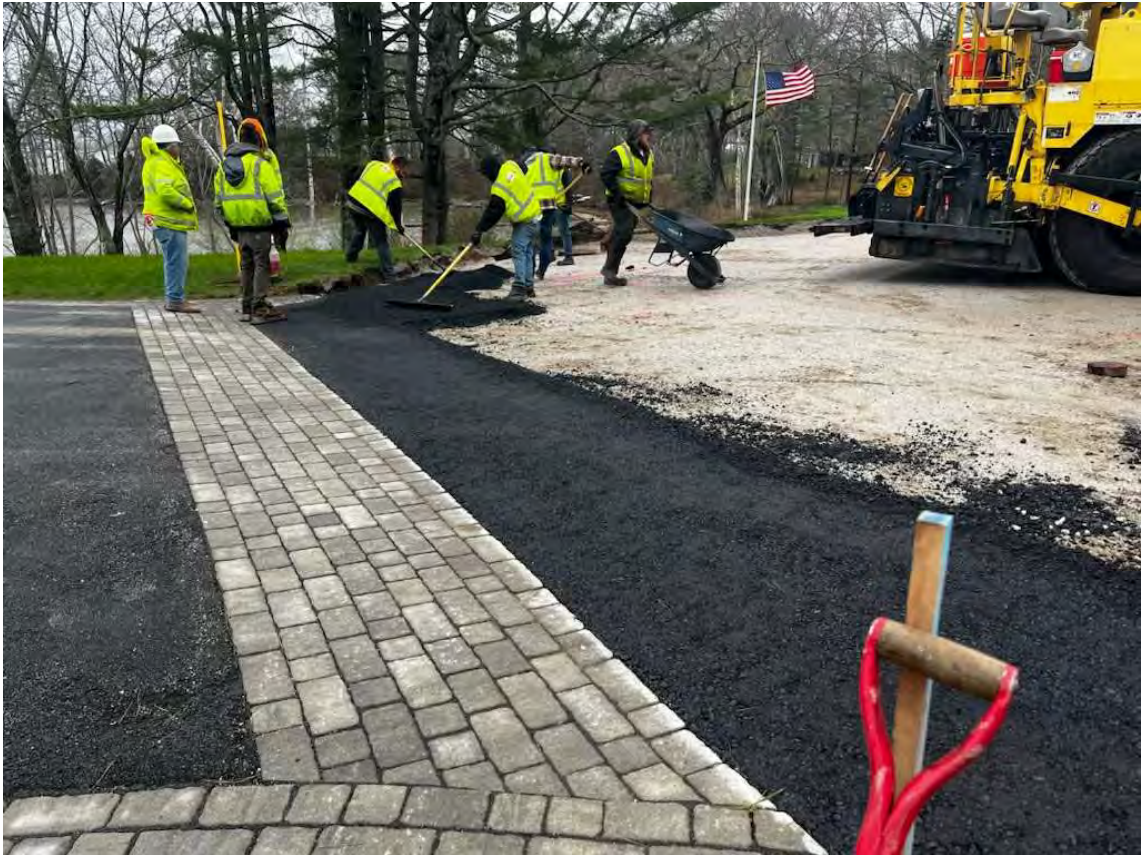
- Driveway aprons were done by hand to ensure correct grade. (Photo 5)
  - A total of 17 trips were made to site to deliver a total of 394.28 tons of 19.0 mm HMA. (Photo 6)  
Crew stopped for the day upon completing the placement of pavement in the road widening section from CB 7 to CB 10, and installed pavement approximately 100 feet of pavement from DMH 4 towards DMH 5 before stopping for the day. A temporary placement of 19.0 mm HMA was placed between CB 10 to CB 9 for ease of vehicle traffic. (Photo 7) As this section of HMA was under temperature from sitting too long, it will be removed by A.H. Grover, Inc. upon paving the remainder of the trench from DMH 4 towards DMH 6 and the road widening section, described further below.

Photo 5 – Crew installing driveway apron by hand.

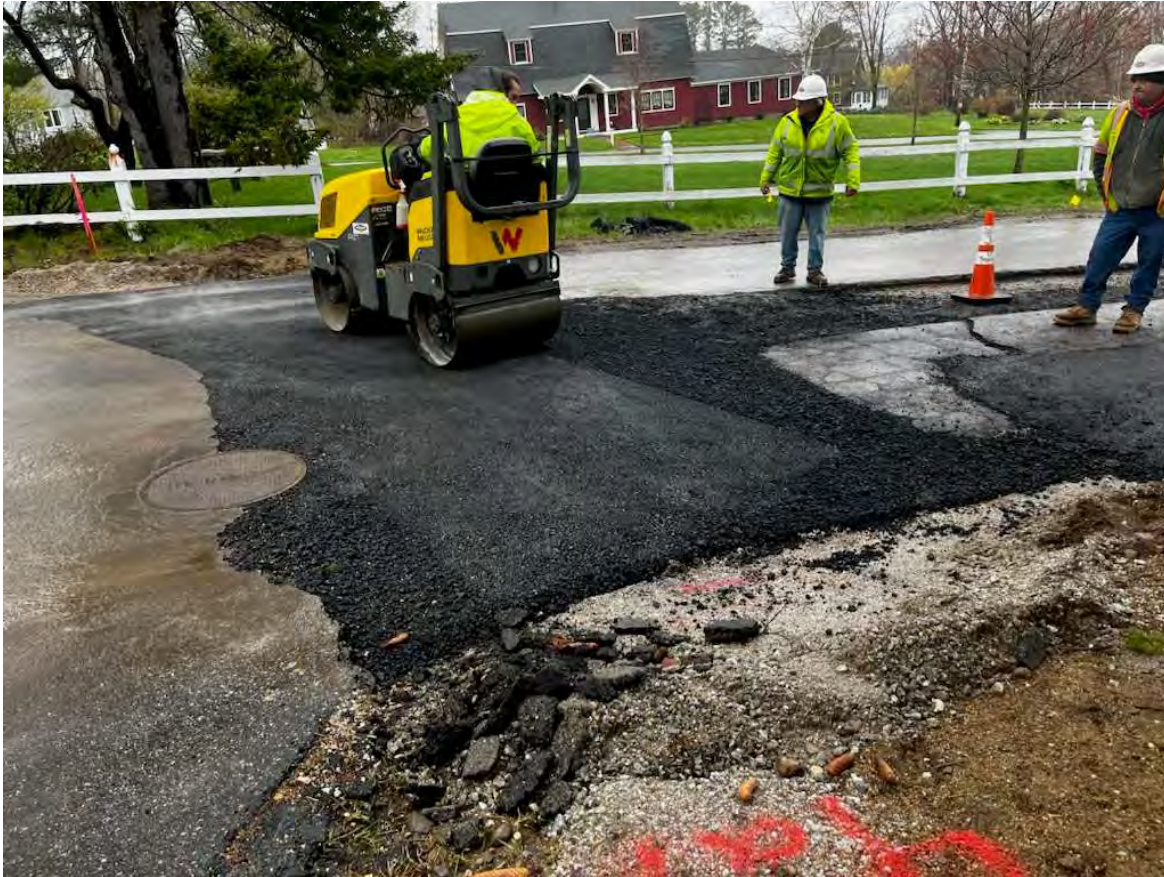
Photo 7 – Temporary patch of HMA placed between CB 9 and CB 10 for ease of vehicle traffic.

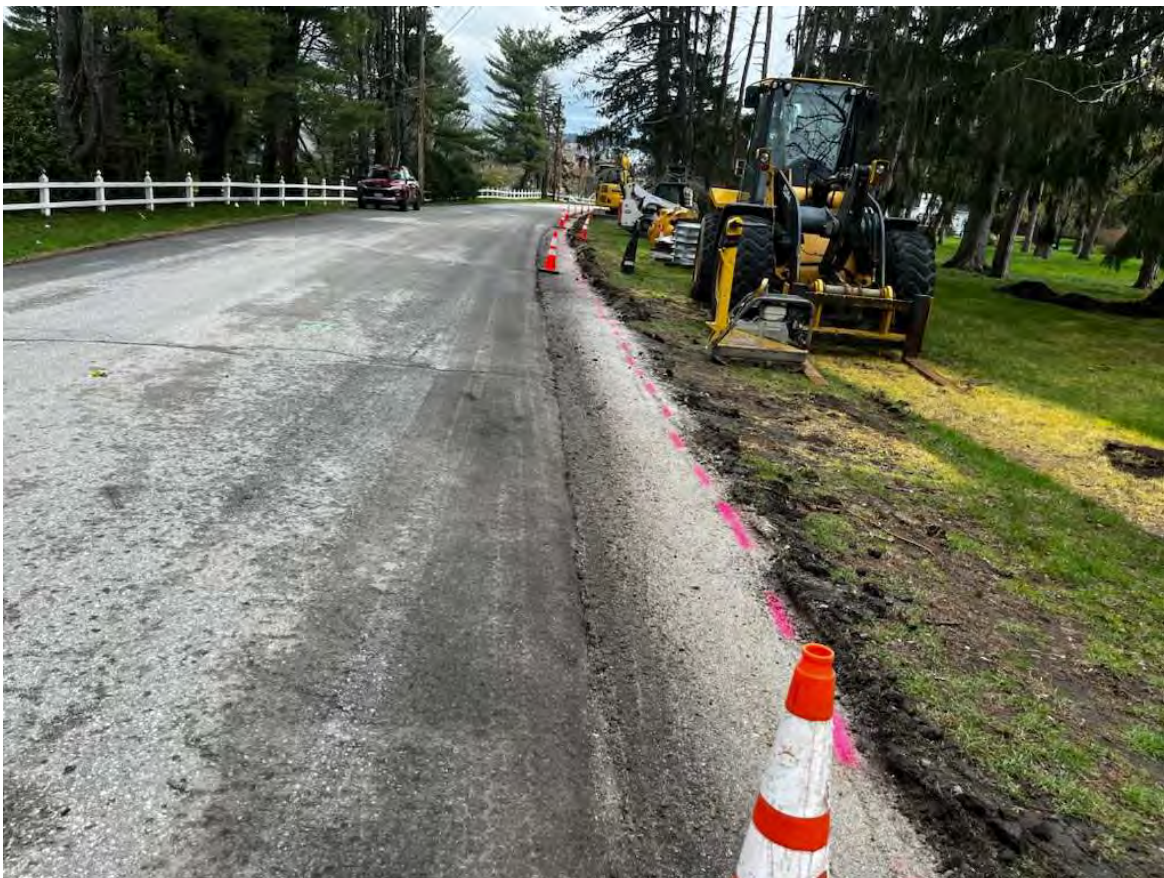
- While Dayton Sand and Gravel installed HMA, A.H. Grover, Inc. widened the road from STA 0+35 to STA 3+86 to obtain 21 feet of road length from face of curb, which was not included in the plans.
  - This road widening area was approximately 351 feet long, and was excavated 2 feet wide, at a depth of 2.25' for a total of 58.5 additional CY of Common Excavation. Material consistent with MaineDOT 703.06 Type D gravel was installed in this area at a depth of approximately 2 feet for a total of 52.0 additional CY of Type D gravel. (Photo 8)
- A.H. Grover, Inc. makes efforts to communicate with homeowners.
  - KN and A.H. Grover, Inc. worked with homeowners to get them out of their driveways in a timely manner once aprons were paved.
- The table below reflects the approximate quantities as of the end of the day May 3, 2023:

Photo 8 – Road widening/ Curb installation box cut area from STA 0+35 to STA 3+86.
