#### **DAILY CONSTRUCTION REPORT**

Date: Monday, 10-02-2017

PROJECT:Middle Road ImprovementsWEATHER:Sunny, Clear w/ high cloudsCLIENT:Town of CumberlandTEMP:AM: upper 40's PM: upper 60's

# SEVEE & MAHER ENGINEERS, INC. CONSTRUCTION PHOTOS October 2, 2017

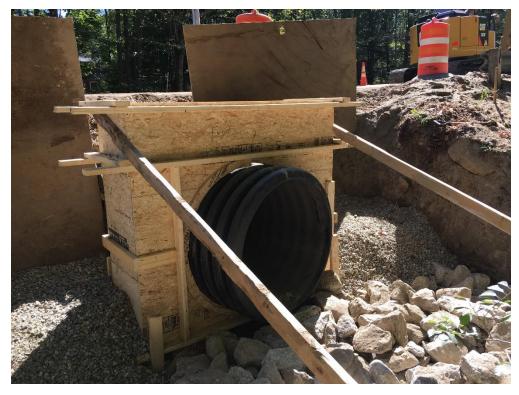
Form constructed in the morning for the cast-in-place concrete headwall.

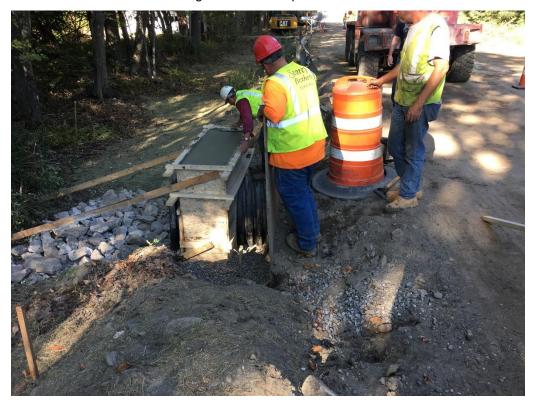
By 3:15 PM, the concrete was placed in the form and troweled to a smooth finish.

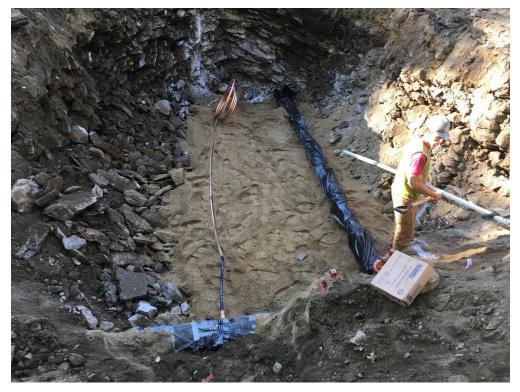
Due to the proximity of the hydrant tee and the "long side" 1-inch copper water services, a single large excavation was used instead of a trench box.

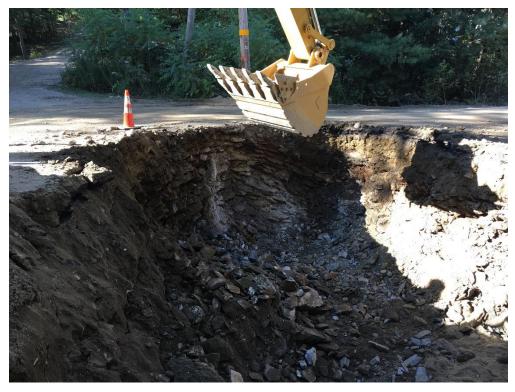
Side view of excavation at STA 15+25 during the installation of the hydrant crossing the road to Evergreen Lane. With much of the overburden removed after blasting to return the road to grade, nearly the entire excavation is in shattered ledge.
