DAILY CONSTRUCTION REPORT

Date: Tuesday, 10-31-2017
(Day 131)

PROJECT: Middle Road Improvements
CLIENT: Town of Cumberland
CONTRACTOR: Storey Brothers
PROJECT MANAGER: Dan Diffin, P.E.

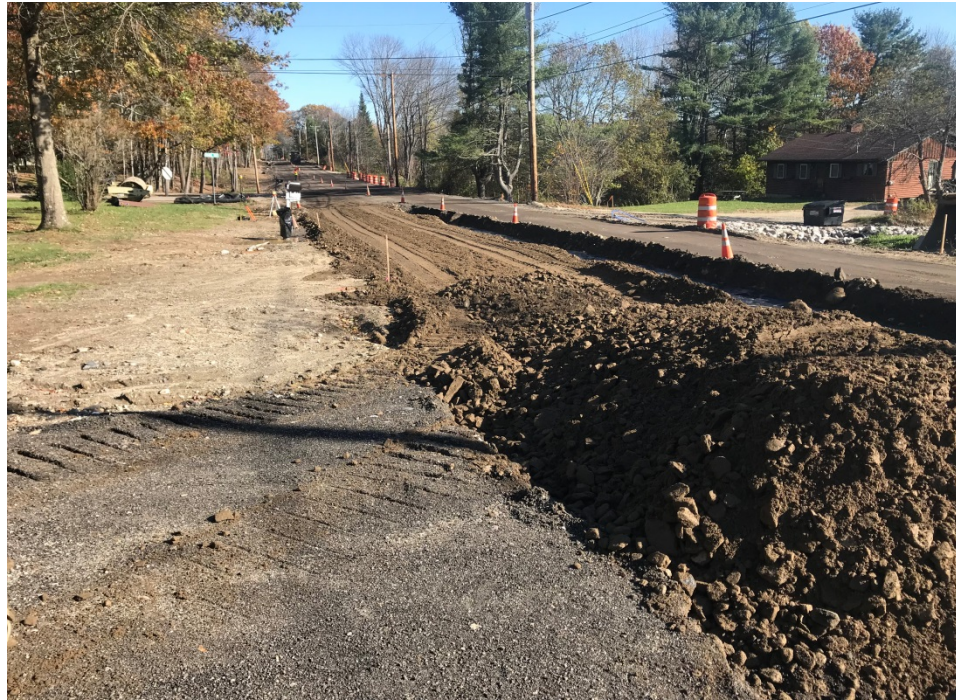
Photo 1 – Actively working on box cut for full depth construction, STA 26+00 headed southward on west side of Middle Road.

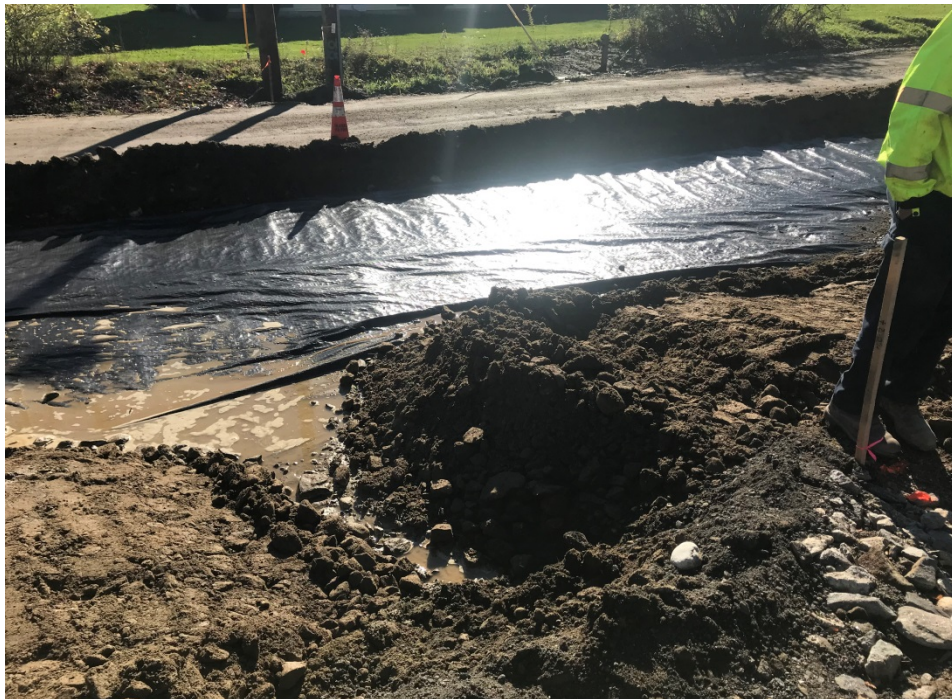
Time	Name	Representing	Remarks
2:30PM	Bill Shane, Town Manager.	Town of Cumberland	Noticed water coming out of the east side ditch into box cut from water main trench. Authorized the installation of 6 inch UD on east and west sides of Middle Road from STA 26+80 to approximate STA 20+00.

Photo 2 – Placing woven fabric on subgrade. Water is entering the box cut from the adjacent driveway. The new 6 inch UD will be installed through this location.

Install 6 inch underdrain on east and west side of Middle Road STA 26+80 to 20+20 southward.

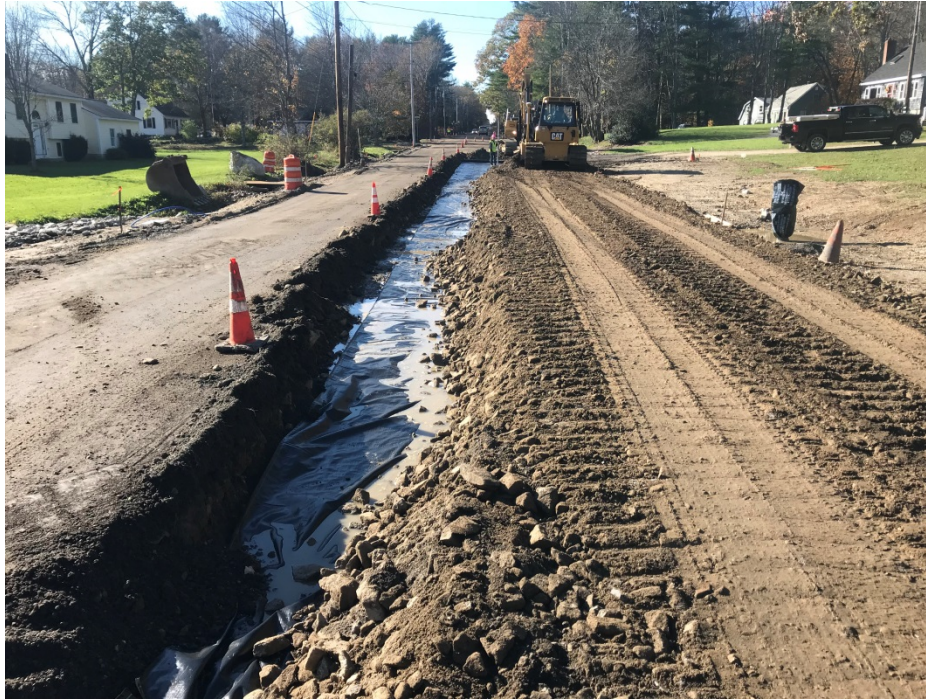
Photo 3 – Box cut for full depth construction on west side of Middle Road.

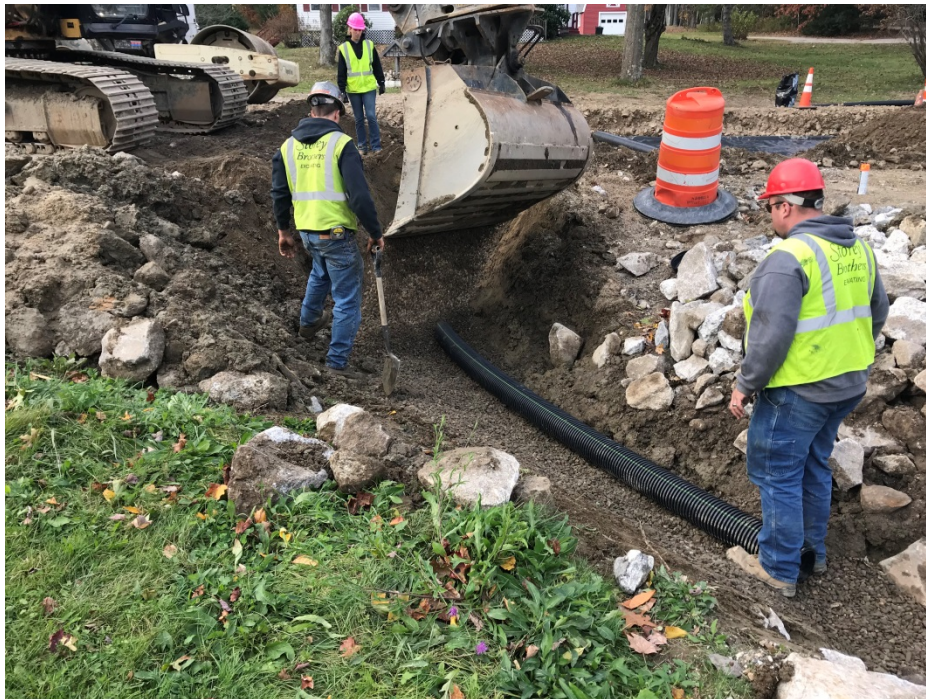
Worked on full depth box cut construction from STA 27+00 to STA 24+50 southward on east travel lane then relocated to west travel lane and worked on full depth box cut construction 27+00 to STA 24+50.
Installed 6 inch UD outlet pipe at STA 26+75 to daylight in rip rap swale.

Photo 4 – Installing 6 inch UD at STA 26+75 to daylight into rip rap swale.

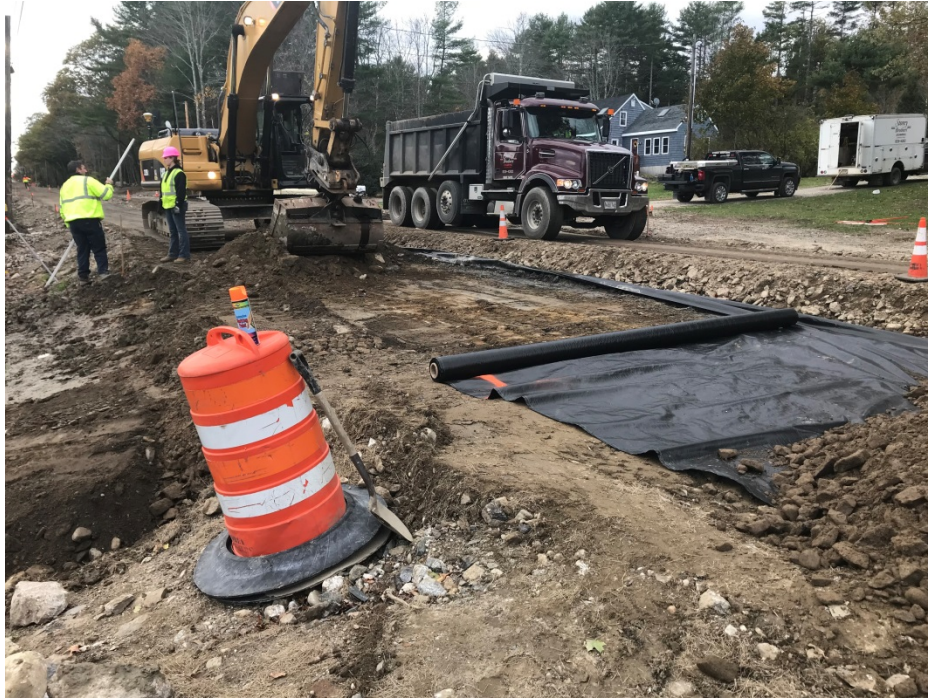
Photo 5 – Continuing box cut for full depth construction on east side of Middle Road STA 26+00.

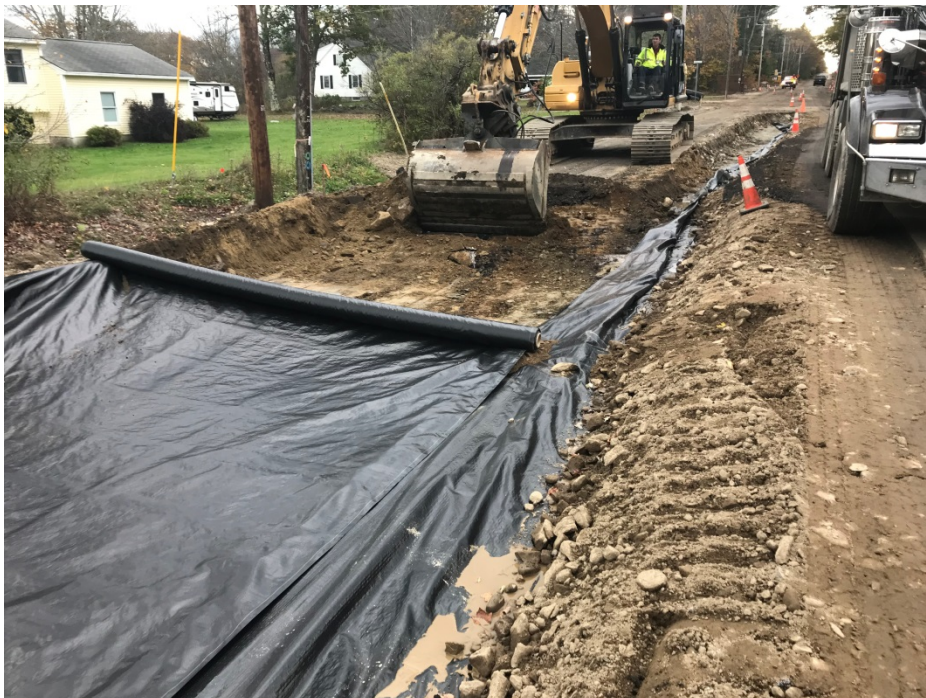
Photo 6 – Box cut for full depth construction on east side of Middle Road.
