**DAILY CONSTRUCTION REPORT**

Date: Tuesday, 09-05-2017  
(Day 94)

**PROJECT:** Middle Road Improvements  
**CLIENT:** Town of Cumberland  
**CONTRACTOR:** Storey Brothers  
**PROJECT MANAGER:** Dan Diffin, P.E.

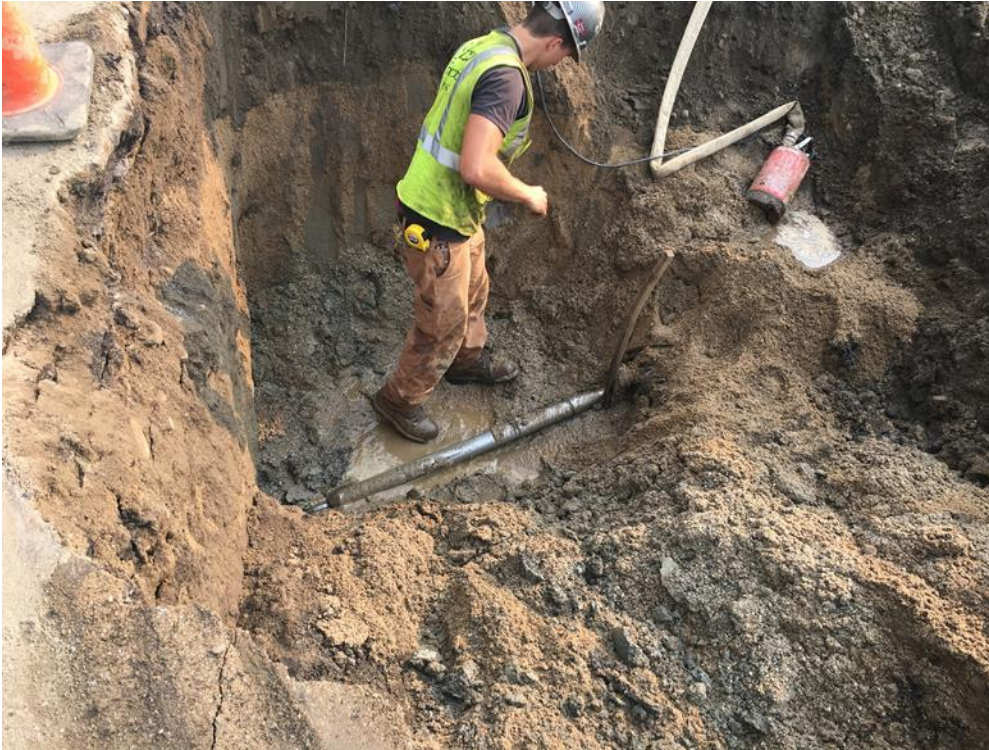
"Long side" services were mainly installed via the "Pneumatic Mole." Copper service line was pulled through the void which helped minimize traffic disruptions.

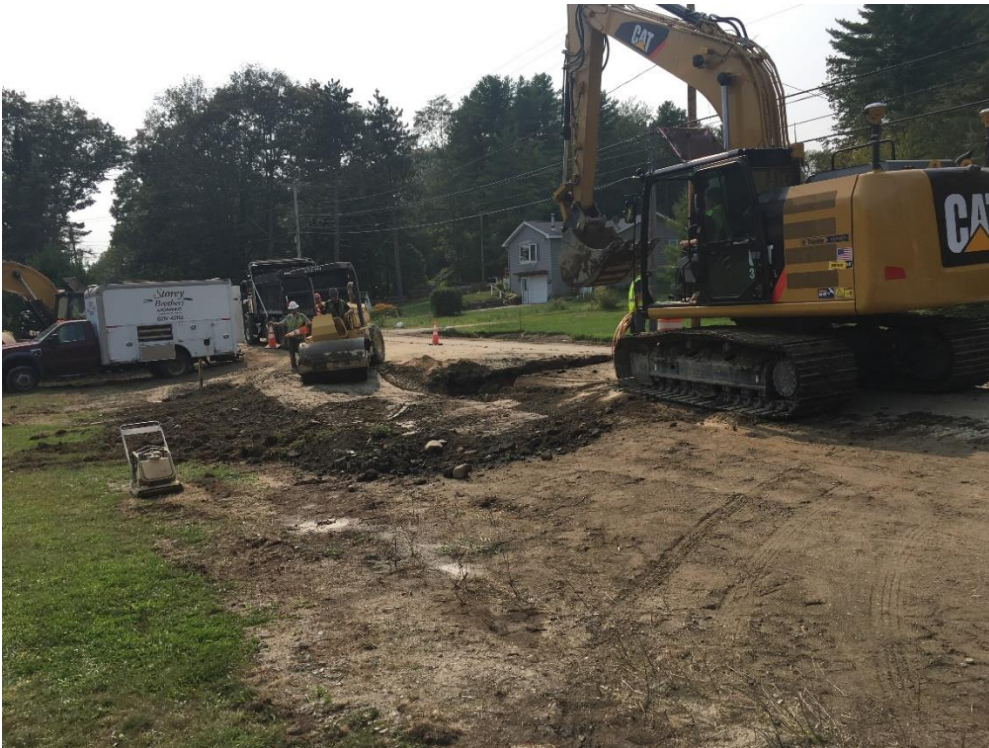
Had to use conventional open trench method when mole did not achieve proper depth.
