DAILY CONSTRUCTION REPORT

Date: Wednesday, 07-19-2017
(Day 62)

PROJECT: Middle Road Improvements
CLIENT: Town of Cumberland
CONTRACTOR: Storey Brothers
PROJECT MANAGER: Dan Diffin, P.E.

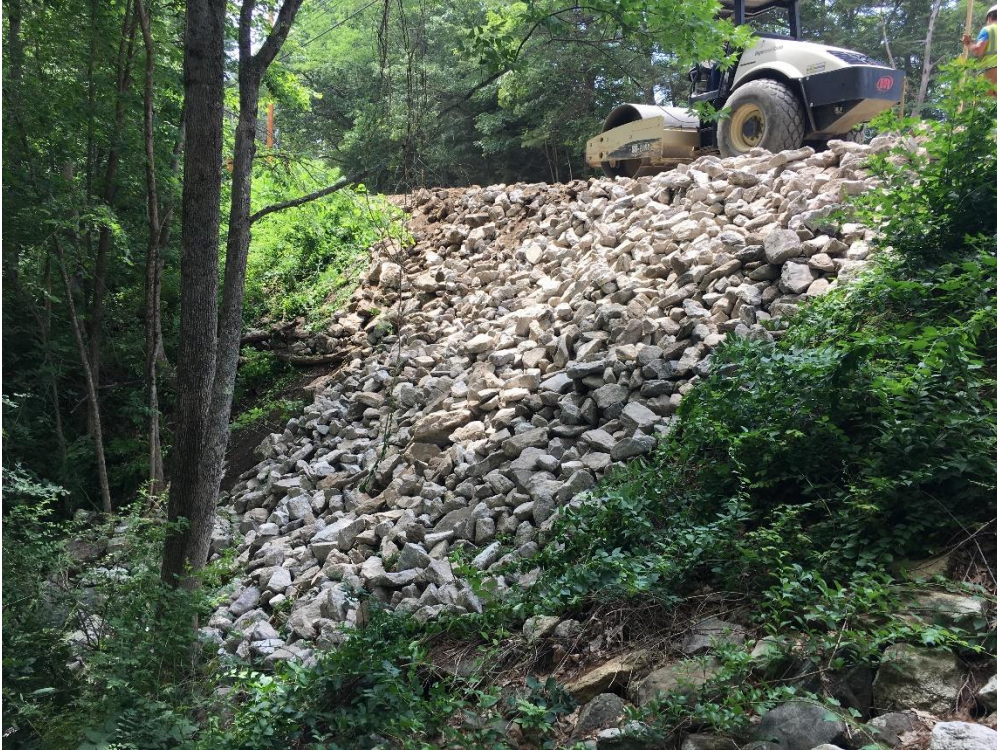
Placement of "Heavy Rip Rap" on outlet (east) side of Chernery Brook Gully above outlet of 42-inch culvert at STA 55+80.

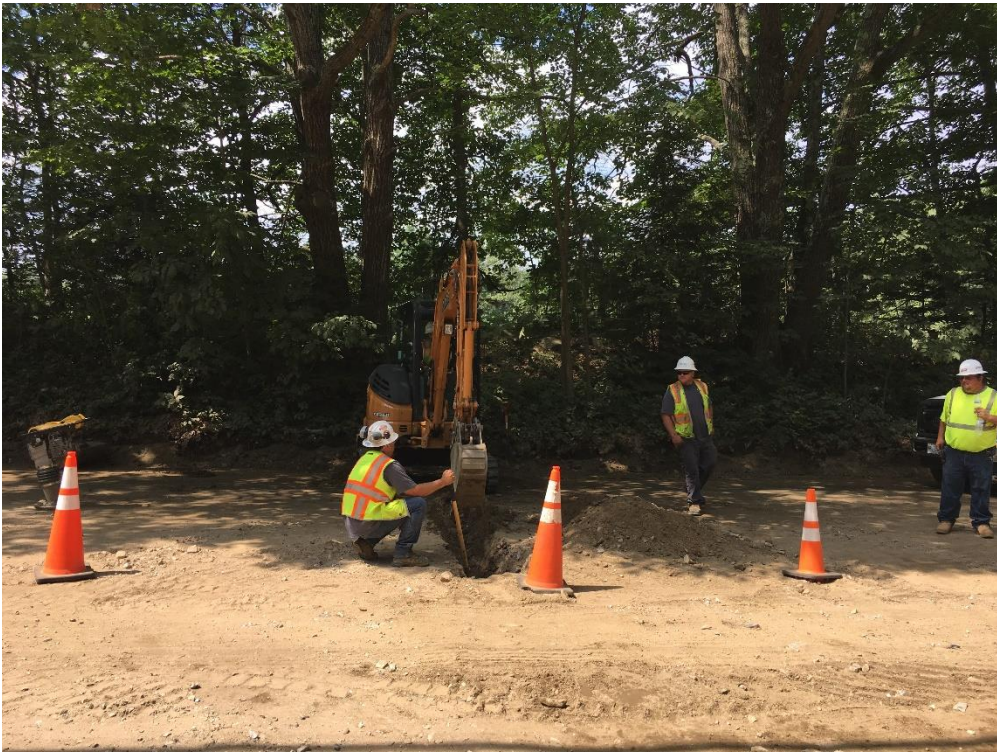
Summit trenching and installing PVC conduit sleeves across road for proposed "long side services."

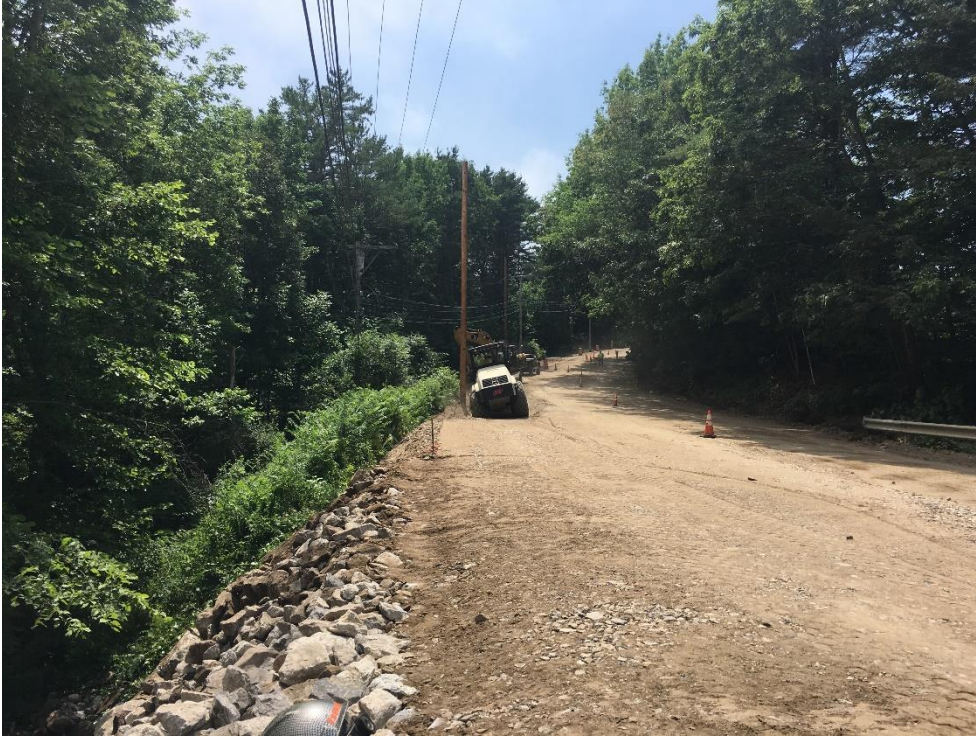
New pole 321 moved towards road by CMP appears to be in area to be paved behind the guardrail.

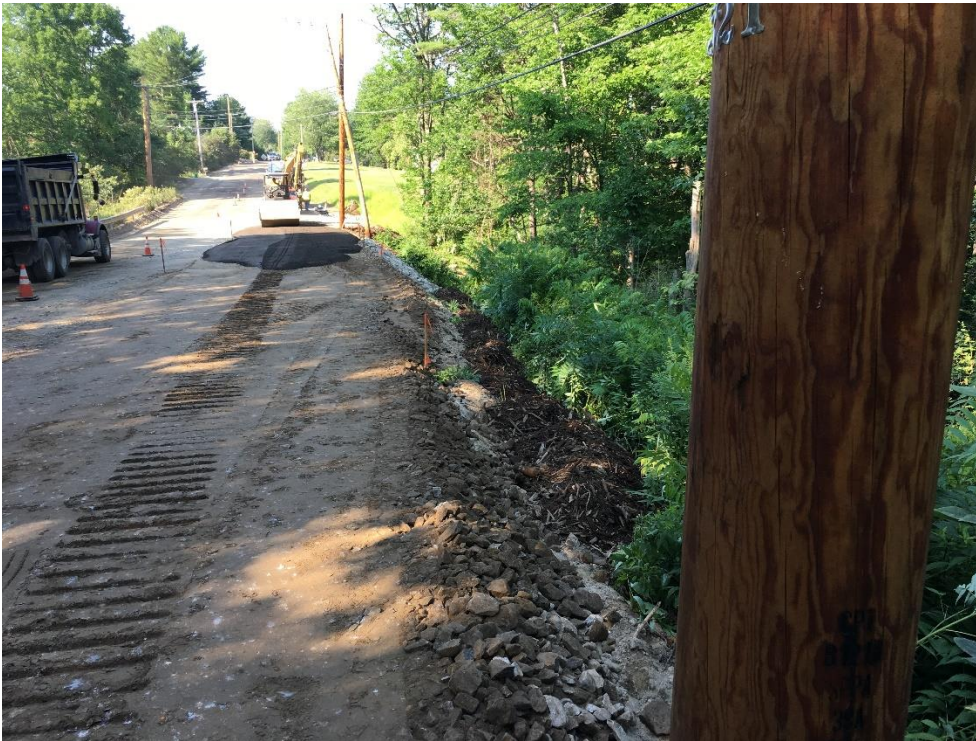
Placement of screened pavement millings (stable base for temporary jersey barriers) and erosion control mix along east side of road near steep slope in gully area.
