DAILY CONSTRUCTION REPORT

Date: Tuesday, 06-20-2017
(Day 44)

PROJECT: Middle Road Improvements
CLIENT: Town of Cumberland
CONTRACTOR: Storey Brothers
PROJECT MANAGER: Dan Diffin, P.E.

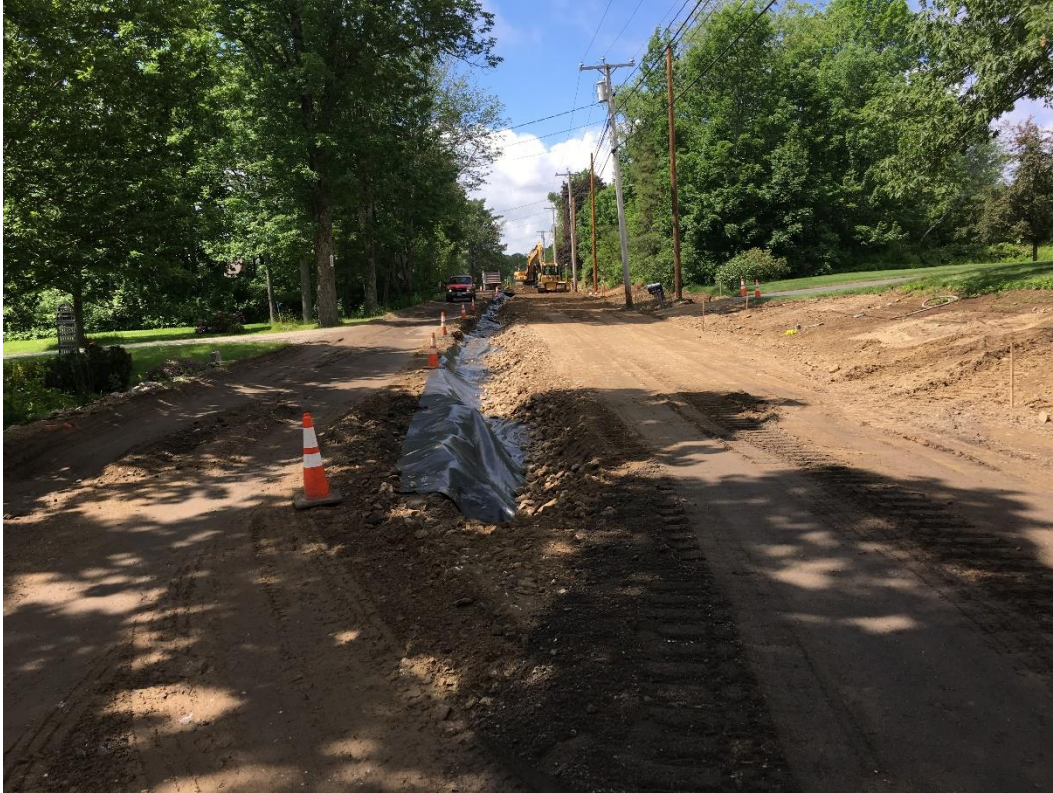
Starting point of today's installation in foreground. Crew nearing turning point in background.

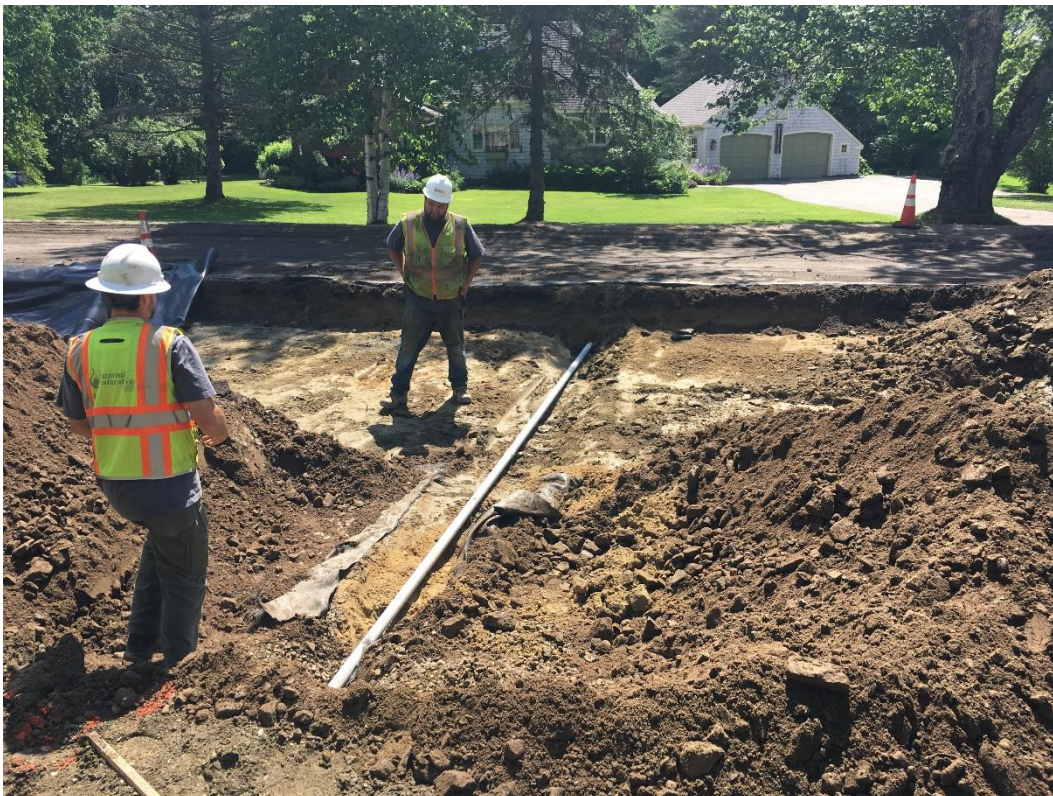
Summit crew placing PVC conduit sleeve for future natural gas service to 137 Middle Road under silty clay subgrade of road prior to backfilling.

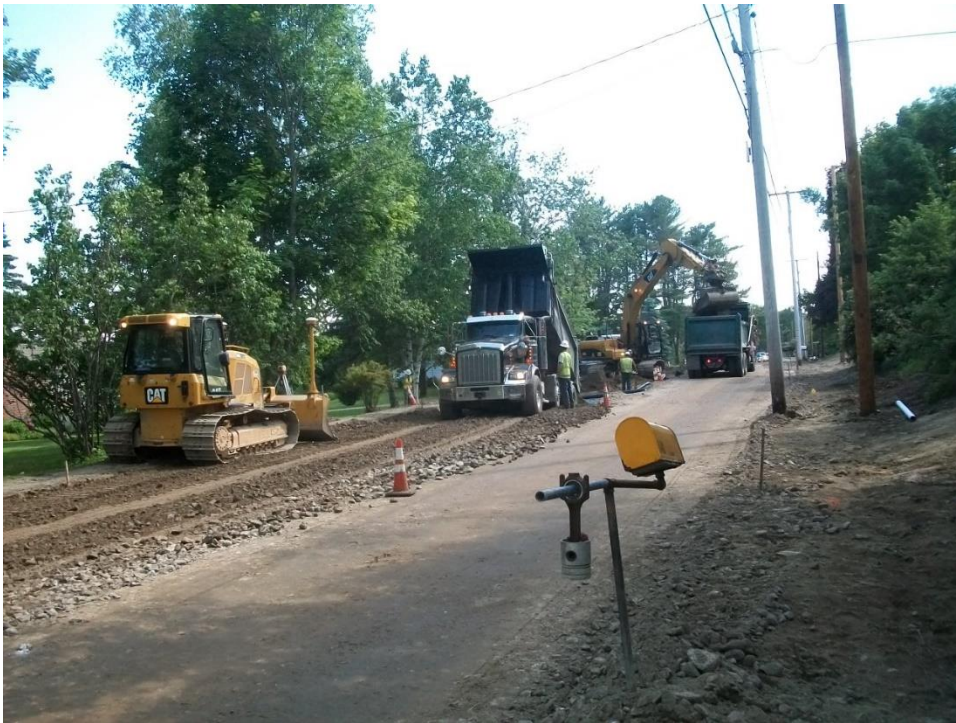
Excavating the eastern side of the road near the end of the day followed closely by placement of gravel. 140 Middle Road (Lewis) mailbox in foreground.

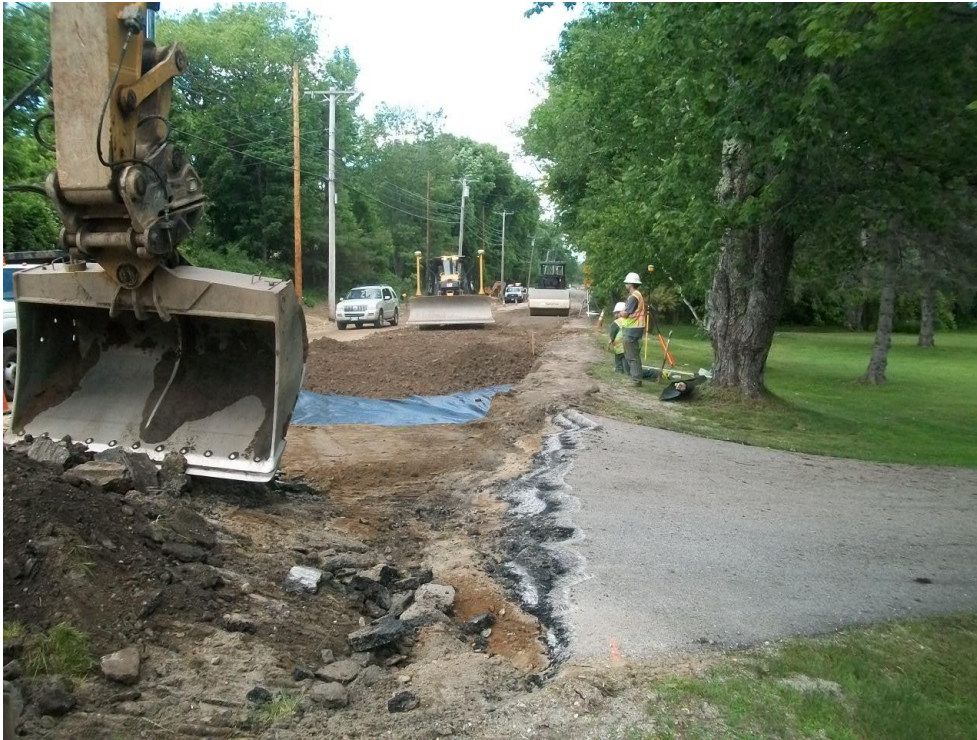
View along the eastern edge of the road in front of driveway for 137 Middle Road looking northward along today's progress.
