DAILY CONSTRUCTION REPORT

Date: Thursday, 06-22-2017
(Day 46)

PROJECT: Middle Road Improvements
CLIENT: Town of Cumberland
CONTRACTOR: Storey Brothers
PROJECT MANAGER: Dan Diffin, P.E.

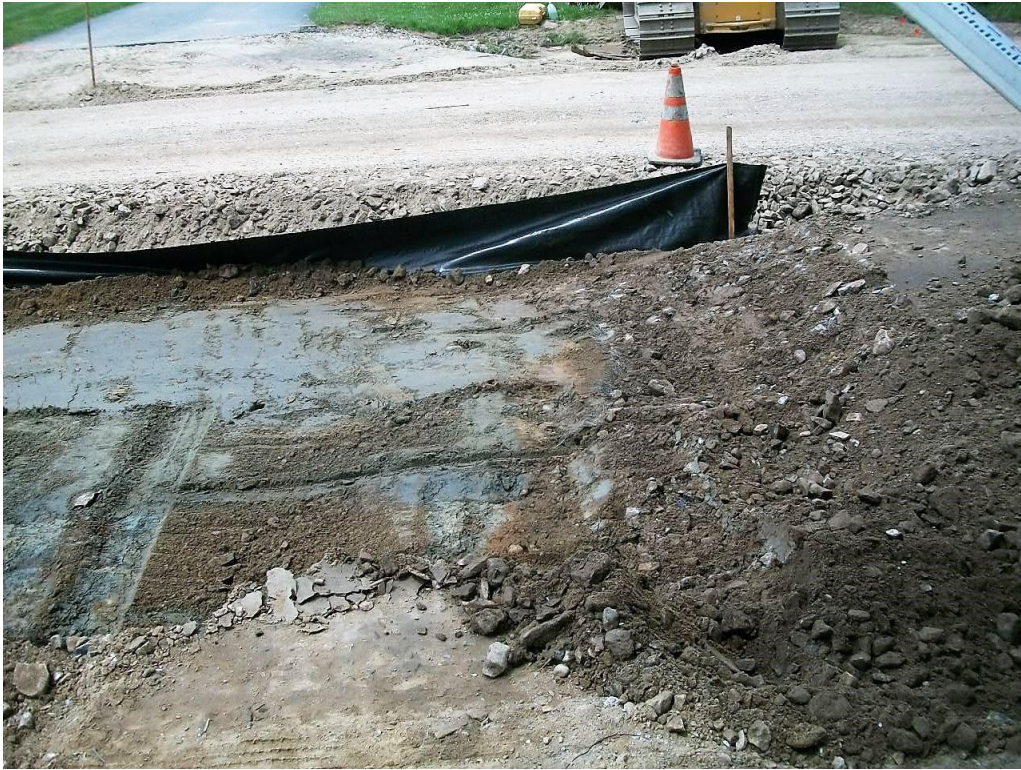
Subgrade of bluish gray clay at the driveway for 129 Middle Road was typical.

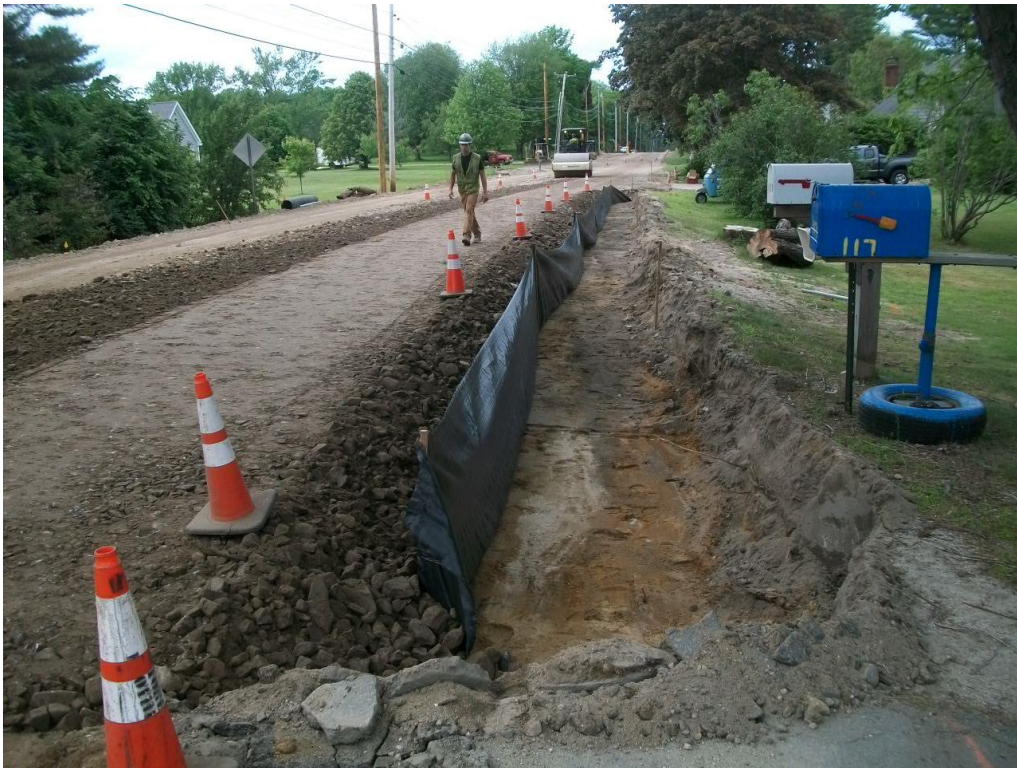
View at end of day looking north from the Casey driveway. Eastern edge of the road remained open so the remaining underdrain can be installed.
