DAILY CONSTRUCTION REPORT

Date: Thursday, 05-11-2017
(Day 16)

PROJECT: Middle Road Improvements
CLIENT: Town of Cumberland
CONTRACTOR: Storey Brothers
PROJECT MANAGER: Dan Diffin, P.E.

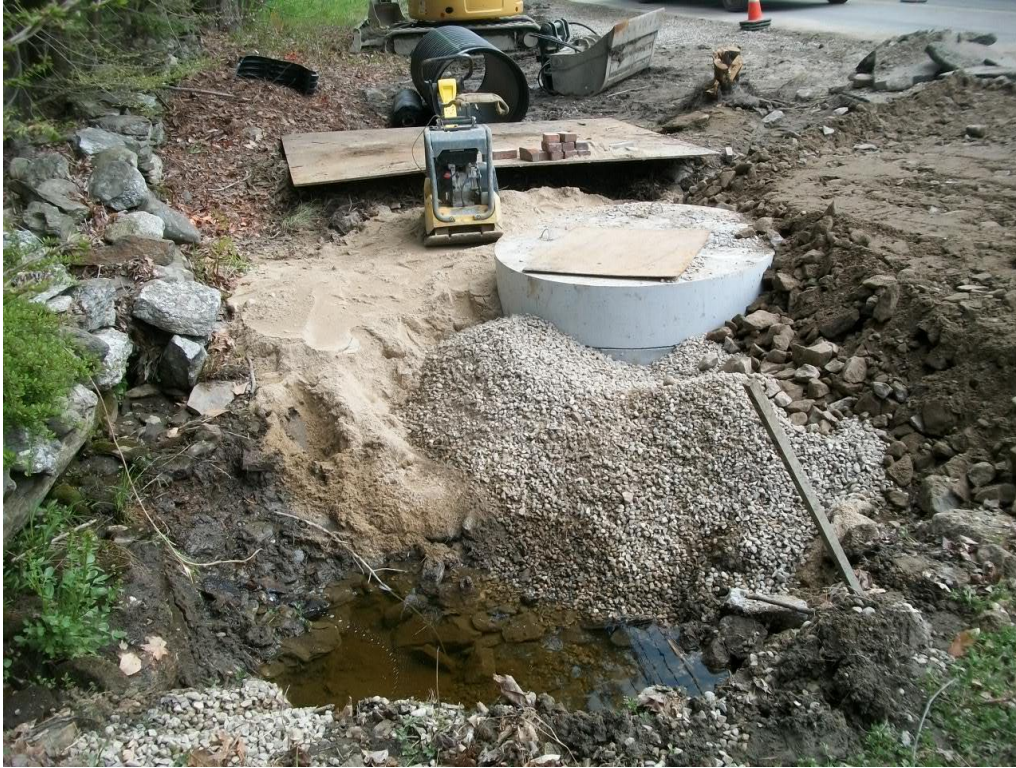
Structure for Catch Basin CB- 7E installed late the previous day was raised so 36" outlet could clear over the existing water main.

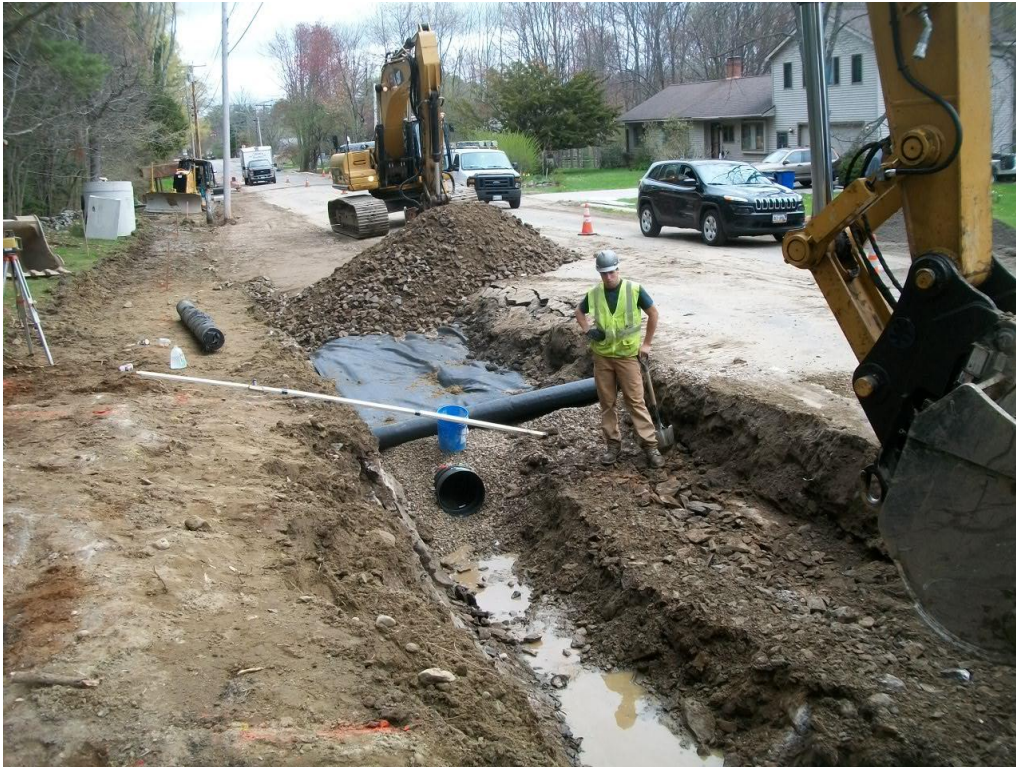
15-inch underdrain near STA 77+50 installed from CB-7E upwards towards CB-7C.

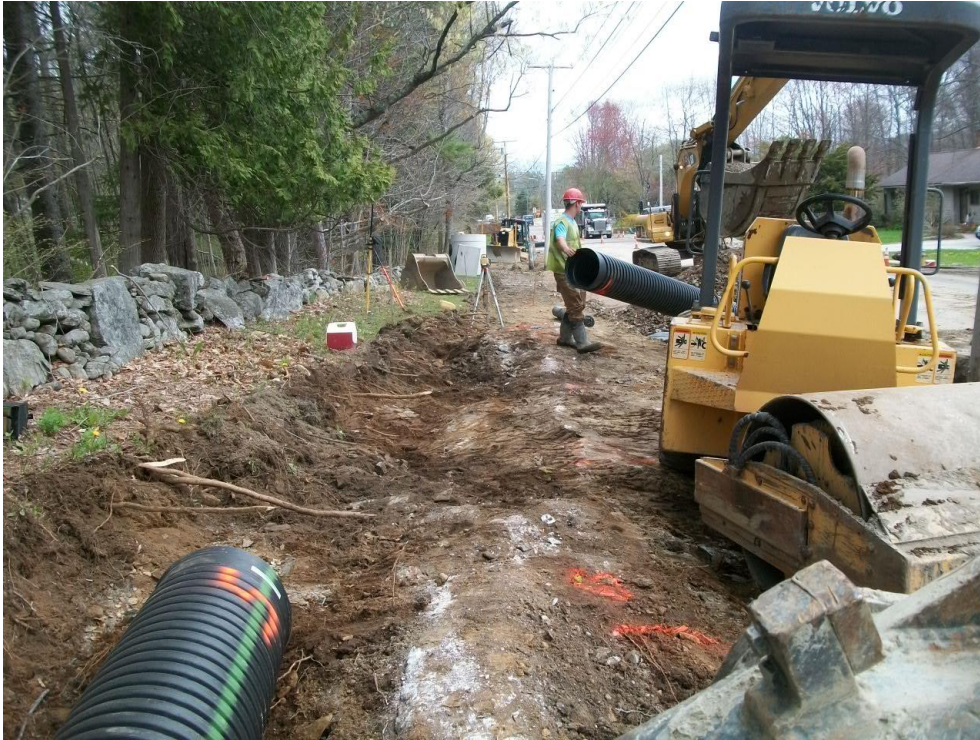
Ledge exposed after stripping away topsoil while construction of the back slopes of the shallow swales between CB-7E and CB-7C.

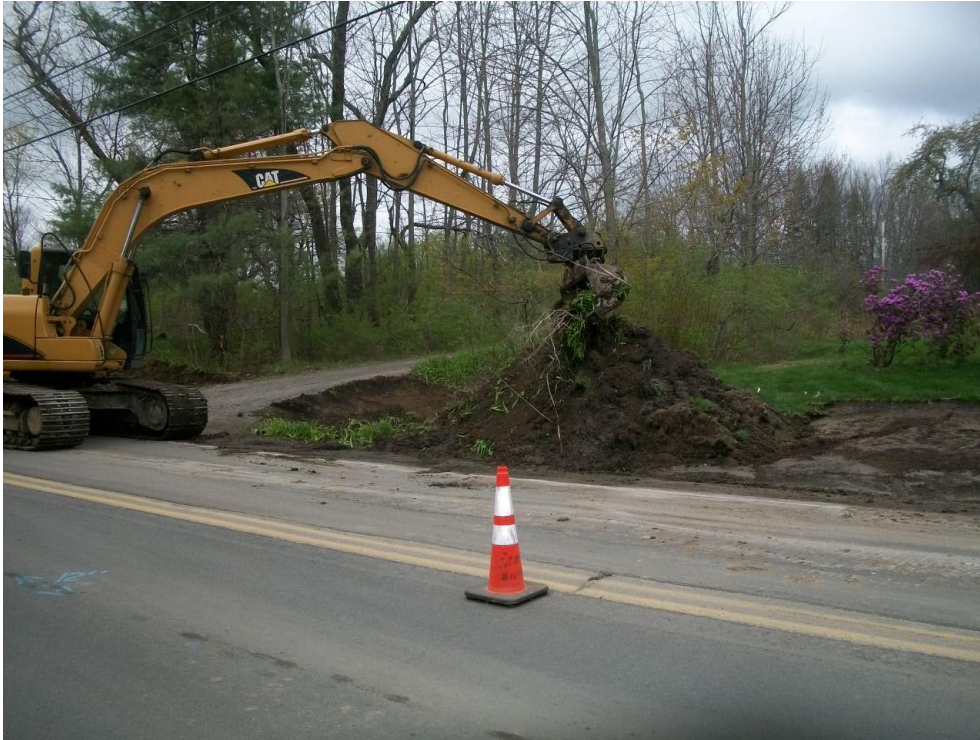
Additional excavator used to strip and rough grade the shallow drainage swales along west side of road between 140 & 142 Middle Road
