FIELD OBSERVATION REPORT

Project: Gas Main – Cumberland-Falmouth-Yarmouth
Client: Towns of Cumberland, Falmouth and Yarmouth
GP Field Rep: Benjamin Grondin (BG)
Weather: Sunny
Temp. Range: 57°F-73°F
Time onsite: Multiple visits

GP Project No: 1636.87
Visit Date: August 29, 2017
Report Date: August 30, 2017

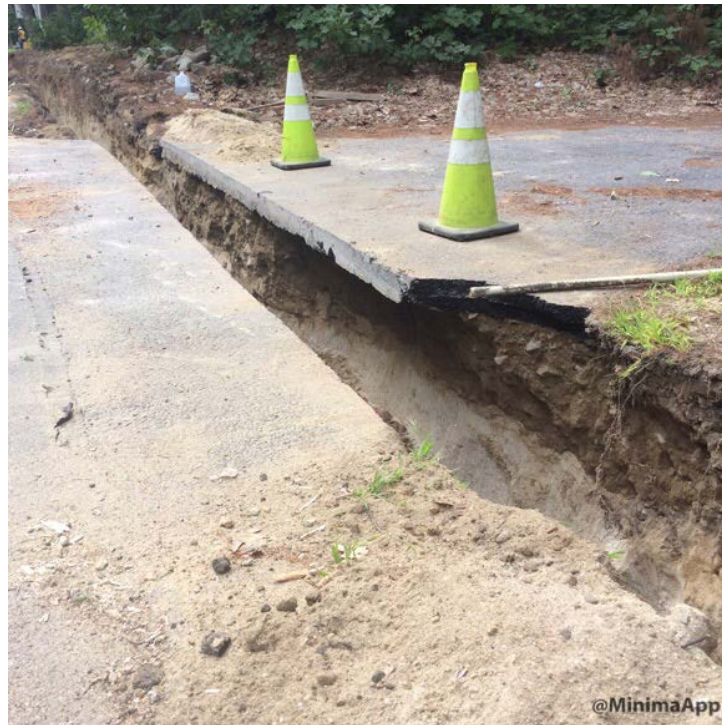
- Work Zone Closure: 1 lane closed on Skillin Road with flaggers maintaining alternating one way traffic.
- Crew installed approximately 400' of 4" gas from near house #36 to near house #38 at approximately 40" depth.
- Pavement removal was limited to driveway crossings. The driveway apron at house #38 was undermined due to trench excavation. Therefore, the pavement shall be sawcut beyond the limit of the undermined area.
- All utilities located via manhole inverts, camera, electronic locator, or hand excavated.
- Depth of utilities is to top of pipe unless noted in the table below.

Driveway trench undermined at house #38

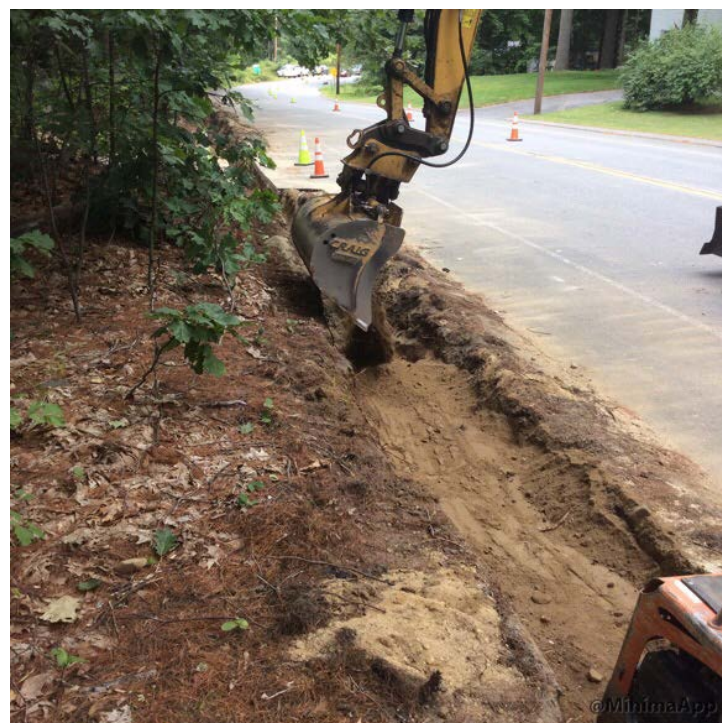
- Crew achieved >1' of separation on all utility crossings.
- Crew achieved >6' of separation from all parallel utilities.
- Crew backfilled trench with sand around the gas main, with existing material on top of the sand. Backfill was placed in lifts with each lift compacted with a plate wacker.
- Crew cleaned worksite and traffic returned to normal by 4:30PM.

Placing backfill in trench

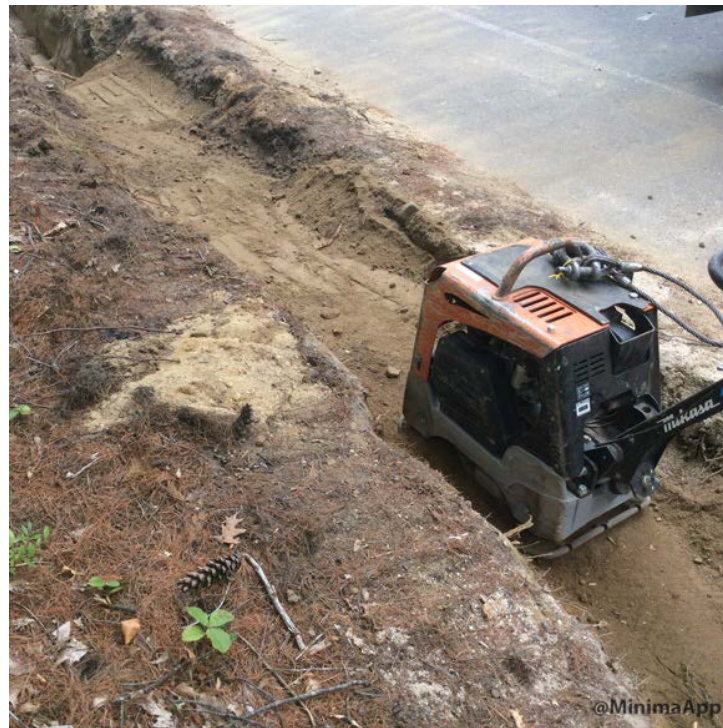
Compacting backfill with plate wacker
