FIELD OBSERVATION REPORT

Project: Gas Main – Cumberland-Falmouth-Yarmouth
Client: Towns of Cumberland, Falmouth and Yarmouth
GP Field Rep: Benjamin Grondin (BG)
Weather: Sunny
Temp. Range: 70-80°F
Time onsite: Multiple visits

GP Project No: 1636.87
Visit Date: August 8, 2017
Report Date: August 9, 2017

Work in Progress – Town of Cumberland

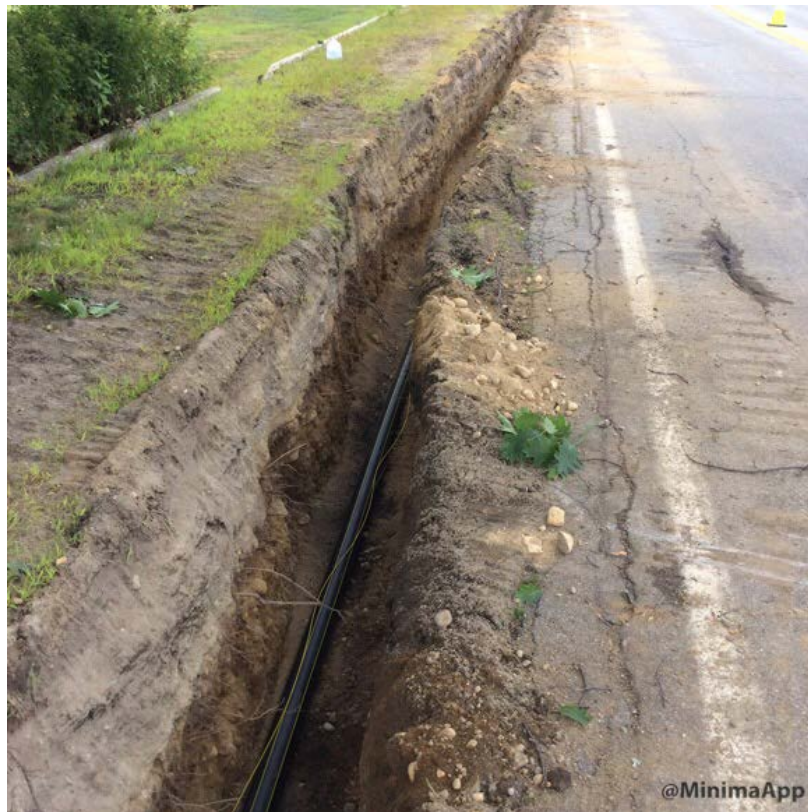
Trench in southbound shoulder of route 100

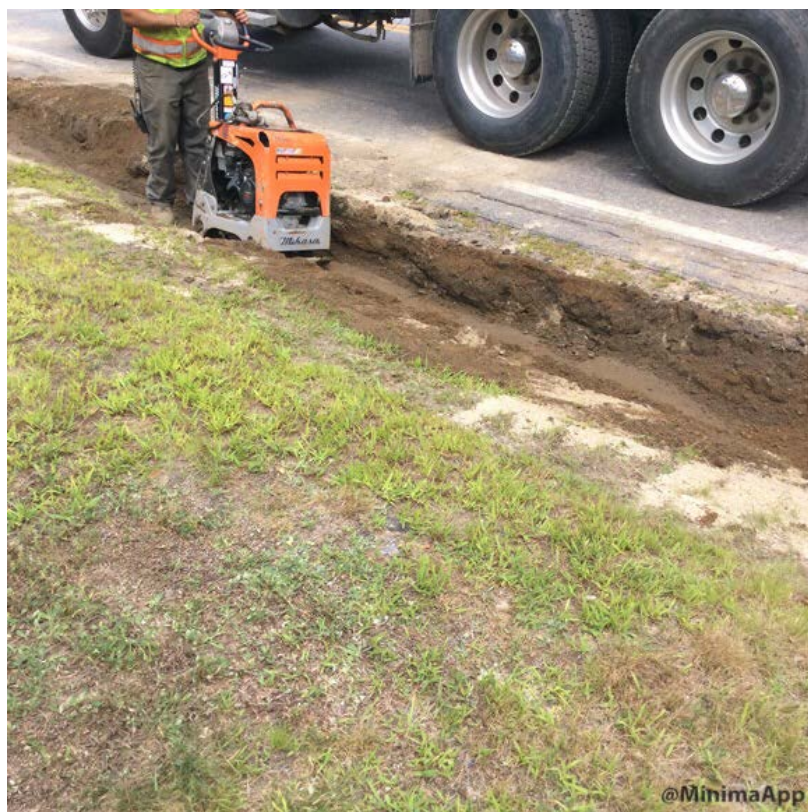
- Crew achieved >1' separation on all utility crossings and achieved >6' separation from all parallel utilities.
- Crew backfilled trench with sand around the gas main and existing material. Backfill was compacted in lifts with a plate wacker.
- Cold patch was not placed in the driveway crossing trench or roadway crossing trench at Highland Ave. due to the size and location of the trench. The gravel trench shall be monitored and repaired as necessary.
- Crew clean worksite and traffic returned to normal at approximately 4:00 PM.

Compacting backfill with plate wacker
