## FIELD OBSERVATION REPORT

Project: Longmeadow Rd & Ole Musket Rd – Drainage Improvements  
Client: Town of Cumberland  
GP Field Rep: Kassey Northrop (KN)  
Weather: Sunny, Windy  
Time onsite: 10:15 – 11:15 AM/ 3:15 – 4:00 PM  
Contractor: A.H. Grover, Inc.  
Distribution: File; Town of Cumberland

GP Project No: 3656  
Visit Date: April 3, 2023  
Report Date: August 3, 2023  
Temp. Range: 42-46°F

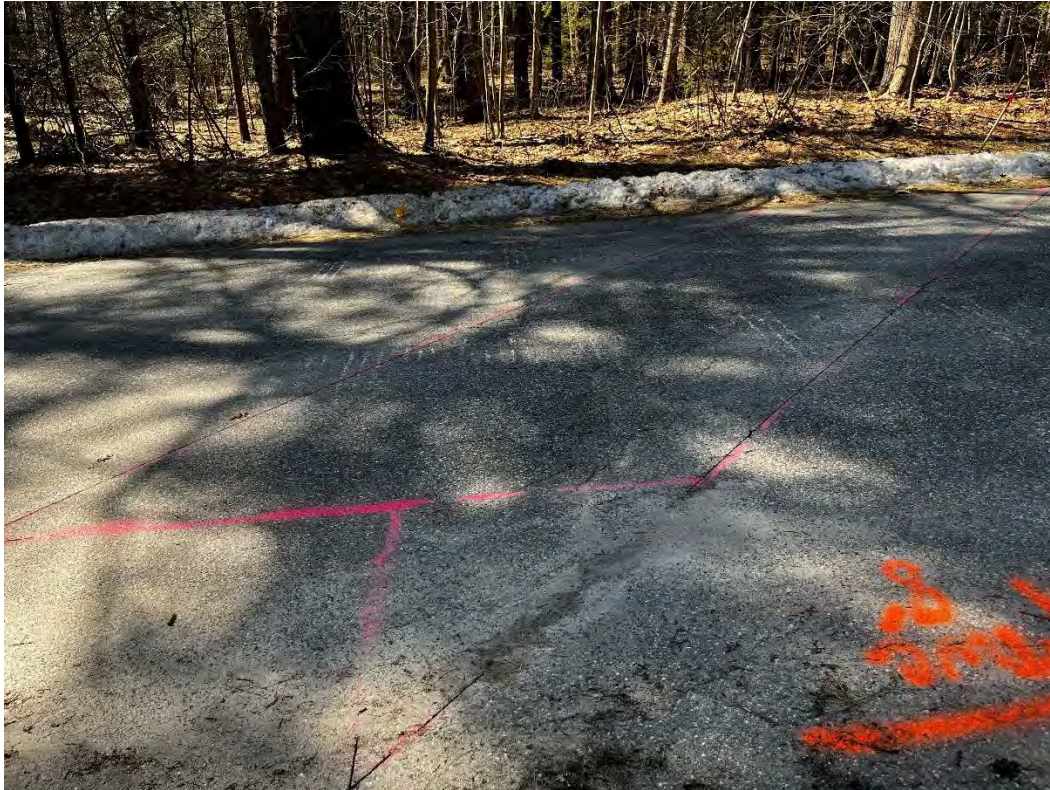
- Prior to arrival A.H. Grover, Inc. had saw cut Ole Musket Road, approximately 4 feet wide where stormdrain pipe is proposed. (Photo 1)
  - House #s 12, 14, and 16 have saw cuts located on their driveway aprons. (Photo 2) Upon discussion with A.H. Grover, Inc. for timeline, KN to communicate approximate disruption to driveway use with homeowners prior to excavating.

Photo 1 – Saw cuts on Ole Musket Road

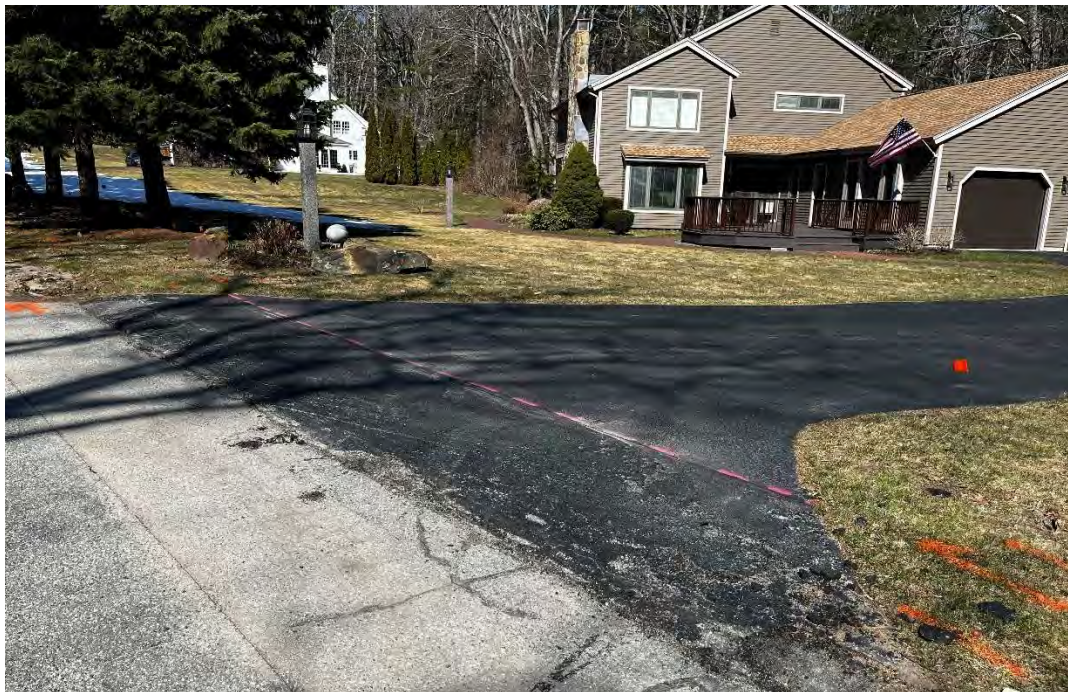
Photo 2 – House #14 with proposed excavation on the driveway apron

- **Communicate with homeowners of house numbers 12, 14, and 16 about driveway disruptions once discussed with A.H. Grover, Inc.**

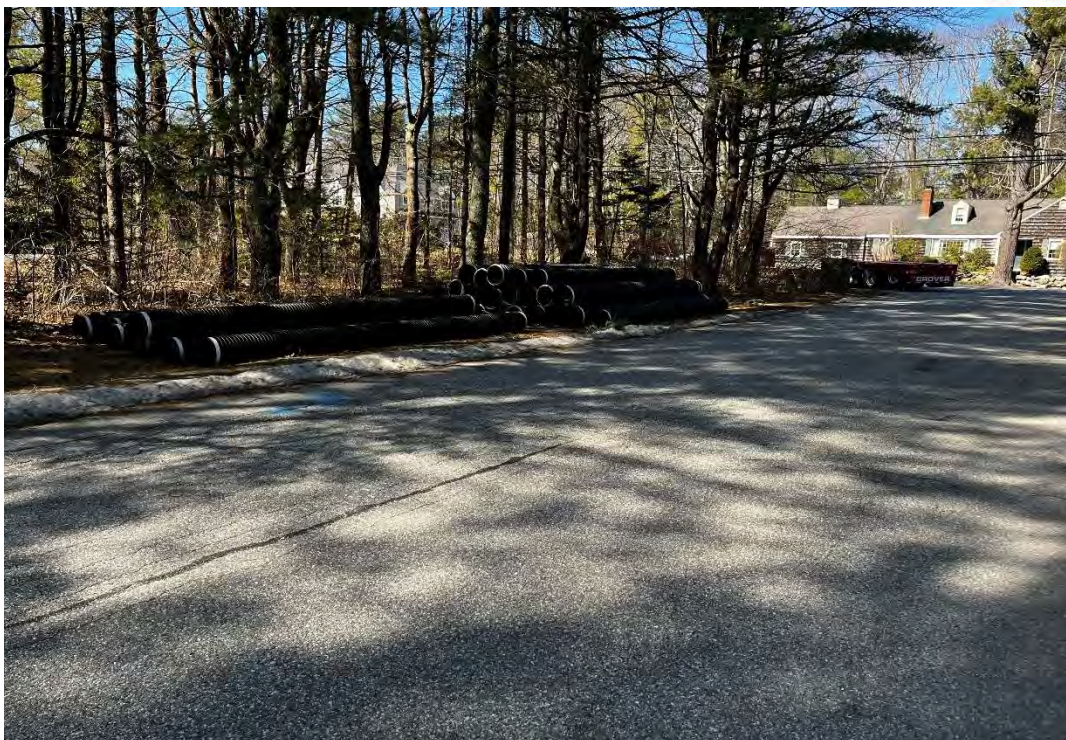
- Storm drain pipes and structures have been stored along the right-of-way, and in front of areas such as wooded, that do not appear to cause a direct visual burden on the homeowners. (Photo 3)

Photo 3 – Storm drain pipes stored along wooded area of Ole Musket Road

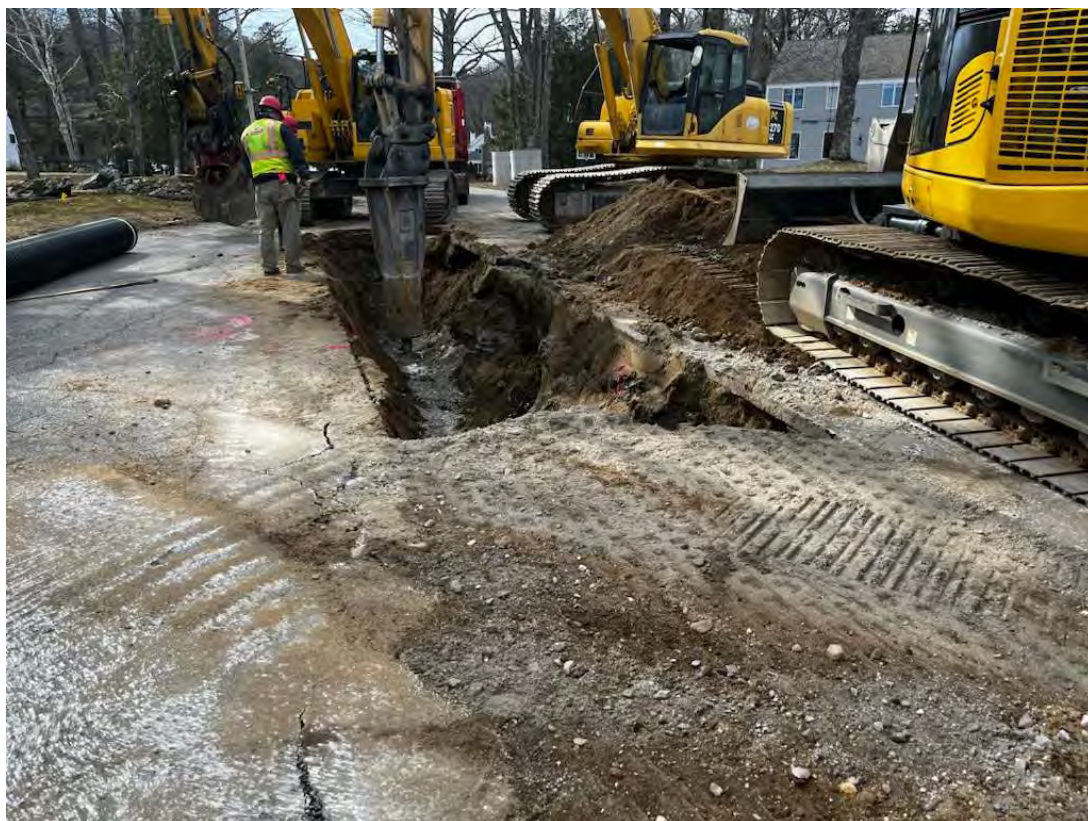
- Upon commencement of excavation starting at the existing catch basin (Exist. CB 2), ledge rock was encountered at depths of approximately 3 feet.
  - Ledge rock significantly delayed excavation. A second excavator was brought in with a breaker hammer attachment to break up the ledge rock. (Photo 4)

Photo 4 – Excavator with rock hammer attachment for ledge rock encountered.

- The invert into Exist. CB 2 was raised to help reduce the rock excavation efforts.
  - It is anticipated that the rock excavation efforts will lessen as the depths of exaction shallow out of the Cul-de-sac area.

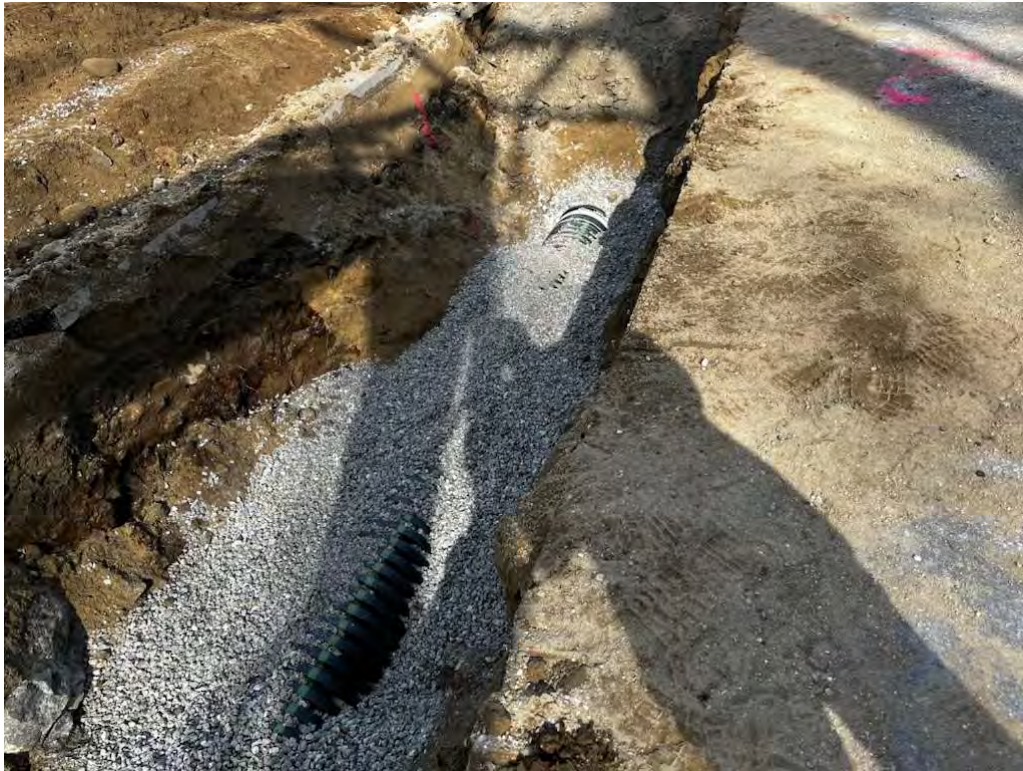
- Approximately 63 feet of 15" SD pipe was embedded with material consistent with MDOT 703.22 Type C - ¾" Crushed Stone from Exist. CB 2 towards proposed CB 28. The 63 feet of 15" SD pipe was then backfilled approximately 1.75 feet from the spring line with material consistent with MDOT 703.22 Type B UD Backfill. (Photo 5)

Photo 5 – Storm drain backfilled with crushed stone.

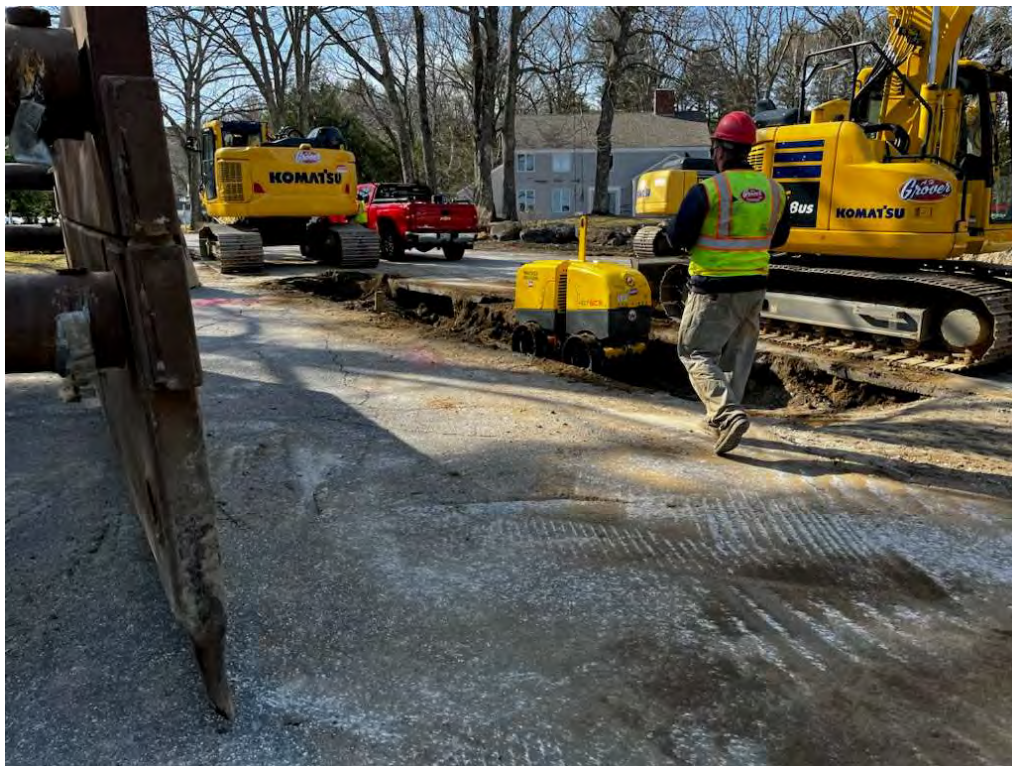
- Excavated material was used to backfill the 70 feet of trench that was excavated today, up to the subbase layer and was compacted with a Remote-Control RTSC3 Wacker Neuson. (Photo 6)

Photo 6 – Remote control Wacker Neuson compacting trench area.
