**DAILY CONSTRUCTION REPORT**

Date: Wednesday, 07-05-2017  
(Day 53)

**PROJECT:** Middle Road Improvements  
**CLIENT:** Town of Cumberland  
**CONTRACTOR:** Storey Brothers  
**PROJECT MANAGER:** Dan Diffin, P.E.

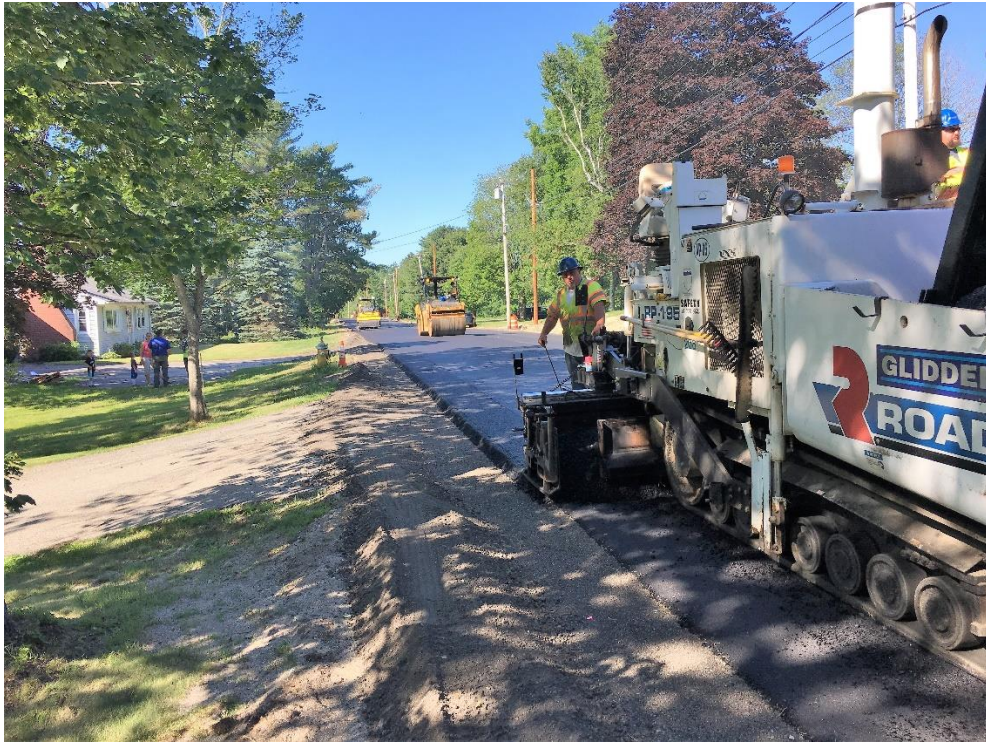
Paving 2<sup>nd</sup> layer of base pavement in the northbound lane in northerly directioning.

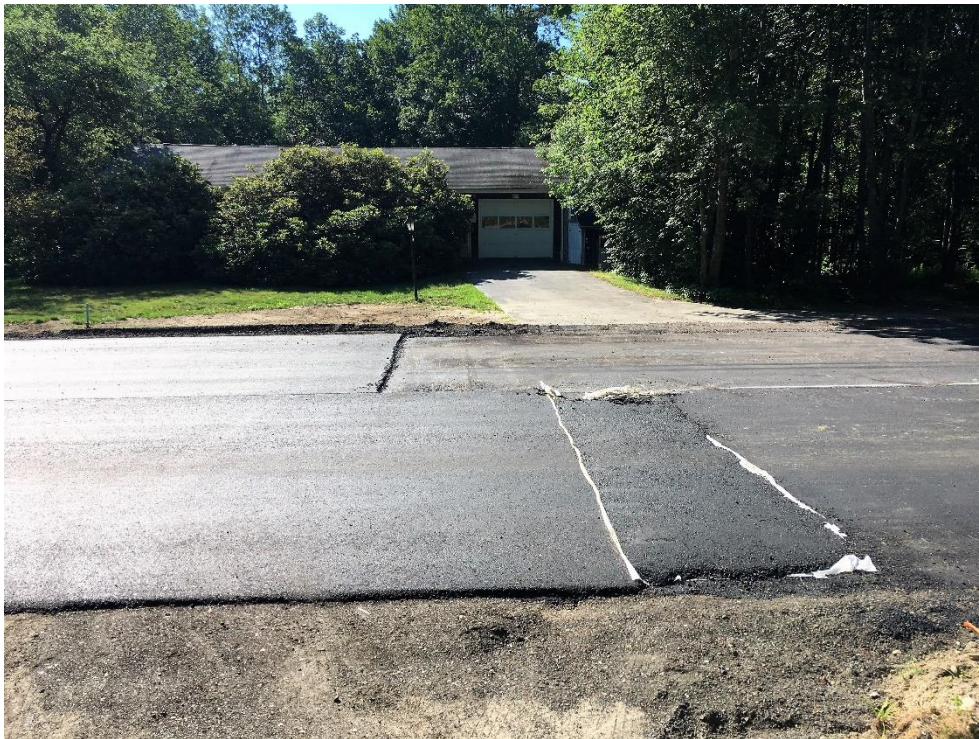
Temporary pavement ramp at STA 79+00 removed in the northbound lane being paved but remaining in the southbound lane until paving switches to southbound lane.

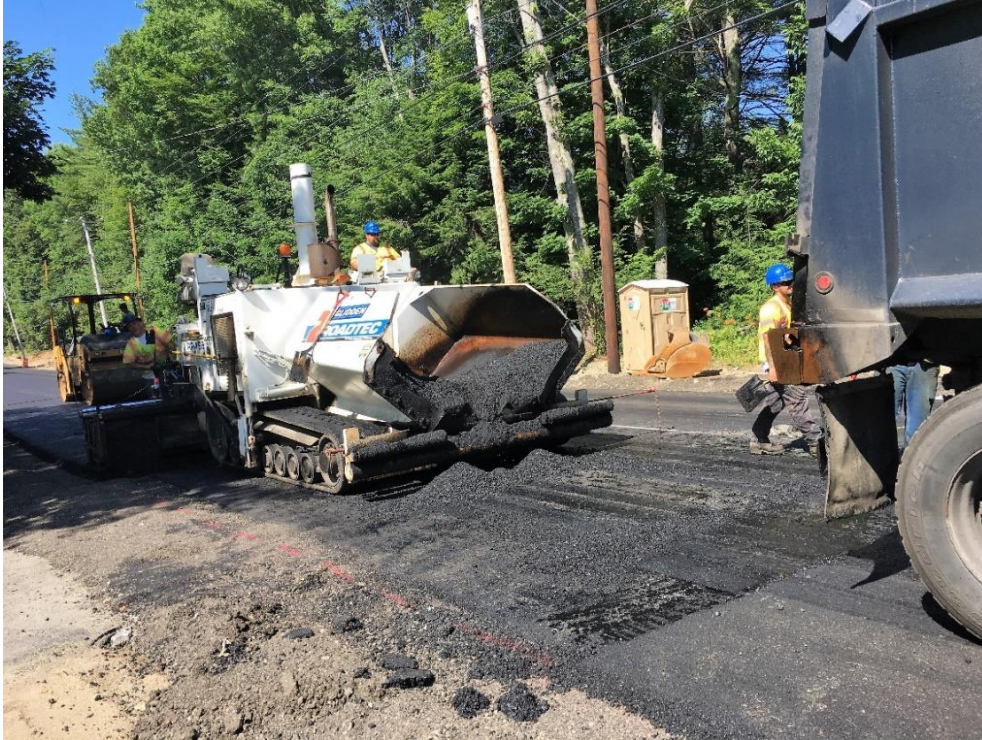
Changing trucks just before paving into the butt joint in the northbound lane at STA 79+00.

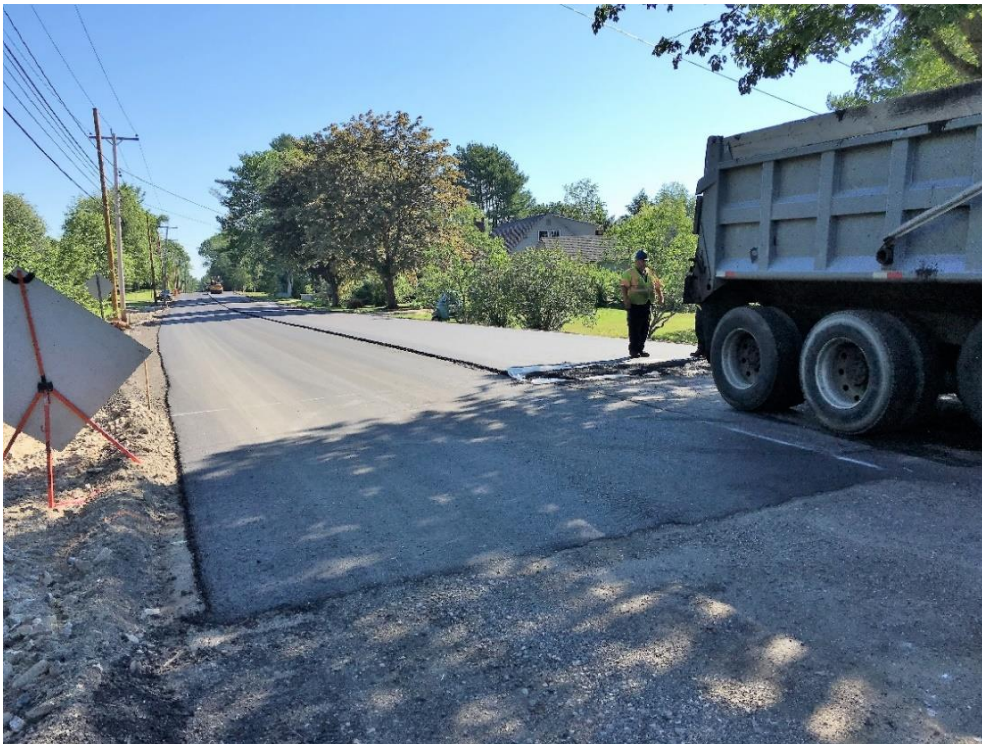
Installing a temporary paved ramp for the northbound lane at STA 62+00 prior to switching over to pave the southbound lane. A similar ramp was installed when the southbound lane was completed.
